dsPIC30F1010/202X Rev. A1 Silicon Errata

The dsPIC30F1010/202X (Rev. A1) devices that you received were found to conform to the specifications and functionality described in the following documents:

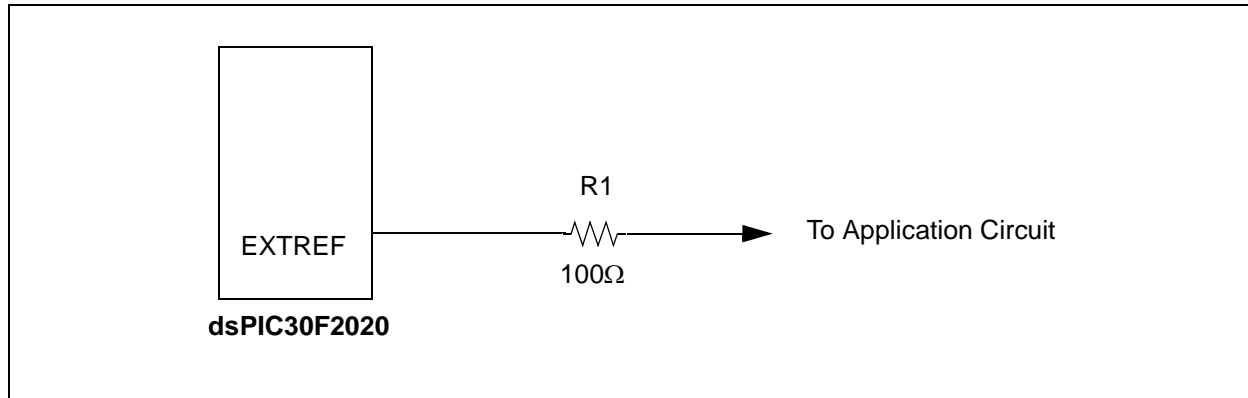
FIGURE 1: ADDITION OF 100 OHMS RESISTOR ON EXTREF PIN

The EXTREF pin is susceptible to voltage spikes below V_{SS} , which induces negative current flow into the pin. A voltage below V_{SS} on any I/O pin is outside the operating specification of the device; however, the device is designed to tolerate small voltage and current transients without experiencing detrimental effects. The EXTREF pin is more susceptible to negative current spikes than the other pins on the dsPIC1010/202X Rev. A1 devices.

If the EXTREF pin is used in any of the configurations shown in Table 2, it is recommended that a 100 ohms 1/8W resistor be added in series with the EXTREF pin (see Figure 1).

The addition of the 100 ohms resistor effectively makes the EXTREF pin as robust as the other pins on the device with respect to tolerating voltage and current transients. In most of the configurations shown in Table 2, the 100 ohms resistor will have little effect on the operation of the pin. An exception to this is when the pin is configured as the comparator reference, EXTREF. Adding a resistor in series with the reference voltage will cause a slight offset in the gain of the comparator DAC. This gain offset is related to the voltage drop across the 100 ohms resistor.
