## dsPIC30F1010/202X Rev. A3 Silicon Errata

The dsPIC30F1010/202X (Rev. A3) devices that you received were found to conform to the specifications and functionality described in the following documents:

dsPIC30F1010/202X Rev. A3 silicon is identified by performing a “Reset and Connect” operation to the device using MPLAB® ICD 2 with MPLAB IDE v7.41.03 or later. The output window will show a successful connection to the device specified in *Configure>Select Device*.

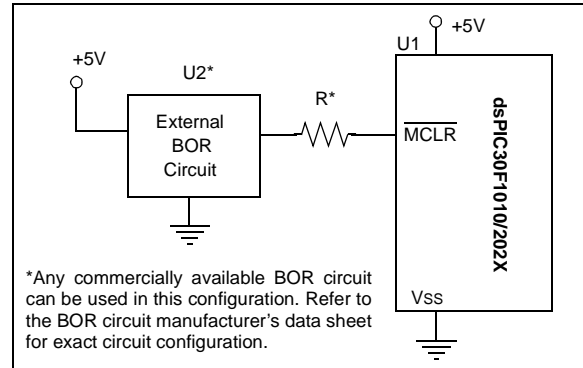
**FIGURE 1:**

It is recommended that an external Brown-out Reset (BOR) circuit be used to hold the device in reset during a brown-out event, to overcome this problem. The external BOR circuit will use the MCLR pin to hold the device in reset. The following work around, in combination with the external BOR circuit, will ensure that the device is cleanly reset after a brown-out event occurs.

The dsPIC DSC SMPS device must be powered up with the PLL disabled, the Fail-Safe Clock Monitor enabled and Clock Switching enabled. The PLL should be enabled in software via a clock switch after the device is reset (refer to **Section 29. "Oscillator"** (DS70268) in the "*dsPIC30F Family Reference Manual*" for details on clock switching). This ensures that the MCLR pin is functional and that the device can be reset by an external BOR circuit (see Figure 1).
