## PIC16(L)F72X Family Silicon Errata and Data Sheet Clarification

The PIC16(L)F72X family devices that you have received conform functionally to the current Device Data Sheet (DS41341E), except for the anomalies described in this document.

The silicon issues discussed in the following pages are for silicon revisions with the Device and Revision IDs listed in [Table 1](#). The silicon issues are summarized in [Table 2](#).

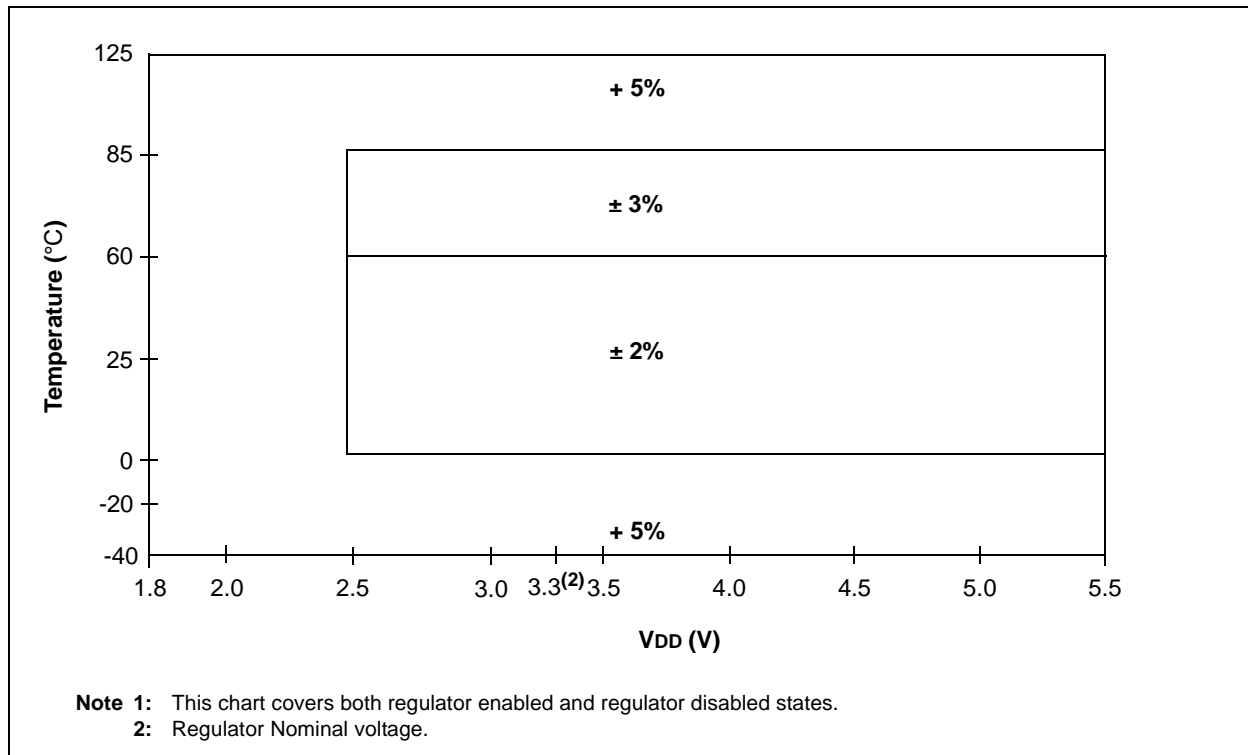
**FIGURE 1: HFINTOSC FREQUENCY ACCURACY OVER DEVICE V<sub>DD</sub> AND TEMPERATURE<sup>(1)</sup>**

The frequency tolerance of the internal oscillator is  $\pm 2\%$  from 0-60°C and  $\pm 3\%$  from 60-85°C (see [Figure 1](#)).
