PIC16(L)F1826/1827 Family Silicon Errata and Data Sheet Clarification

The PIC16(L)F1826/1827 family devices that you have received conform functionally to the current Device Data Sheet (DS41391C), except for the anomalies described in this document.

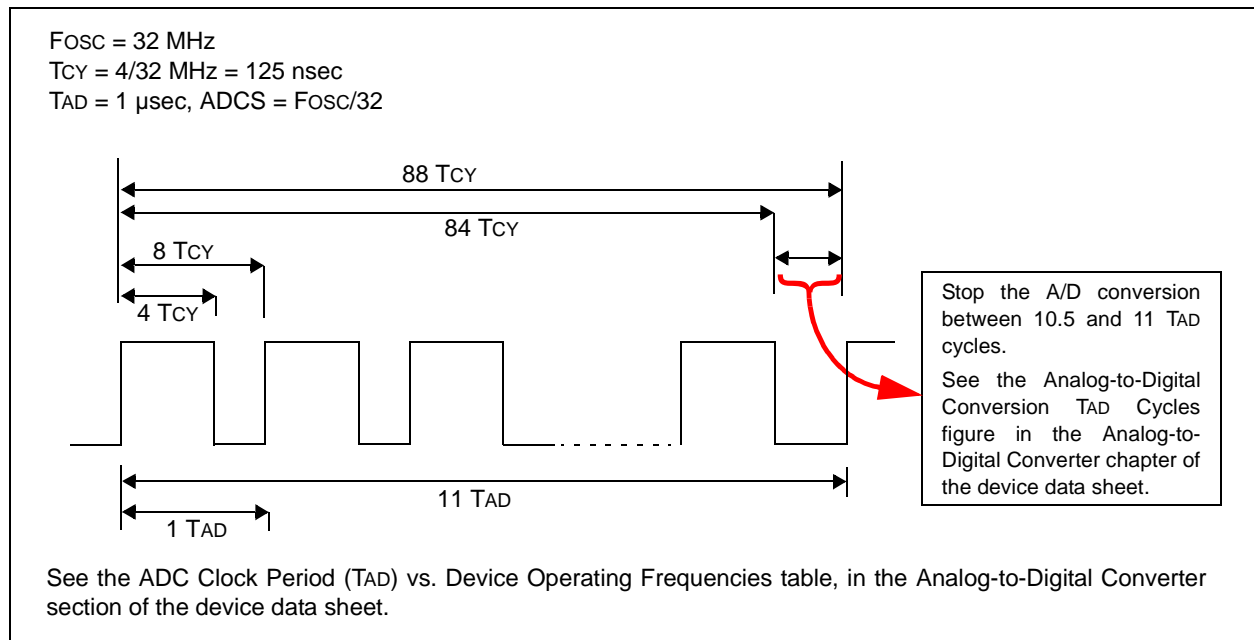
FIGURE 1: INSTRUCTION CYCLE DELAY CALCULATION EXAMPLE

An ADC conversion may not complete under these conditions:

1. When FOSC is greater than 8 MHz and it is the clock source used for the ADC converter.
2. The ADC is operating from its dedicated internal FRC oscillator and the device is not in Sleep mode (any FOSC frequency).

When this occurs, the ADC Interrupt Flag (ADIF) does not get set, the GO/DONE bit does not get cleared, and the conversion result does not get loaded into the ADRESH and ADRESL result registers.

In Figure 1, 88 instruction cycles (TCY) will be required to complete the full conversion. Each TAD cycle consists of 8 TCY periods. A fixed delay is provided to stop the A/D conversion after 86 instruction cycles and terminate the conversion at the correct time as shown in the figure above.

Method 3: This method is provided if the application cannot use Sleep mode and requires continuous operation at frequencies above 8 MHz. This method requires early termination of an ADC conversion. Provide a fixed time delay in software to stop the A-to-D conversion manually, after all 10 bits are converted, but before the conversion would complete automatically. The conversion is stopped by clearing the GO/DONE bit in software. The GO/DONE bit must be cleared during the last ½ TAD cycle, before the conversion would have completed automatically. Refer to Figure 1 for details.

Note: The exact delay time will depend on the TAD divisor (ADCS) selection. The Tcy counts shown in the timing diagram above apply to this example only. Refer to [Table 3](#) for the required delay counts for other configurations.
