PIC16F1934/1936/1937 and PIC16LF1934/1936/1937 Family Silicon Errata and Data Sheet Clarification

The PIC16F1934/1936/1937 and PIC16LF1934/1936/1937 family devices that you have received conform functionally to the current Device Data Sheet (DS41364**D**), except for the anomalies described in this document.

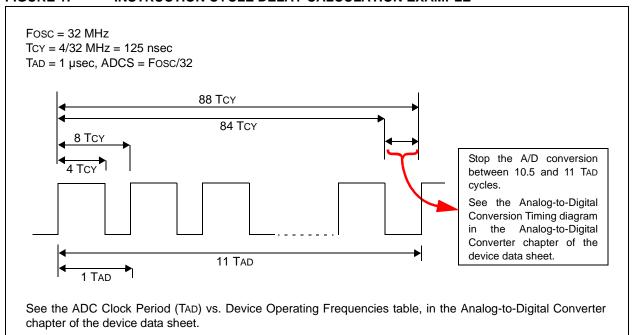
FIGURE 1: INSTRUCTION CYCLE DELAY CALCULATION EXAMPLE

An ADC conversion may not complete under these conditions:

- When Fosc is greater than 8 MHz and it is the clock source used for the ADC converter.
- The ADC is operating from its dedicated internal FRC oscillator and the device is not in Sleep mode (any Fosc frequency).

When this occurs, the ADC Interrupt Flag (ADIF) does not get set, the GO/DONE bit does not get cleared, and the conversion result does not get loaded into the ADRESH and ADRESL result registers.

In Figure 1, 88 instruction cycles (TcY) will be required to complete the full conversion. Each TAD cycle consists of 8 TcY periods. A fixed delay is provided to stop the A/D conversion after 86 instruction cycles and terminate the conversion at the correct time as shown in the figure above.

Method 3: This method is provided if the application cannot use Sleep mode and requires continuous operation at frequencies above 8 MHz. This method requires early termination of an ADC conversion. Provide a fixed time delay in software to stop the A-to-D conversion manually, after all 10 bits are converted, but before the would conversion complete automatically. The conversion is stopped by clearing the GO/ DONE bit in software. The GO/ DONE bit must be cleared during the last ½ TAD cycle, before the would conversion have completed automatically. Refer to Figure 1 for details.

The exact delay time will depend on the TAD divisor (ADCS) selection. The TCY counts shown in the timing diagram above apply to this example only. Refer to Table 3 for the required delay counts for other configurations.

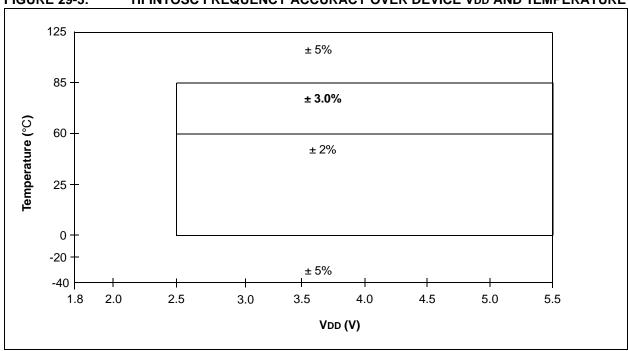
FIGURE 29-3: HFINTOSC FREQUENCY ACCURACY OVER DEVICE VDD AND TEMPERATURE

In Figure 29-3, HFINTOSC Frequency Accuracy Over Device VDD and Temperature, the oscillator accuracy should be +/- 3.0% when VDD is equal to, and above 2.5V and when temperatures are equal to, and above 60°C, yet still equal to, or below 85°C, as shown below.
