**PIC18F1XK22/LF1XK22 Family
Silicon Errata and Data Sheet Clarification**

The PIC18F1XK22/LF1XK22 family devices that you have received conform functionally to the current Device Data Sheet (DS41365D), except for the anomalies described in this document.

The silicon issues discussed in the following pages are for silicon revisions with the Device and Revision IDs listed in Table 1. The silicon issues are summarized in Table 2.

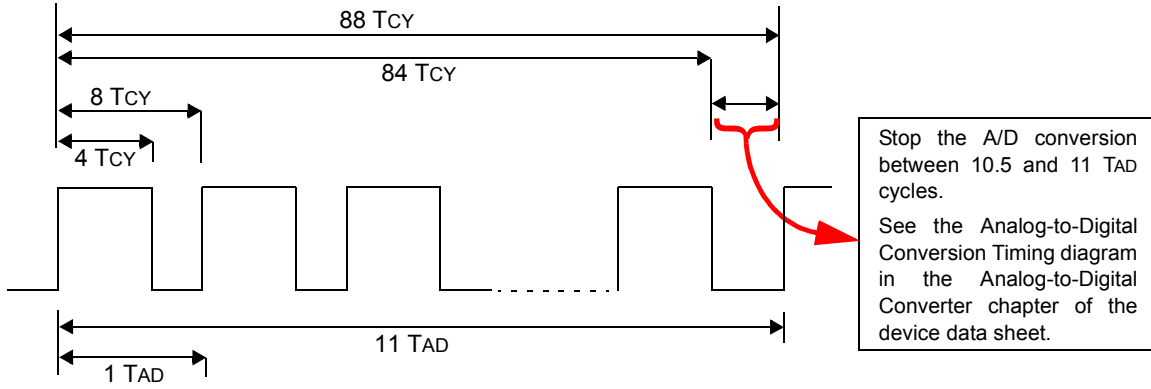
FIGURE 1: INSTRUCTION CYCLE DELAY CALCULATION EXAMPLE

- 1.2 An ADC conversion may not complete under these conditions:

1. When Fosc is greater than 8 MHz and is the clock source used for the ADC converter.
2. The ADC is operating from its dedicated internal FRC oscillator and the device is not in Sleep mode (an Fosc frequency).

When this occurs, the ADC Interrupt Flag (ADIF) does not get set, the GO/DONE bit does not get cleared, and the conversion result does not get loaded into the ADRESH and ADRESL result registers.

In Figure 1, 88 instruction cycles (T_{cy}) will be required to complete the full conversion. Each TAD cycle consists of 8 T_{cy} periods. A fixed delay is provided to stop the A/D conversion after 86 instruction cycles and terminate the conversion at the correct time as shown in the figure above.

Method 3: Method 3 is provided if the application cannot use Sleep mode and requires continuous operation at frequencies above 8 MHz. This method requires early termination of an ADC conversion. Provide a fixed time delay in software to stop the A-to-D conversion manually, after all 10 bits are converted, but before the conversion would complete automatically. The conversion is stopped by clearing the GO/DONE bit in software. The GO/DONE bit must be cleared during the last ½ TAD cycle, before the conversion would have completed automatically. Refer to Figure 1 for details.

Note: The exact delay time will depend on the TAD divisor (ADCS) selection. The T_{cy} counts shown in the timing diagram above apply to this example only. Refer to Table 3 for the required delay counts for other configurations.

```
BSF    ADCON0, GO    ; Start ADC conversion
                    ; Provide 86
                    ; instruction cycle
                    ; delay here
BCF    ADCON0, GO    ; Terminate the
                    ; conversion manually
MOVF   ADRESH, W     ; Read conversion
                    ; result
```
