PIC16(L)F1946/1947 Family Silicon Errata and Data Sheet Clarification

The PIC16(L)F1946/1947 family devices that you have received conform functionally to the current Device Data Sheet (DS41414B), except for the anomalies described in this document.

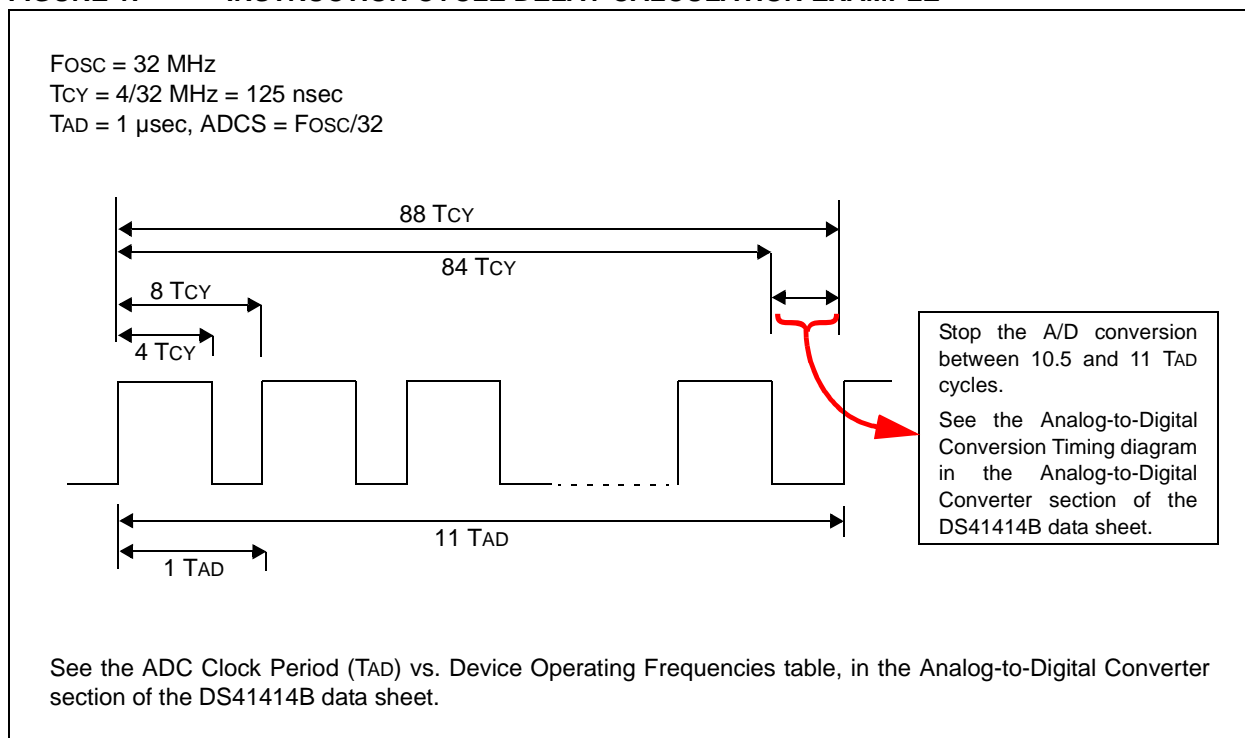
FIGURE 1: INSTRUCTION CYCLE DELAY CALCULATION EXAMPLE

Under certain device operating conditions, the ADC conversion may not complete properly. When this occurs, the ADC Interrupt Flag (ADIF) does not get set, the ADGO/DONE bit does not get cleared and the conversion result does not get loaded into the ADRESH and ADRESL result registers.

In Figure 1, 88 instruction cycles (Tcy) will be required to complete the full conversion. Each TAD cycle consists of 8 Tcy periods. A fixed delay is provided to stop the A/D conversion after 86 instruction cycles and terminate the conversion at the correct time as shown in the figure above.

Method 2: Provide a fixed delay in software to stop the A-to-D conversion manually, after all 10 bits are converted, but before the conversion would complete automatically. The conversion is stopped by clearing the GO/DONE bit in software. The GO/DONE bit must be cleared during the last ½ TAD cycle, before the conversion would have completed automatically. Refer to [Figure 1](#) for details.

Note: The exact delay time will depend on the choice of FOSC and the TAD divisor (ADCS) selection. The Tcy counts shown in the timing diagram above apply to this example only. Refer to Table 3 for the required delay counts for other configurations.
