## PIC18F85J11 Family Silicon Errata and Data Sheet Clarification

The PIC18F85J11 family devices that you have received conform functionally to the current Device Data Sheet (DS39774D), except for the anomalies described in this document.

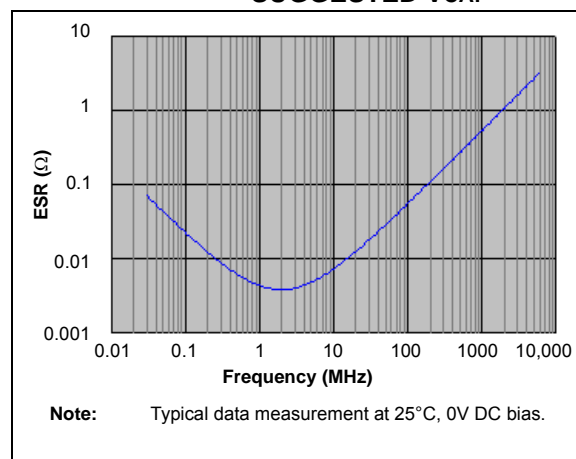
**FIGURE 2-3 FREQUENCY vs. ESR PERFORMANCE FOR SUGGESTED VCAP**

When the regulator is enabled, a low-ESR (< 5Ω) capacitor is required on the VCAP/VDDCORE pin to stabilize the voltage regulator output voltage. The VCAP/VDDCORE pin must not be connected to VDD and must use a capacitor of 10 μF connected to ground. The type can be ceramic or tantalum. Suitable examples of capacitors are shown in Table 2-1. Capacitors with equivalent specifications can be used.

Designers may use Figure 2-3 to evaluate ESR equivalence of candidate devices.

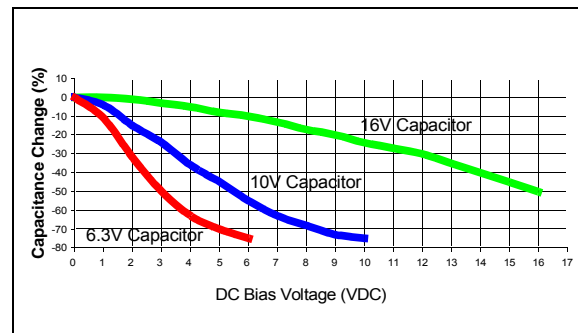
**FIGURE 2-4 DC BIAS VOLTAGE vs. CAPACITANCE CHARACTERISTICS**

In addition to temperature tolerance, the effective capacitance of large value ceramic capacitors can vary substantially, based on the amount of DC voltage applied to the capacitor. This effect can be very significant, but is often overlooked or is not always documented.

A typical DC bias voltage vs. capacitance graph for X7R type and Y5V type capacitors is shown in Figure 2-4.

When selecting a ceramic capacitor to be used with the VDDCORE voltage regulator, it is suggested to select a high-voltage rating, so that the operating voltage is a small percentage of the maximum rated capacitor voltage. For example, choose a ceramic capacitor rated at 16V for the 2.5V VDDCORE voltage. Suggested capacitors are shown in Table 2-1.
