PIC18F47J13 Family Silicon Errata and Data Sheet Clarification

The PIC18F47J13 Family devices that you have received conform functionally to the current Device Data Sheet (DS39974A), except for the anomalies described in this document.

PIC18F47J13 FAMILY

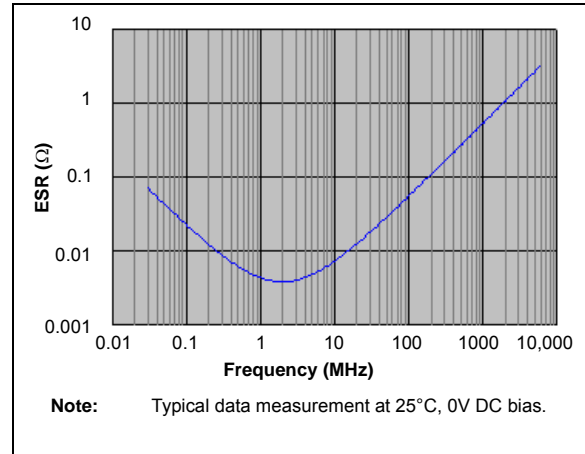
FIGURE 2-3 FREQUENCY vs. ESR PERFORMANCE FOR SUGGESTED VCAP

On “F” devices, a low-ESR ($< 5\Omega$) capacitor is required on the VCAP/VDDCORE pin to stabilize the voltage regulator output voltage. The VCAP/VDDCORE pin must not be connected to VDD and must use a capacitor of 10 μF connected to ground. The type can be ceramic or tantalum. Suitable examples of capacitors are shown in [Table 2-1](#). Capacitors with equivalent specifications can be used.

Designers may use [Figure 2-3](#) to evaluate ESR equivalence of candidate devices.

It is recommended that the trace length not exceed 0.25 inch (6 mm). Refer to [Section 30.0 “Electrical Characteristics”](#) for additional information.

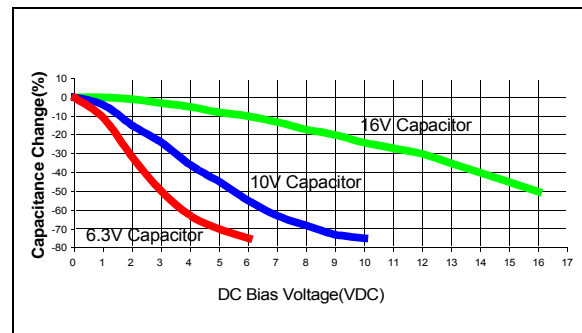
FIGURE 2-4 DC BIAS VOLTAGE vs. CAPACITANCE CHARACTERISTICS

In addition to temperature tolerance, the effective capacitance of large value ceramic capacitors can vary substantially, based on the amount of DC voltage applied to the capacitor. This effect can be very significant, but is often overlooked or is not always documented.

A typical DC bias voltage vs. capacitance graph for 16V, 10V and 6.3V rated capacitors is shown in Figure 2-4.

When selecting a ceramic capacitor to be used with the internal voltage regulator, it is suggested to select a high-voltage rating, so that the operating voltage is a small percentage of the maximum rated capacitor voltage. For example, choose a ceramic capacitor rated at 16V for the 2.5V core voltage. Suggested capacitors are shown in Table 2-1.
