# MICROCHIP PIC18F6310/6410/8310/8410

## PIC18F6310/6410/8310/8410 Rev. B3 Silicon Errata

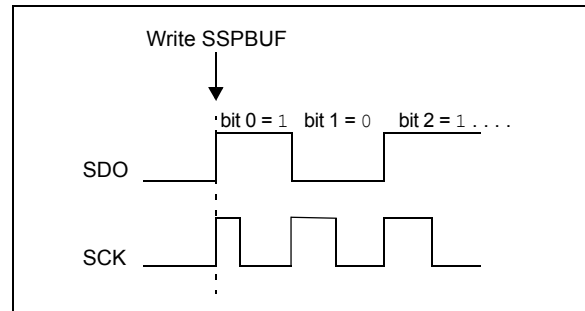
**FIGURE 1: SCK PULSE VARIATION USING TIMER2/2**

When the SPI is using Timer2/2 as the clock source, a shorter than expected SCK pulse may occur on the first bit of the transmitted/received data (Figure 1).

To avoid producing the short pulse, turn off Timer2 and clear the TMR2 register, load the SSPBUF with the data to transmit and then turn Timer2 back on. Refer to Example 4 for sample code.
