# MICROCHIP PIC18F2410/2510/4410/4510

## PIC18F2410/2510/4410/4510 Rev. B3 Silicon Errata

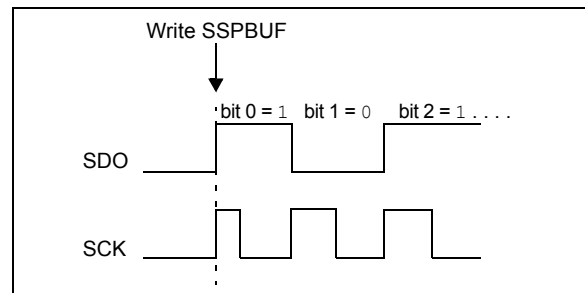
FIGURE 1: SCK PULSE VARIATION USING TIMER2/2

When the SPI is using Timer2/2 as the clock source, a shorter than expected SCK pulse may occur on the first bit of the transmitted/received data (Figure 1).

To avoid producing the short pulse, turn off Timer2 and clear the TMR2 register, load the SSPBUF with the data to transmit and then turn Timer2 back on. Refer to Example 1 for sample code.
