## CAN Microcontrollers

**T89C51CC01**  
**T89C51CC01UA**  
**T89C51CC01CA**

## Errata Sheet

4131J-CAN-05/06

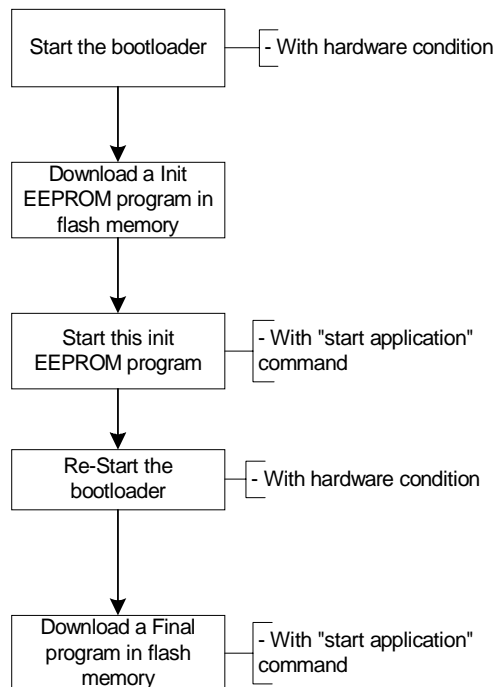
## 16. EEPROM – Lock-up during ISP write

Program lock-up can be experienced when using Atmel FLIP software or a custom In system Programming tools to write in the internal EEPROM. This problem occurs with clock frequency > 12MHz in X2 mode or 24MHz in X1 mode. Neither the code Flash nor the EEPROM are corrupted by the lock-up. Although the EEPROM cannot be written by the bootloader.

This problem is bootloader related and doesn't affect the capability for the user to read and write into the EEPROM. This problem is technology dependant. The likelihood of experiencing the problem is low at Clock frequency > 24 MHz in X1 mode and non-existent below. A reset can be applied to recover from the lock-up.

### Workaround

The following process can be done to work around the problem.

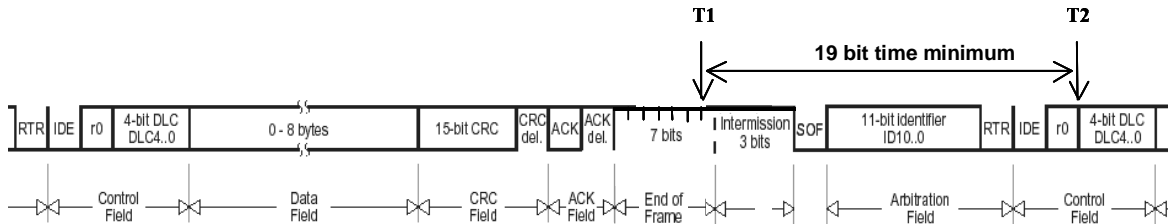
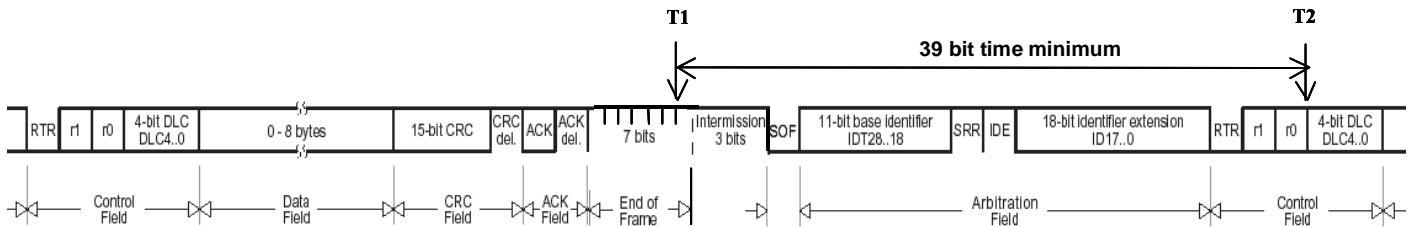
## 17. Transmission after a 3 bit Intermessage

If a Transmit Message Object (MOB) is enabled while the CAN bus is busy with an on going message, the transmitter will wait for the 3-bit Intermission before starting its transmission. This is in full agreement with the CAN recommendation.

If the transmitter lost arbitration against another node, two conditions can occur :

1. At least one Receive MOB of the chip are programmed to accept the incoming message. In this case, the transmitter will wait for the next 3-bit Intermission to retry its transmission.
2. No Receive MOB of the chip are programmed to accept the incoming message. In this case the transmitter will wait for a 4-bit Intermission to retry its transmission. In this case, any other CAN nodes ready to transmit after a 3-bit Intermission will start transmit before the chip transmitter, even if their messages have lower priority IDs.

### Workaround

Always have a Receive MOB enabled ready to accept any incoming messages. Thanks to the implementation of the CAN interface, a Receive MOB must be enable at latest, before the 1<sup>st</sup> bit of the DLC field. The Receive MOB status register is written (RXOK if message OK) immediately after the 6th bit of the End of Frame field. This will leave in CAN2.0A mode a minimum 19-bit time delay to respond to the end of message interrupt (RXOK) and re-enable the Receive MOB before the start of the DLC field of the next incoming message. This minimum delay will be 39-bit time in CAN2.0B. See CAN2.0A CAN2.0B frame timings below.

The workaround is to have the last MOB (MOB14) as "spy" enabled all the time; it is the MOB of lowest priority : If a Mob other than MOB14 is programmed in receive mode and its acceptance filter matches with the incoming message ID, this Mob will take the message. MOB14 will only take messages than no other MOBs will have accepted. MOB14 will need to be re-enabled fast enough to manage back to back frames. The deadline to do this is the beginning of DLC slot of incoming frames as explained above.

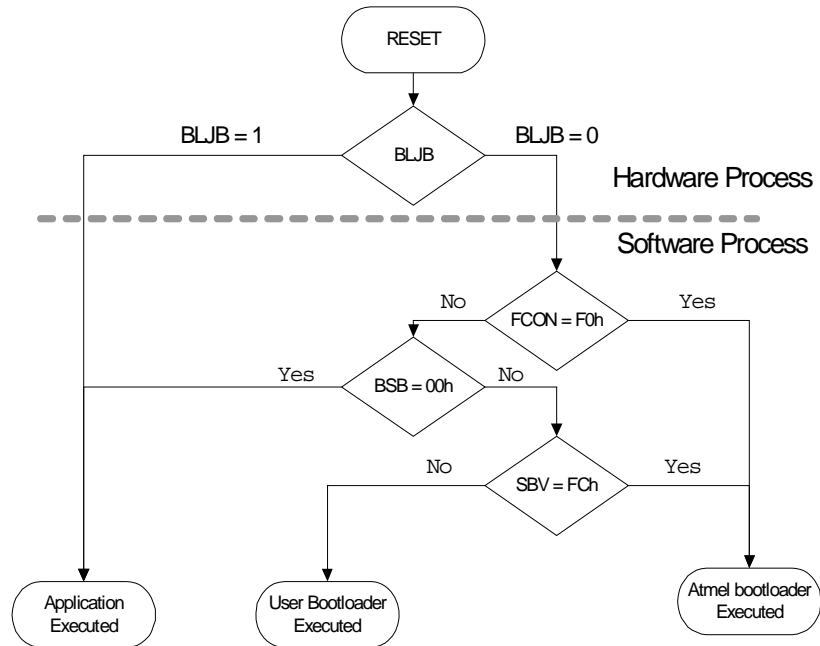
## Version 1.2:

### 4. Boot Process Compatibility

There are some differences between Boot process of bootloader 1.2 and newer versions (see below).

### Workaround

Use the fuse bit BLJB to start the application in both versions.
