MICROCHIP PIC18F2515/2610/4515/4610

PIC18F2515/2610/4515/4610 Rev. A3 Silicon Errata

The PIC18F2515/2610/4515/4610 Rev. A3 parts you have received conform functionally to the Device Data Sheet (DS39636C), except for the anomalies described below. Any Data Sheet Clarification issues related to the PIC18F2515/2610/4515/4610 will be reported in a separate Data Sheet errata. Please check the Microchip web site for any existing issues.

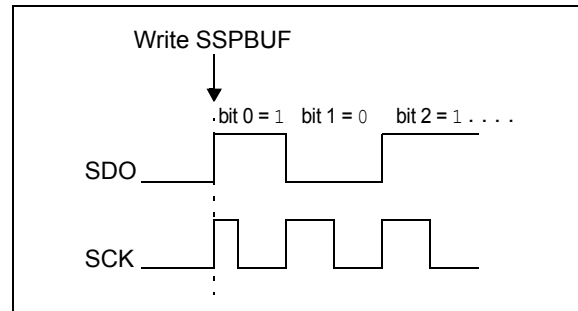
FIGURE 1: SCK PULSE VARIATION USING TIMER2/2

When the SPI is using Timer2/2 as the clock source, a shorter than expected SCK pulse may occur on the first bit of the transmitted/received data (Figure 1).

To avoid producing the short pulse, turn off Timer2 and clear the TMR2 register, load the SSPBUF with the data to transmit and then turn Timer2 back on. Refer to Example 5 for sample code.
