dsPIC30F5011/5013 Family Silicon Errata and Data Sheet Clarification

The dsPIC30F5011/5013 family devices that you have received conform functionally to the current Device Data Sheet (DS70116H), except for the anomalies described in this document.

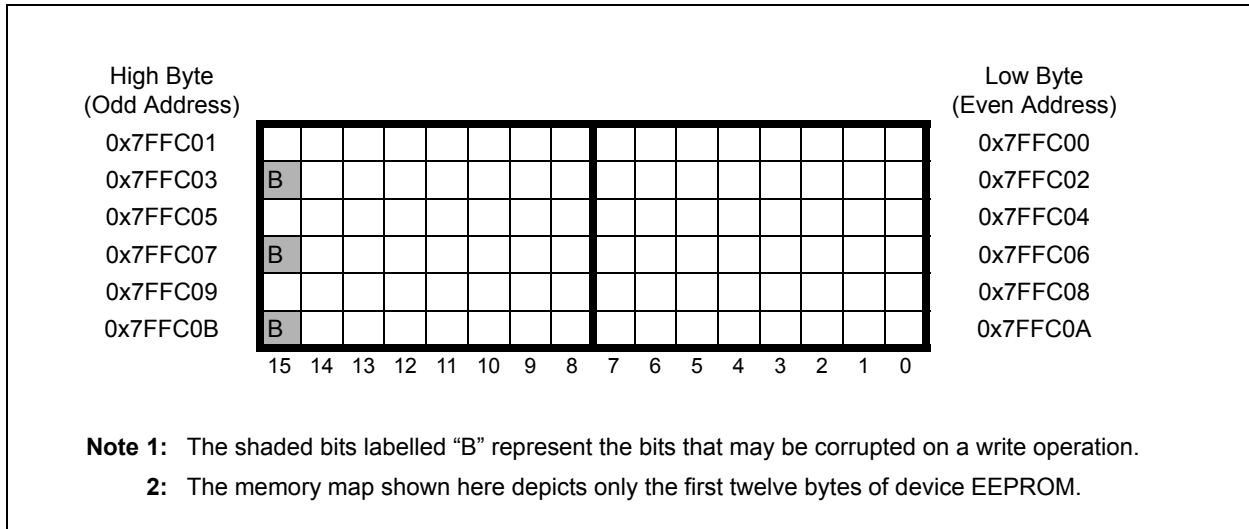
FIGURE 1: dsPIC30F5011/5013 DATA EEPROM

Data EEPROM	—	26.	The Most Significant bit (MSb) of every fourth byte in data EEPROM may be corrupted.	X	X		
Flash Memory	IDD Current	27.	This release of silicon exhibits a current draw (IDD) of approximately 190 mA during a Row Erase operation performed on program Flash memory.	X	X		
I/O	RC15 Pin for Digital I/O	28.	For this revision of silicon, if the pin RC15 is required for digital input/output, the FPR<4:0> bits in the FOSC Configuration register may not be set up for FRC w/PLL 4x/8x/16x modes.	X	X		
CAN	RX Filters 3, 4 and 5	29.	CAN Receive filters 3, 4 and 5 may not work for a given combination of instruction cycle speed and CAN bit time quanta.	X	X	X	X
ADC	Current Consumption in Sleep Mode	30.	If the ADC module is in an enabled state when the device enters Sleep Mode, the power-down current (IPD) of the device may exceed the device data sheet specifications.	X	X	X	X
