# Errata on AT91SAM9G45 Engineering Sample Devices

### AT91SAM9G45

## Errata Sheet

6485B-ATARM-28-Sep-09

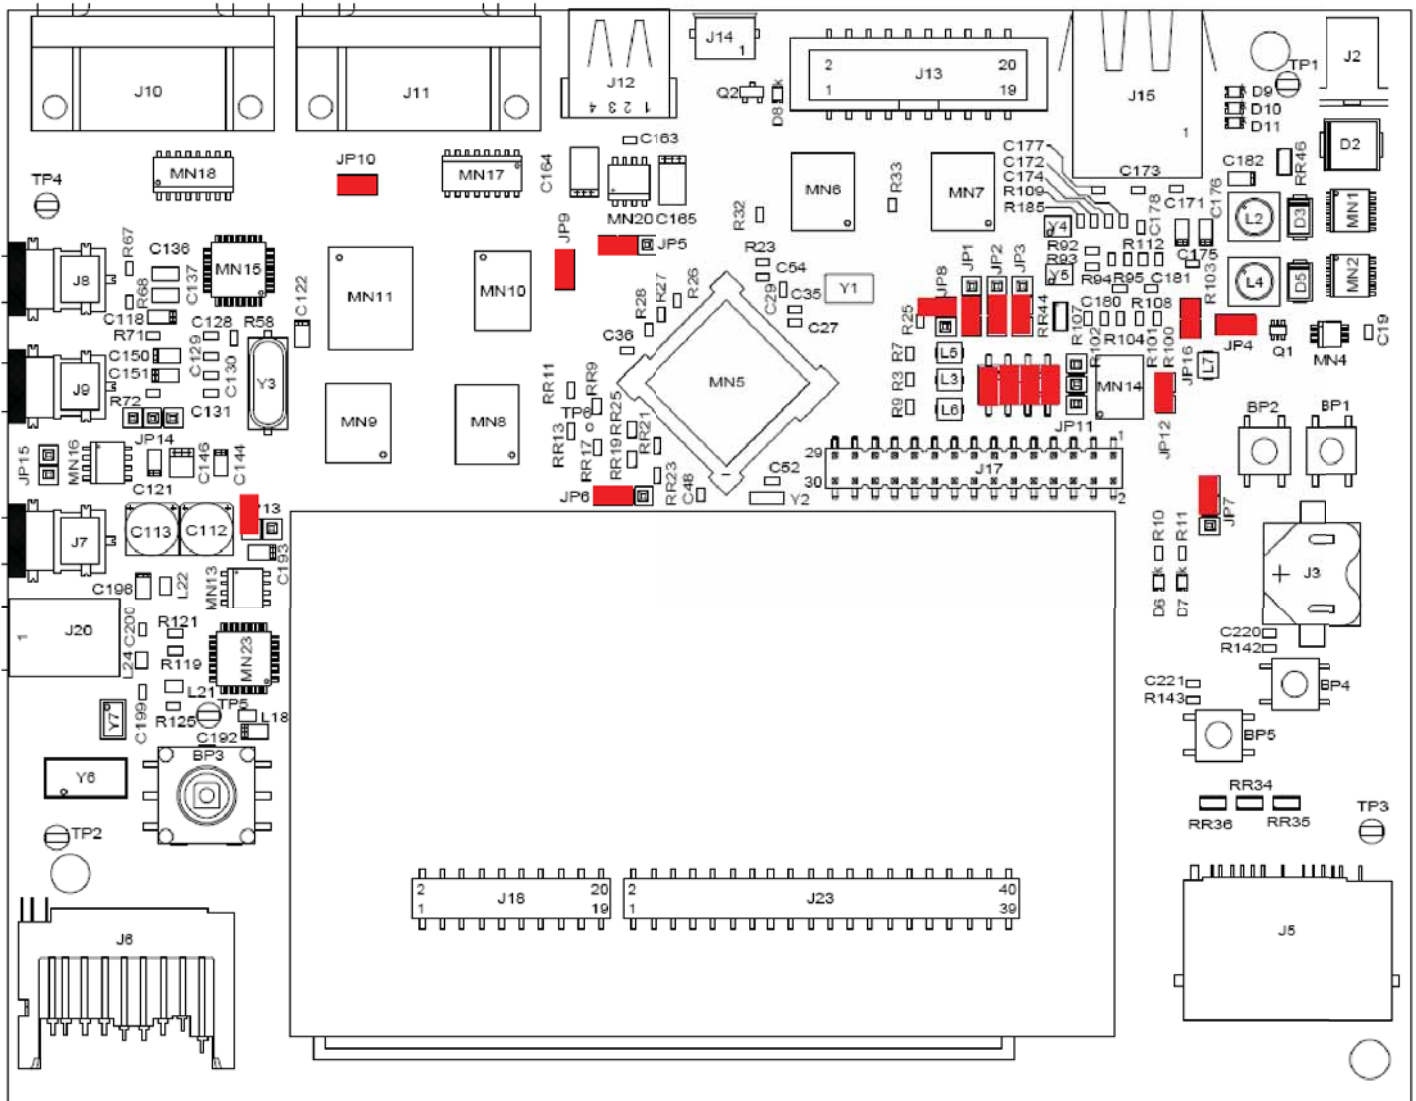
Figure 2-1. Default Jumpers Settings

Prior to any operation, the user needs to install *AT91-ISP.exe 1.13* and unzip [AT91SAM9G45\\_RomCode\\_Replacement.zip](#) file that contains a version of ROM binary code with USB issue fixed. Check and conform to the following Default Jumpers Settings.

1. unplug power supply
2. unplug USB device cable
3. remove jumper JP10 (NandFlash Chip Select) & JP12 (DataFlash Chip Select)
4. plug serial cable
5. launch hyper terminal (115,200 bauds, 8 bits, parity none, 1 stop bit, no flow control)
6. plug-in power supply
7. type on hyper terminal: "Alt-0128 Alt-0128 #"
8. AT91SAM9G45-EKES returns ">"
9. close hyper terminal
10. close jumper JP12 (DataFlash® Chip Select)
11. launch SAM-BA (Choose right COM port and AT91SAM9G45-EKES)
12. choose DataFlash media tab in the SAM-BA GUI interface

13. initialize DataFlash, choosing the Enable action in the Scripts rolling menu and press Execute
14. choose Send boot file, press Execute
15. select *AT91SAM9G45\_RomCode\_Replacement.bin* binary file and press Open; the media is written down
16. close SAM-BA
