ES_LPC3250 Errata sheet LPC3250 Rev. 8 — 1 February 2011

Info	Content
Keywords	LPC3250 errata
Abstract	This errata sheet describes both the known functional problems and any deviations from the electrical specifications known at the release date of this document.
	Each deviation is assigned a number and its history is tracked in a table at the end of the document.

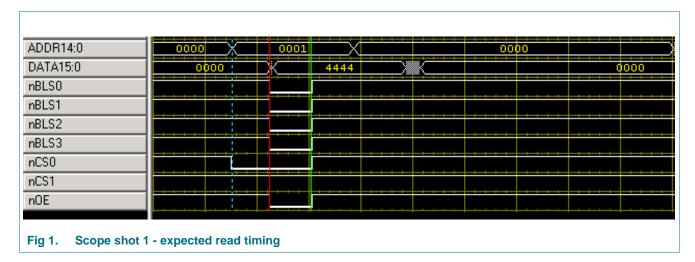
When using memory-to-memory DMA with the EMC static chip select (EMC_CS[x]_N) as the DMA source and the DMA channel source burst size is set for a single transfer (DMACCxControl:SBSIZE = 0), each DMA source read should be a single bus-wide access. The access should be similar to reading the EMC_CS[x]_N static memory with an ARM LDR instruction, as shown in Figure 1. Note the EMC signal timing for the read is controlled by the EMCSTATICx registers. In all example scope shots the EMCSTATICWAITx registers are set to the maximum value.

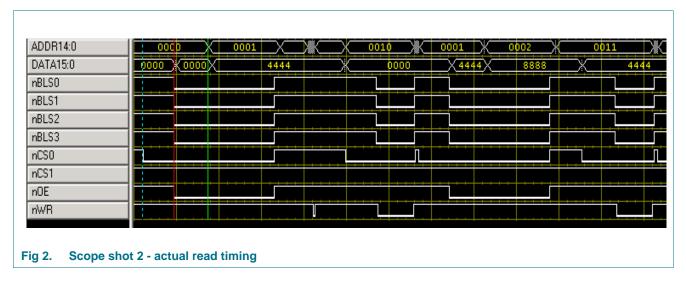
DMA register values used in Figure 2:

However, the actual EMC timing for the source DMA read is a double wide chip select with a burst of two reads (notice how the address increments near the halfway point of nCS0 active), see Figure 2. The second data read during the burst is discarded, as the DMA destination write (also to nCS0 in Figure 2) following each read, always writes the first value read during the read burst. When the DMA source address is set to auto-increment, the last DMA read transfer will address the last address of the source buffer and the last source buffer address +1. This behavior only happens during the read part of the DMA transfer. Memory-to-memory DMA destination writes to the EMC static chip select work as expected.

- DMA reads from an external memory will have lower performance than a software read loop. The source read burst of two, to get one transfer, will significantly increase the time to complete all transfers in the memory-to-memory DMA, therefore decreasing the overall throughput possible on the EMC_CSx_N static memory interface.
- Potential unintended consequence when the last DMA read accesses the address beyond the DMA source buffer address in the FPGA or external peripheral chip. This extra address is the second access during the last DMA source read.

- 1. Avoid using DMA to transfer read blocks of data from the external device. Instead use a software loop with LDR instruction to read blocks of data from the external device.
- 2. If DMA can't be avoided, ensure there is at least one unused address between the highest address used for the external device DMA data buffer and any status or control register in the device that will initiate any unwanted action just by reading from the register (i.e. clear an interrupt or status).

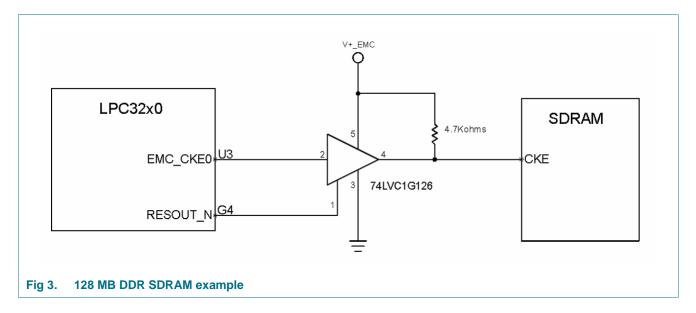
If the LPC3250 is reset during an SDRAM access, the SDRAM clock and clock enable will be immediately de-asserted. If the de-assertion occurs during the period of time the SDRAM is driving the data bus, the SDRAM will hold that state until the next clock occurs at the SDRAM clock input when the clock enable is active. However, the LPC3250 won't deliver the clock and clock enables until software actually sets up the EMC state to do this, so the SDRAM will remain in the data assertion state on the data bus while the LPC3250 tries to boot.

When the chip attempts to load boot code from NOR FLASH after reset, the correct signals are asserted to the NOR FLASH device and the NOR FLASH device places its data on the data bus. But if the SDRAM is still driving the bus, the NOR FLASH device and SDRAM device are in contention and the data will not be read correctly into the LPC3250. In this situation, the LPC3250 will fail to boot.

If booting from NOR FLASH is a requirement, the simple circuit shown in Figure 3 can be used to clear the SDRAM state at system reset. This will not change the normal functioning of the LPC3250 EMC or SDRAM operations. If SDRAM devices are also present on the 2nd SDRAM chip select, a similar circuit will be needed for those devices using EMC_CKE1.

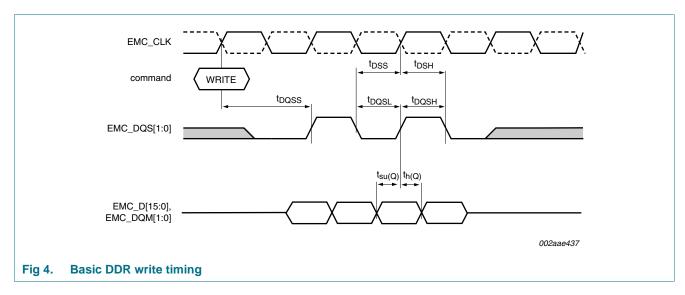
For DDR writes the LPC3250 drives the EMC_DQS[1:0] earlier in the data valid window than center aligned. With the EMC_CLK at 133 MHz this produces a minimum set-up time between the EMC_D[15:0] and EMC_DQS[1:0] of 600 ps across silicon process, voltage and temperature. Test conditions are with the EMC buffers set to fast slew rate driving 2 inches of 50 Ω transmission line and 10 pF load capacitance. DDR memories specify EMC_D[15:0] to EMC_DQS[1:0] set-up time minimum as 400 ps. This leaves 200 ps set-up time margin due to customer specific load and PCB layout implementation. See the LPC3220_30_40_50 data sheet for the complete range of DDR data output set-up time, $t_{su(Q)}$, and data output hold time $t_{h(Q)}$ times.
