# ES\_LPC3240

Errata sheet LPC3240

Rev. 8 — 1 February 2011

Errata sheet

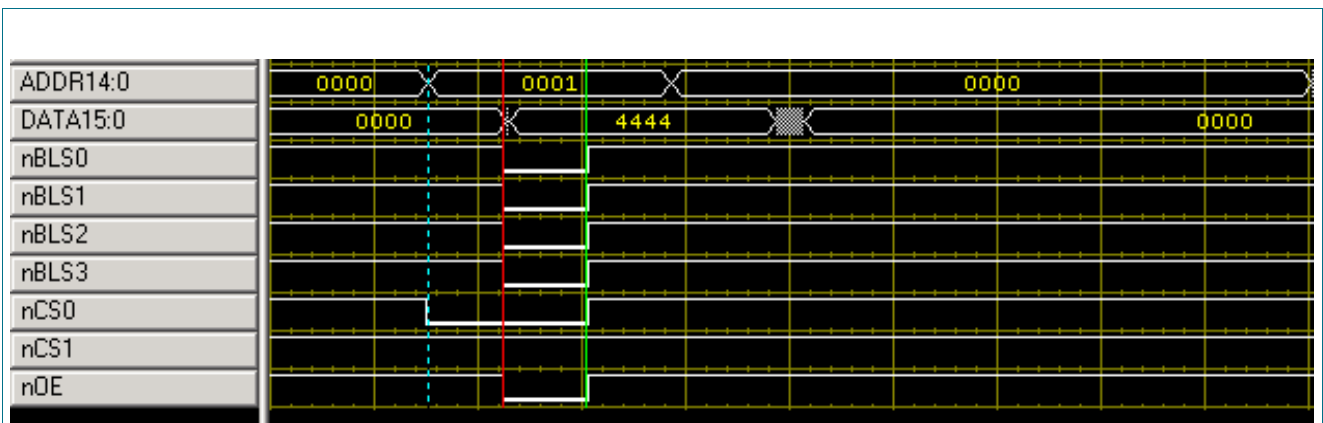
Fig 1. Scope shot 1 - expected read timing

When using memory-to-memory DMA with the EMC static chip select (EMC\_CS[x]\_N) as the DMA source and the DMA channel source burst size is set for a single transfer (DMACCxControl:SBSIZE = 0), each DMA source read should be a single bus-wide access. The access should be similar to reading the EMC\_CS[x]\_N static memory with an ARM LDR instruction, as shown in [Figure 1](#). Note the EMC signal timing for the read is controlled by the EMCSTATICx registers. In all example scope shots the EMCSTATICWAITx registers are set to the maximum value.

1. Avoid using DMA to transfer read blocks of data from the external device. Instead use a software loop with LDR instruction to read blocks of data from the external device.
2. If DMA can't be avoided, ensure there is at least one unused address between the highest address used for the external device DMA data buffer and any status or control register in the device that will initiate any unwanted action just by reading from the register (i.e. clear an interrupt or status).

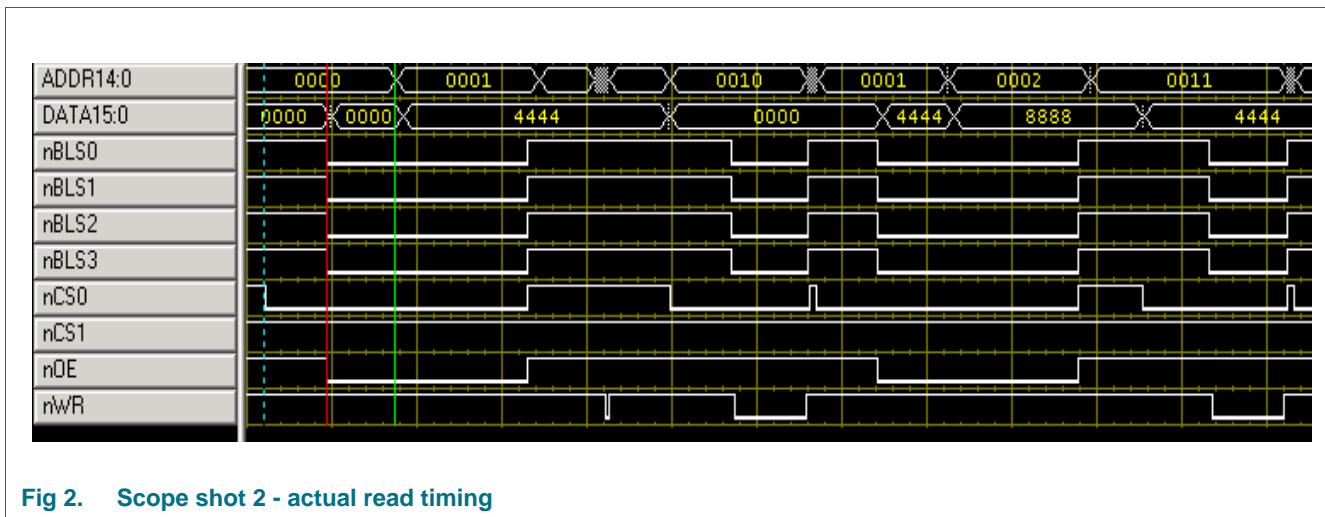
**Fig 2. Scope shot 2 - actual read timing**

However, the actual EMC timing for the source DMA read is a double wide chip select with a burst of two reads (notice how the address increments near the halfway point of nCS0 active), see [Figure 2](#). The second data read during the burst is discarded, as the DMA destination write (also to nCS0 in [Figure 2](#)) following each read, always writes the first value read during the read burst. When the DMA source address is set to auto-increment, the last DMA read transfer will address the last address of the source buffer and the last source buffer address +1. This behavior only happens during the read part of the DMA transfer. Memory-to-memory DMA destination writes to the EMC static chip select work as expected.

1. DMA reads from an external memory will have lower performance than a software read loop. The source read burst of two, to get one transfer, will significantly increase the time to complete all transfers in the memory-to-memory DMA, therefore decreasing the overall throughput possible on the EMC\_CSx\_N static memory interface.
2. Potential unintended consequence when the last DMA read accesses the address beyond the DMA source buffer address in the FPGA or external peripheral chip. This extra address is the second access during the last DMA source read.

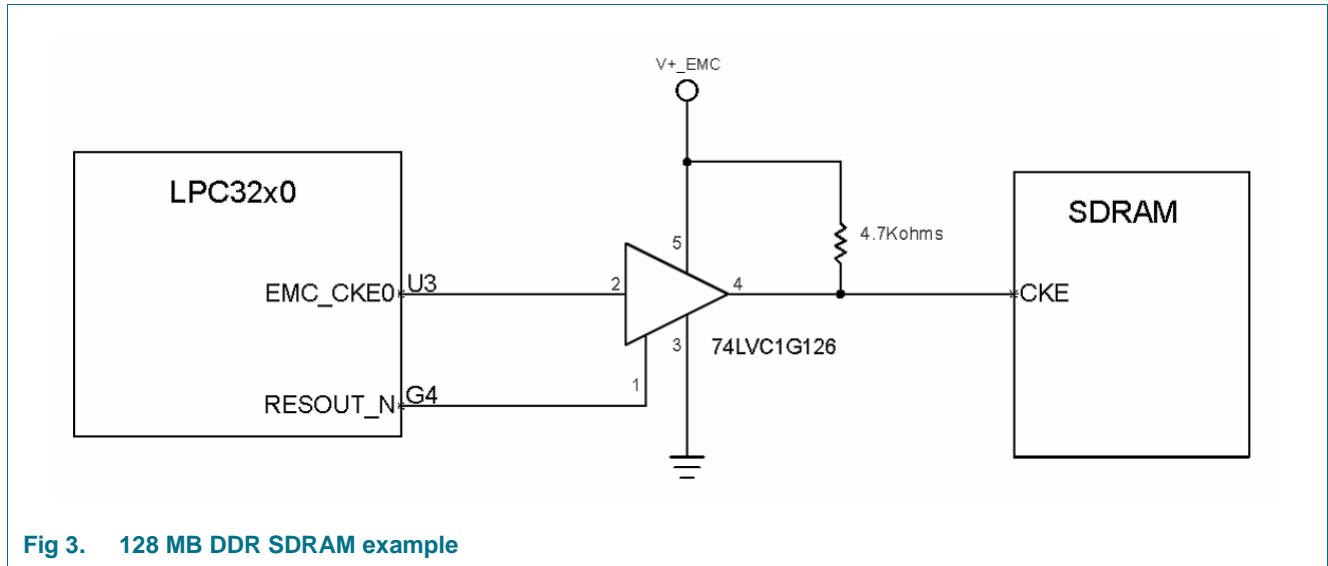
Fig 3. 128 MB DDR SDRAM example

If the LPC3240 is reset during an SDRAM access, the SDRAM clock and clock enable will be immediately de-asserted. If the de-assertion occurs during the period of time the SDRAM is driving the data bus, the SDRAM will hold that state until the next clock occurs at the SDRAM clock input when the clock enable is active. However, the LPC3240 won't deliver the clock and clock enables until software actually sets up the EMC state to do this, so the SDRAM will remain in the data assertion state on the data bus while the LPC3240 tries to boot.

When the chip attempts to load boot code from NOR FLASH after reset, the correct signals are asserted to the NOR FLASH device and the NOR FLASH device places its data on the data bus. But if the SDRAM is still driving the bus, the NOR FLASH device and SDRAM device are in contention and the data will not be read correctly into the LPC3240. In this situation, the LPC3240 will fail to boot.

If booting from NOR FLASH is a requirement, the simple circuit shown in [Figure 3](#) can be used to clear the SDRAM state at system reset. This will not change the normal functioning of the LPC3240 EMC or SDRAM operations. If SDRAM devices are also present on the 2nd SDRAM chip select, a similar circuit will be needed for those devices using EMC\_CKE1.

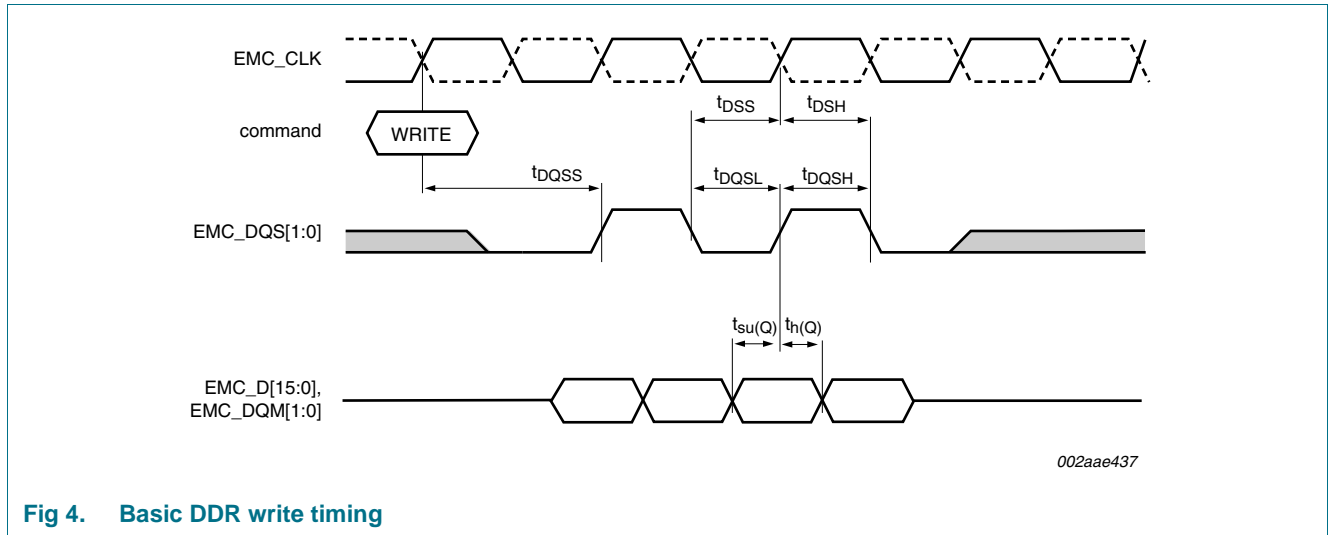
Fig 4. Basic DDR write timing

For DDR writes the LPC3240 drives the EMC\_DQS[1:0] earlier in the data valid window than center aligned. With the EMC\_CLK at 133 MHz this produces a minimum set-up time between the EMC\_D[15:0] and EMC\_DQS[1:0] of 600 ps across silicon process, voltage and temperature. Test conditions are with the EMC buffers set to fast slew rate driving 2 inches of 50 Ω transmission line and 10 pF load capacitance. DDR memories specify EMC\_D[15:0] to EMC\_DQS[1:0] set-up time minimum as 400 ps. This leaves 200 ps set-up time margin due to customer specific load and PCB layout implementation. See the LPC3220\_30\_40\_50 data sheet for the complete range of DDR data output set-up time,  $t_{su(Q)}$ , and data output hold time  $t_{h(Q)}$  times.
