ES_LPC3230

Errata sheet LPC3230

Rev. 8 — 1 February 2011

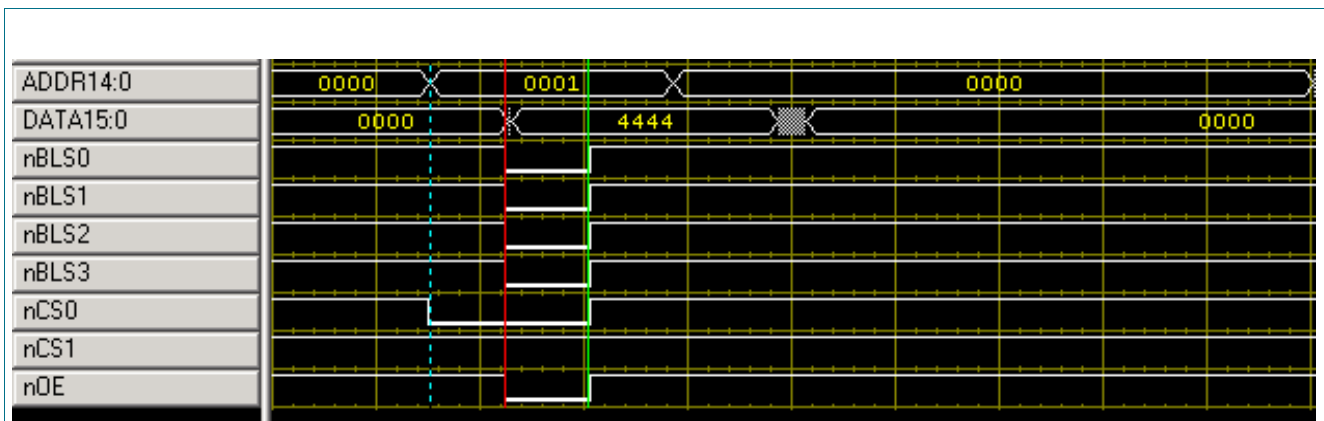
When using memory-to-memory DMA with the EMC static chip select (EMC_CS[x]_N) as the DMA source and the DMA channel source burst size is set for a single transfer (DMACCxControl:SBSIZE = 0), each DMA source read should be a single bus-wide access. The access should be similar to reading the EMC_CS[x]_N static memory with an ARM LDR instruction, as shown in [Figure 1](#). Note the EMC signal timing for the read is controlled by the EMCSTATICx registers. In all example scope shots the EMCSTATICWAITx registers are set to the maximum value.

Fig 1. Scope shot 1 - expected read timing

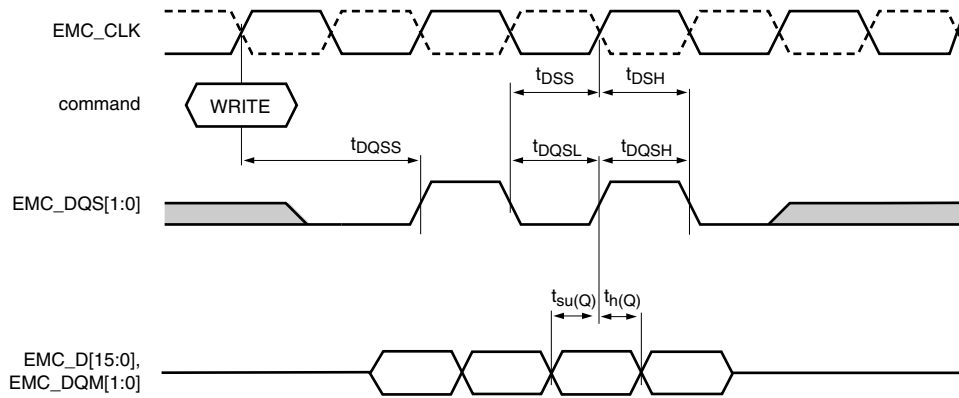
Fig 4. Basic DDR write timing

For DDR writes the LPC3230 drives the EMC_DQS[1:0] earlier in the data valid window than center aligned. With the EMC_CLK at 133 MHz this produces a minimum set-up time between the EMC_D[15:0] and EMC_DQS[1:0] of 600 ps across silicon process, voltage and temperature. Test conditions are with the EMC buffers set to fast slew rate driving

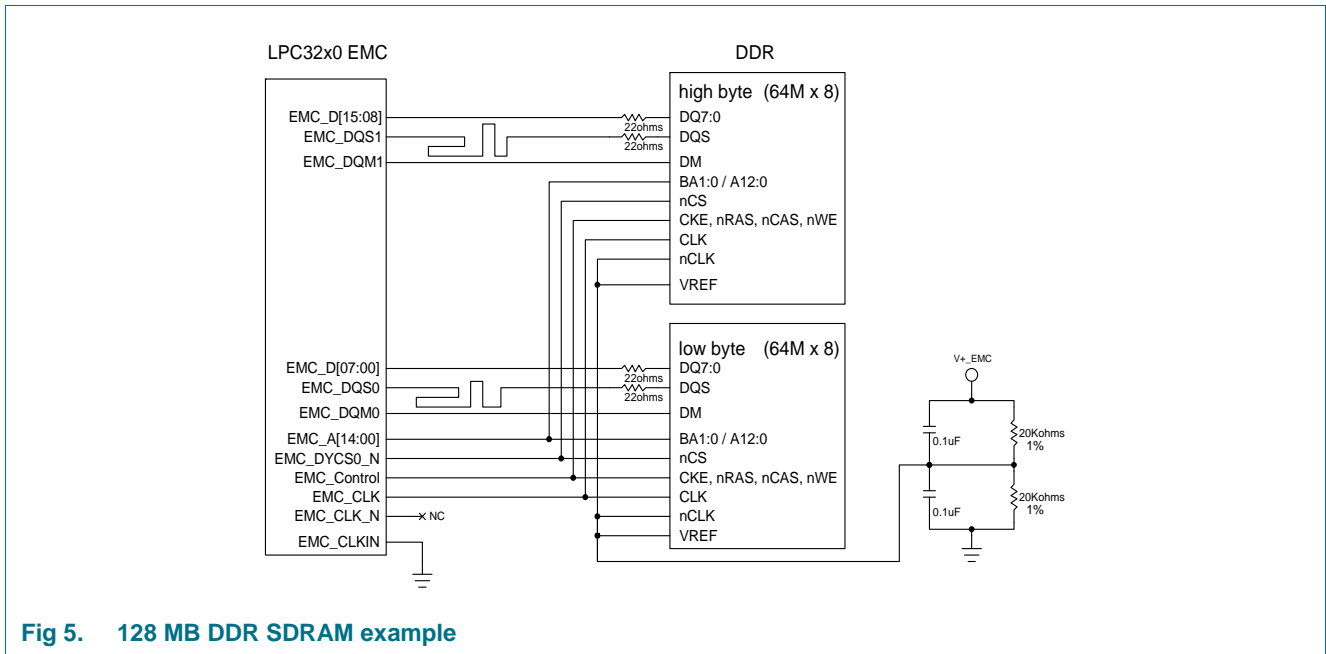
Fig 5. 128 MB DDR SDRAM example

2. Systems requiring 128 MB or less of DDR should be implemented using a single EMC_DYCSx_N for DDR. The single chip select system may be constructed with a single 16-bit wide DDR or two 8-bit wide DDR SDRAMs using up to the maximum supported 512 Mbit DDR density. Using two 8-bit wide DDRs will have less capacitive loading and facilitate simple point-to-point routing of EMC_D[15:0] and EMC_DQS[1:0] signals over using two 16-bit DDRs and two EMC_DYCSx banks.

5. The PCB trace length of EMC_DQS[1:0] should be at least 2 inches (but not more than 4 inches) longer than EMC_DQ[15:0] and EMC_DQM[1:0]. On a typical FR4 PCB this adds at least 334 ps to set-up time margin for DDR writes. For reads from DDR the increased trace length of EMC_DQS[1:0] will be automatically compensated for by the software initialization function `find_dds_dqs_in_delay()` which sets the optimal value `DDR_DQSIN_DELAY(SDRAMCLK_CTRL[6:2])`. The function `find_dds_dqs_in_delay()` can be found in the "DDR SDRAM setup code for the LPC32x0 series" on the NXP web site.
