PIC12(L)F1822/PIC16(L)F1823

PIC12(L)F1822/PIC16(L)F1823 Family Silicon Errata and Data Sheet Clarification

The PIC12(L)F1822/PIC16(L)F1823 family devices that you have received conform functionally to the current Device Data Sheet (DS41413B), except for the anomalies described in this document.

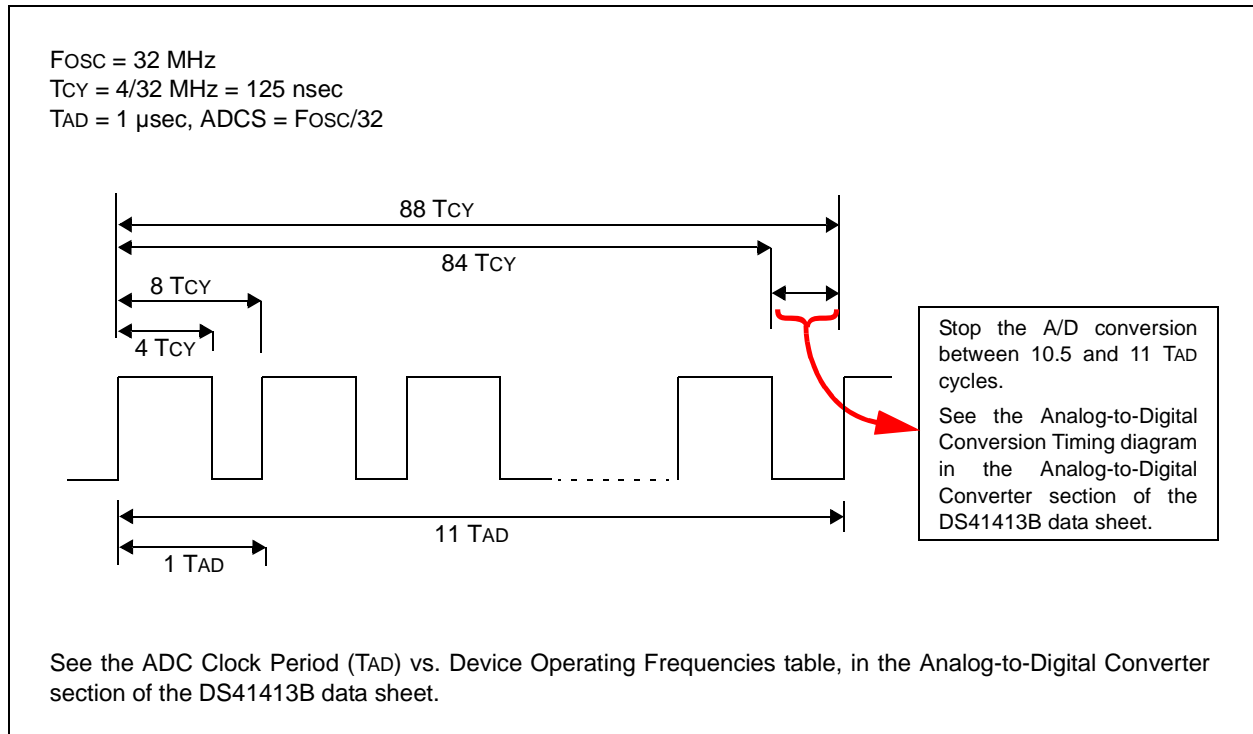
FIGURE 1: INSTRUCTION CYCLE DELAY CALCULATION EXAMPLE

Under certain device operating conditions, the ADC conversion may not complete properly. When this occurs, the ADC Interrupt Flag (ADIF) does not get set, the GO/DONE bit does not get cleared and the conversion result does not get loaded into the ADRESH and ADRESL result registers.

In Figure 1, 88 instruction cycles (Tcy) will be required to complete the full conversion. Each TAD cycle consists of 8 Tcy periods. A fixed delay is provided to stop the A/D conversion after 86 instruction cycles and terminate the conversion at the correct time as shown in the figure above.

Note: The exact delay time will depend on the choice of Fosc and the TAD divisor (ADCS) selection. The Tcy counts shown in the timing diagram above apply to this example only. Refer to Table 3 for the required delay counts for other configurations.

Method 2: Provide a fixed delay in software to stop the A-to-D conversion manually, after all 10 bits are converted, but before the conversion would complete automatically. The conversion is stopped by clearing the GO/DONE bit in software. The GO/DONE bit must be cleared during the last ½ TAD cycle, before the conversion would have completed automatically. Refer to [Figure 1](#) for details.

```
BSF    ADCON0, GO/DONE; Start ADC conversion
      ; Provide 86
      ; instruction cycle
      ; delay here
BCF    ADCON0, GO/DONE; Terminate the
      ; conversion manually
MOVF   ADRESH, W      ; Read conversion
      ; result
```

Fosc	TAD	Instruction Cycle Delay Counts
32 MHz	Fosc/64	172
	Fosc/32	86
16 MHz	Fosc/64	172
	Fosc/32	86
	Fosc/16	43
8 MHz	Fosc/32	86
	Fosc/16	43
