## Errata Sheet V1.0

**AT91  
ARM<sup>®</sup> Thumb<sup>®</sup>  
Microcontrollers**

**AT91M63200  
AT91M43300  
Errata Sheet  
V1.0**

Rev. 1781B–01/02

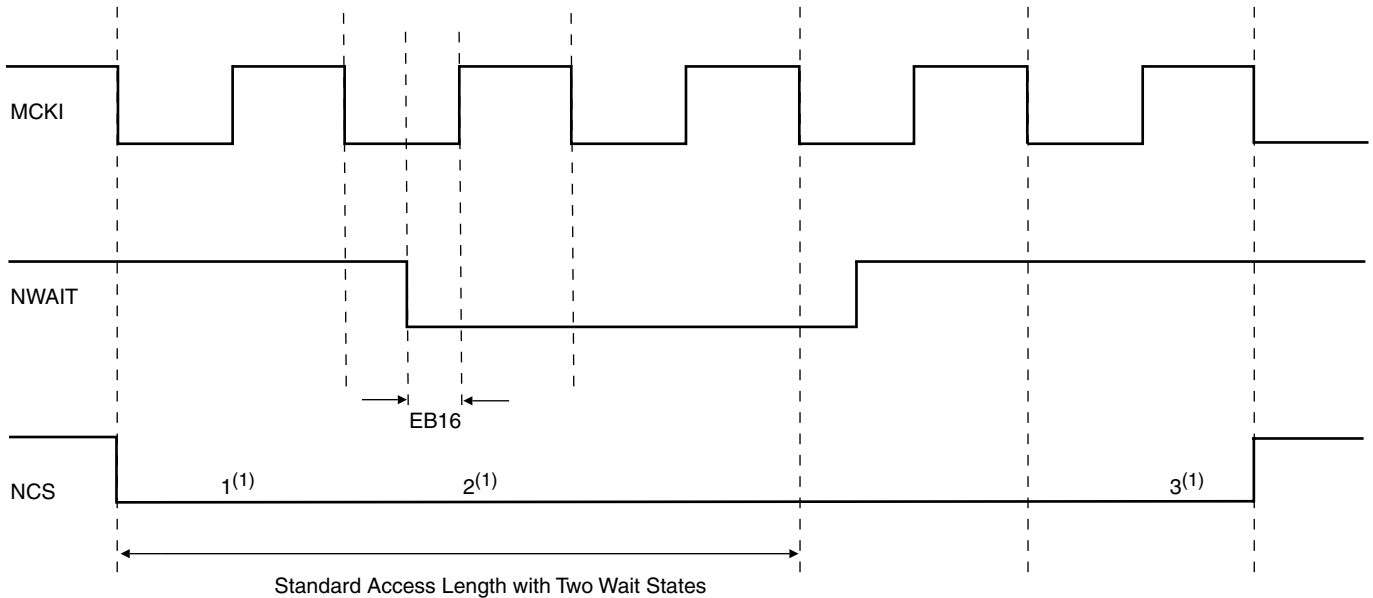
**Figure 2. Number of Standard Wait States is Two**

If the NWAIT setup time is satisfied on the following edges of MCKI and if at least one standard wait state remains to be executed, the behavior is accurate. In the following example, the number of standard wait states is two. The NWAIT setup time on the second rising edge of MCKI must be met.

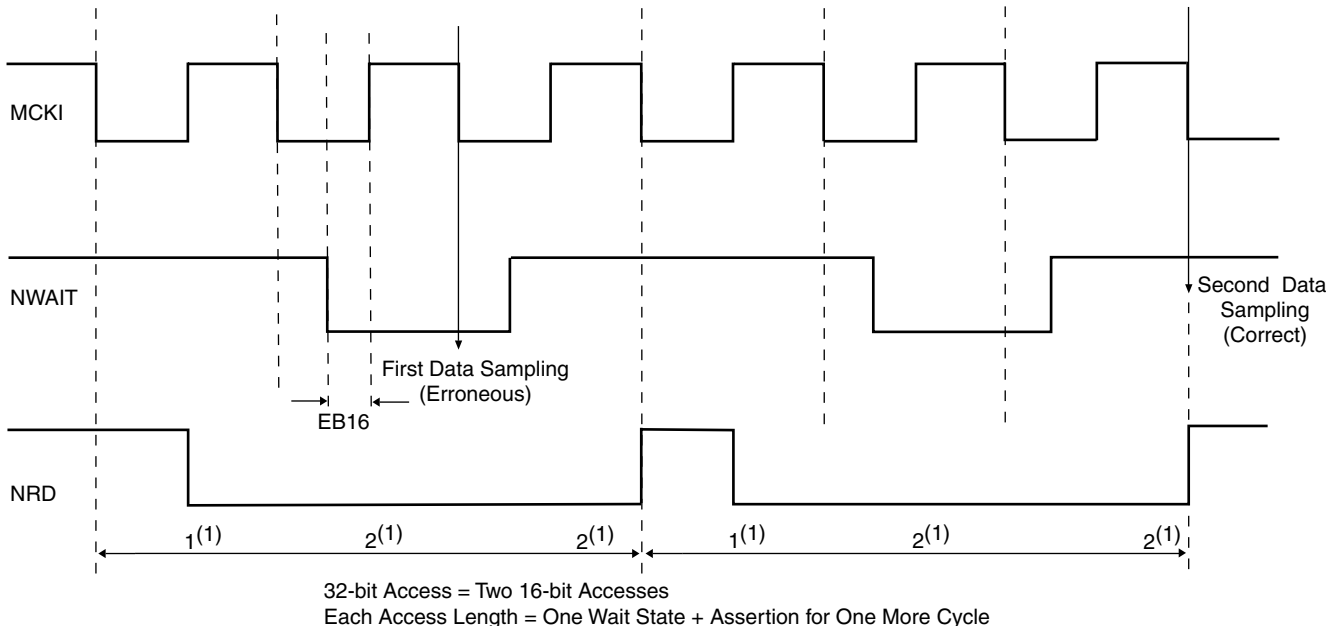
**Figure 3.** Number of Standard Wait States is One

- 32-bit read accesses are not managed correctly and the first 16-bit data sampling takes into account only the standard wait states. 16- and 8-bit accesses are not affected.
- During write accesses of any type, the NWE rises on the rising edge of the last cycle as defined by the programmed number of wait states. However, NWAIT assertion does affect the length of the total access. Only the NWE pulse length is inaccurate.

If the first two conditions are not met during a 32-bit read access, the first 16-bit data is read at the end of the standard 16-bit read access. In the following example, the number of standard waits is one. NWAIT assertions do affect both NRD pulse lengths, but first data sampling is not delayed. The second data sampling is correct.

At maximum speed, asserting the NWAIT in the first access cycle is not possible, as the sum of the timings “MCKI Falling to Chip Select” and “NWAIT setup to MCKI rising” are generally higher than one half of a clock period. This leads to using at least one standard wait state. However, this is not sufficient except to perform byte or half-word read accesses. Word and write accesses require at least two standard wait states.
