dsPIC30F5011/5013 Rev. A1/A2 Silicon Errata

dsPIC30F5011/5013 (Rev. A1/A2) Silicon Errata

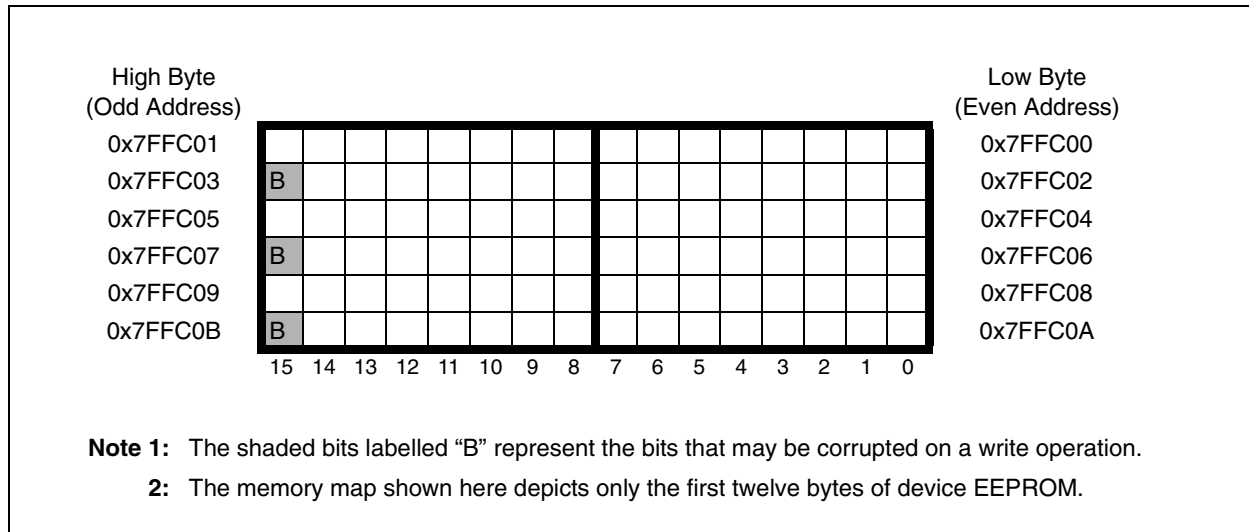
FIGURE 1: dsPIC30F5011/5013 DATA EEPROM

The Most Significant bit of every fourth byte in data EEPROM may be corrupted on any write operation. This write corruption may occur while using either PRO MATE®, MPLAB ICD 2 or Run-Time Self-Programming (RTSP).

Figure 1 shows the first twelve bytes in data EEPROM and indicates the affected bits.

Use program Flash memory instead of data EEPROM to store constant data.

Use less than 16 bits in each word in the available data EEPROM, excluding the Most Significant bit.

Avoid using every fourth byte. Example 1 shows how the ASM30 assembler can be used to allocate data in the EEPROM under this constraint.
