dsPIC30F601X Rev. A3 Silicon Errata

dsPIC30F601X (Rev. A3) Silicon Errata

The dsPIC30F601X (Rev. A3) samples you have received have been tested for an operational voltage, VDD, in the range of 4.5 to 5.5 volts. These samples were found to conform to the specifications and functionality described in the following documents:

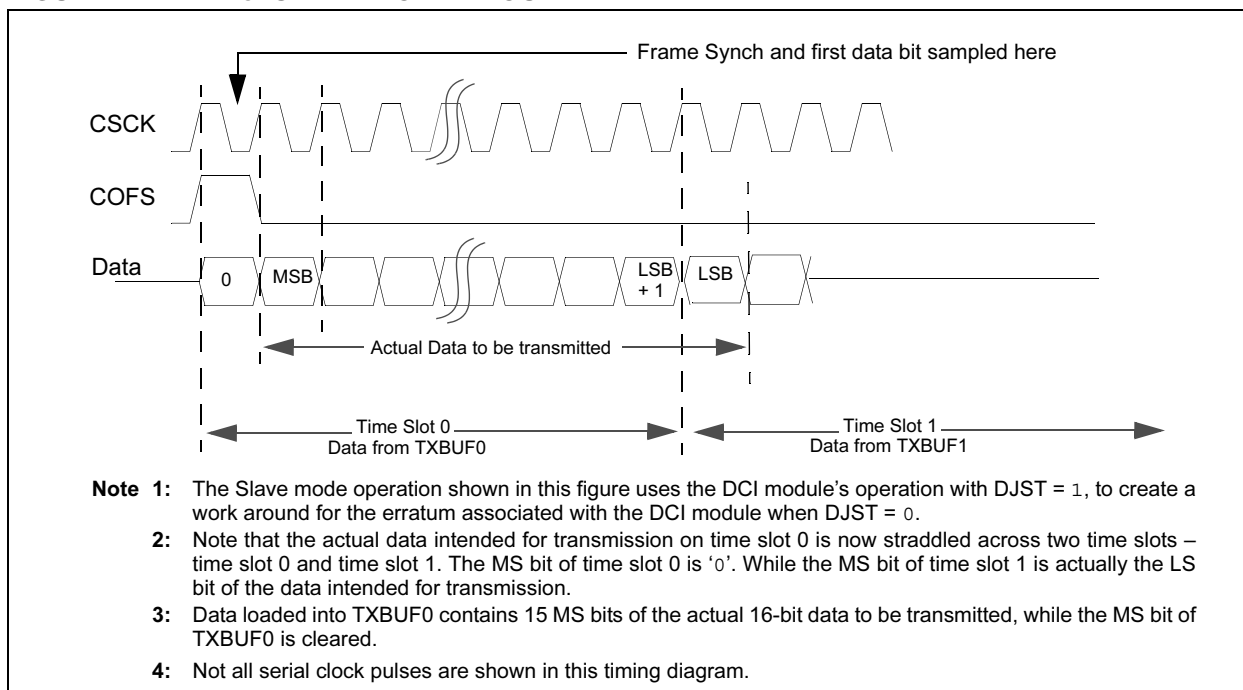
FIGURE 1: DCI SLAVE WORK AROUND

The Data Converter Interface (DCI) module does not function correctly in Slave mode when the following conditions are true:

- The DCI module is configured to transmit/receive one serial clock (bit clock) after the frame synchronization pulse,
DJST(DCICON1<5>) = 0.
- The frame length chosen is longer than 1 word,
COFSG(DCICON2<8:5>) > 0000.

An example of loading the DCI Transmit buffers for the configuration above is shown in Example 8. A timing diagram in Figure 1 illustrates the various signals for this example. A similar rule may be applied to reading the received data from the RXBUF n SFRs.

The following work around may be applied to enable DCI communication in Slave mode when it is configured to transmit one serial clock after the frame synchronization pulse is received in a multi-word frame:

1. Set the DJST bit to '1'.
2. Enable an additional time slot immediately following each time slot intended for communication.
3. Enable an additional transmit/receive buffer word (modify COFSG bits) or an additional bit per word (modify WS) for each time slot intended for communication.
4. Shift the data word by 1 bit to the right and load the transmit buffer word(s), such that the LS Bit of the original data word to be transmitted is loaded into the additionally enabled bit of the transmit buffer register, TXBUF_n, or the MS bit of the additionally enabled transmit buffer, TXBUF_{n+1}.

Assume, the application needs the DCI module to act as a Slave transmitting 1 serial clock after the frame synchronization pulse is received. Further, assume that the application needs to transmit 16-bit data word on Time Slot 0 and the communication is over a $256 \cdot F_s$ channel. In order to reduce interrupt frequency we enable all 4 transmit buffers. The DCI module SFRs should be initialized as follows before being enabled:

- DCICON1 = 0x0720, DCICON2 = 0x0DEF
DCICON3 = 0x0000, TSCON = RSCON = 0x0003
