PIC16(L)F1824/1828 Family Silicon Errata and Data Sheet Clarification

The PIC16(L)F1824/1828 family devices that you have received conform functionally to the current Device Data Sheet (DS41419A), except for the anomalies described in this document.

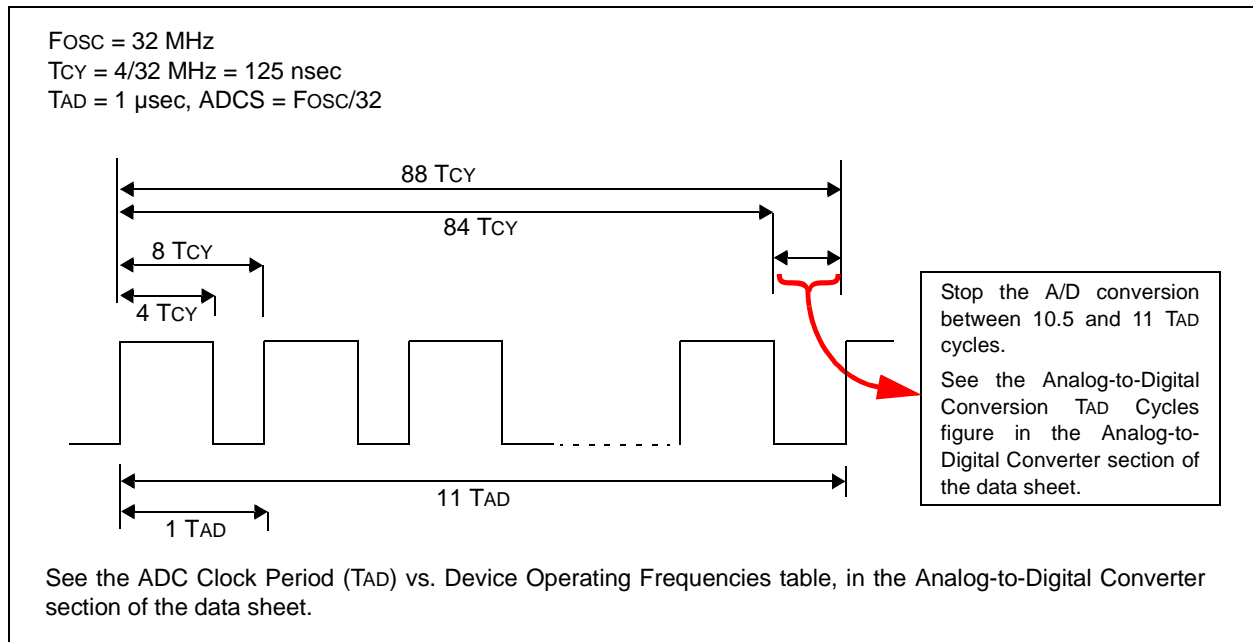
FIGURE 1: INSTRUCTION CYCLE DELAY CALCULATION EXAMPLE

In Figure 1, 88 instruction cycles (Tcy) will be required to complete the full conversion. Each TAD cycle consists of 8 Tcy periods. A fixed delay is provided to stop the A/D conversion after 86 instruction cycles and terminate the conversion at the correct time as shown in the figure above.

Note: The exact delay time will depend on the TAD divisor (ADCS) selection. The Tcy counts shown in the timing diagram above apply to this example only. Refer to Table 3 for the required delay counts for other configurations.

Method 3: This method is provided if the application cannot use Sleep mode and requires continuous operation at frequencies above 8 MHz. This method requires early termination of an ADC conversion. Provide a fixed time delay in software to stop the A-to-D conversion manually, after all 10 bits are converted, but before the conversion would complete automatically. The conversion is stopped by clearing the GO/DONE bit in software. The GO/DONE bit must be cleared during the last 1/2 TAD cycle, before the conversion would have completed automatically. Refer to [Figure 1](#) for details.
