# **Intel® 82571EB/82572EI Ethernet Controller**

**Specification Update**

*April 2009  
Revision 6.1  
Order Number 321896-001*

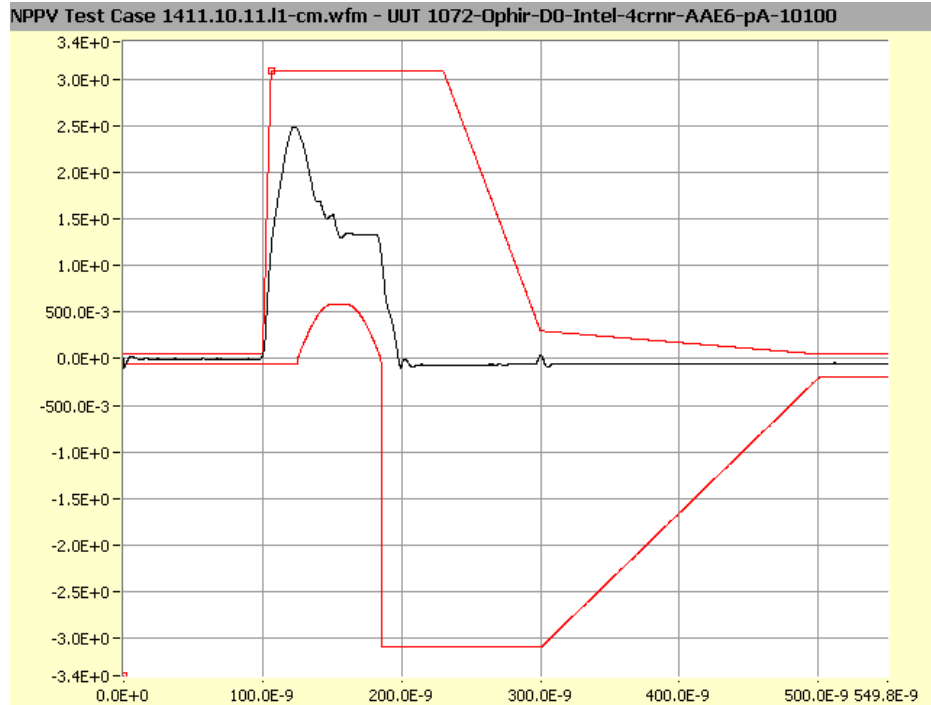
## 27. 10base-T Link Pulse Hits the Template Mask Due to Voltage Ripple/Glitch

Problem: The 10base-T link pulse touches the template due to voltage ripple/glitch.

Implication: Compliance with the specification is not complete, however, there is no effect at system level.

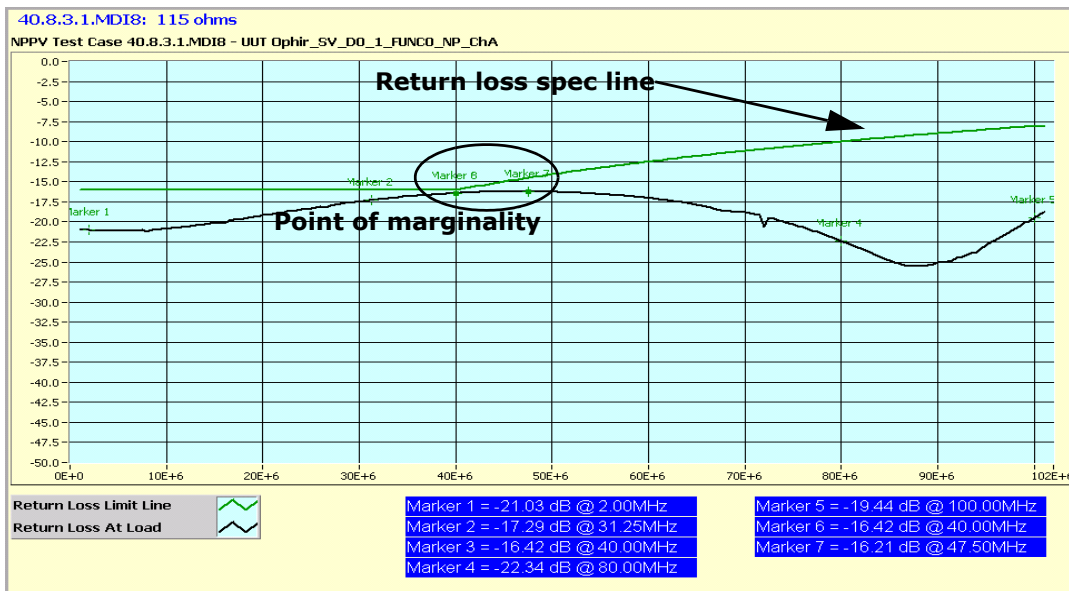
Clarification: Return loss for 115 ohm load is marginal (Gigabit IEEE specification Section 40.8.3.1) near the frequency of 40MHz. Return loss is acceptable throughout the rest of the frequency spectrum and conforms to the 10Base-T and 100Base-TX specification limits.

IEEE conformance is marginal. There is no impact on system-level performance.
