Intel® 82571EB/82572EI Ethernet Controller

Specification Update

*July 2010
Revision 6.3*

322206US

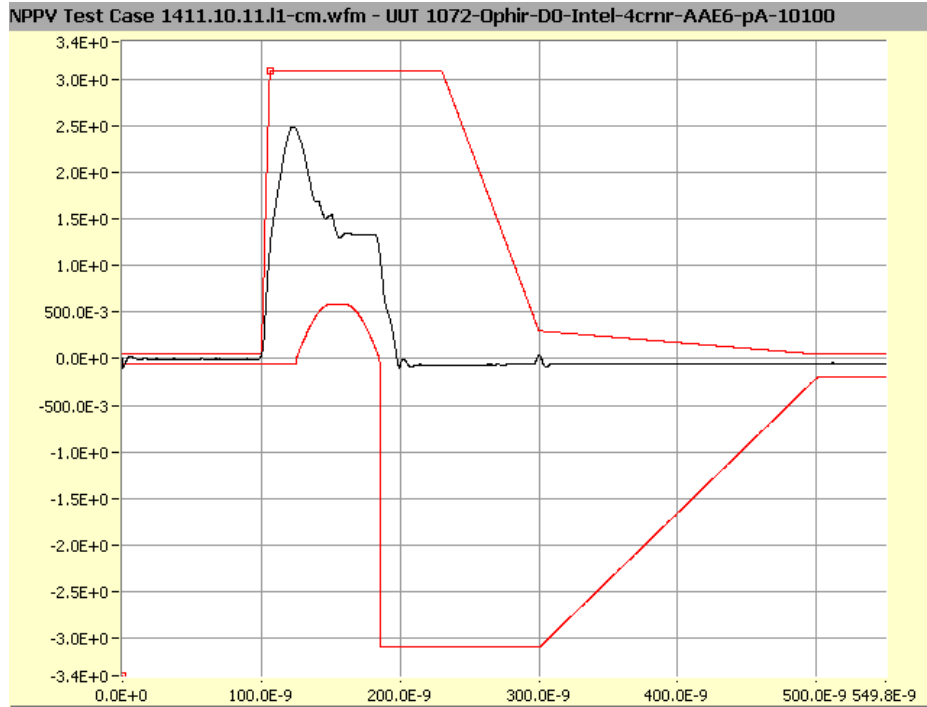
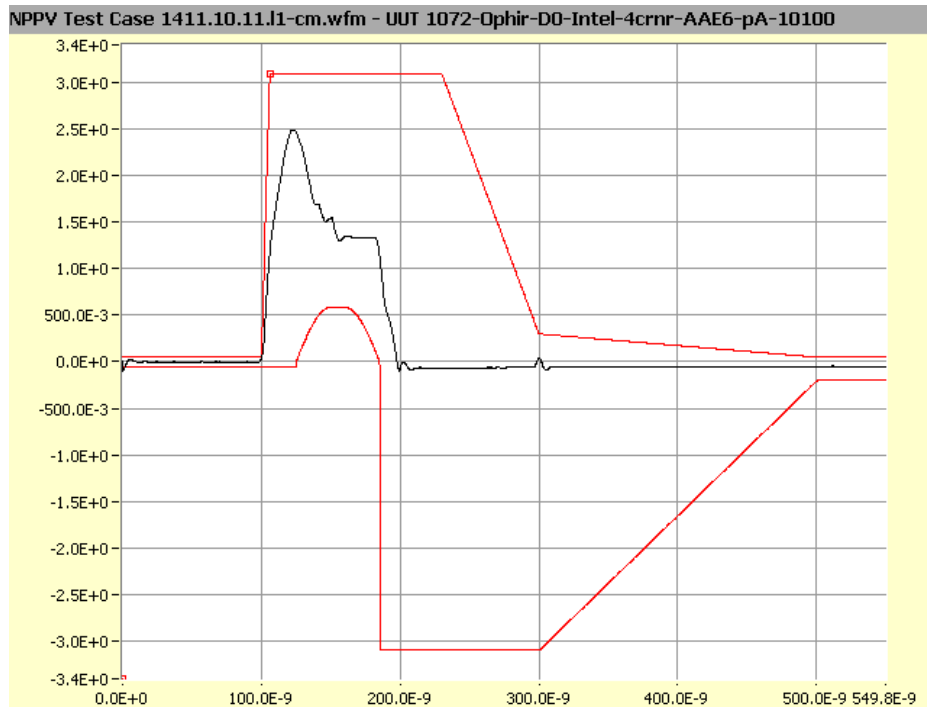
27. 10base-T Link Pulse Hits the Template Mask Due to Voltage Ripple/Glitch

Problem: The 10base-T link pulse touches the template due to voltage ripple/glitch.

Implication: Compliance with the specification is not complete, however, there is no effect at system level.

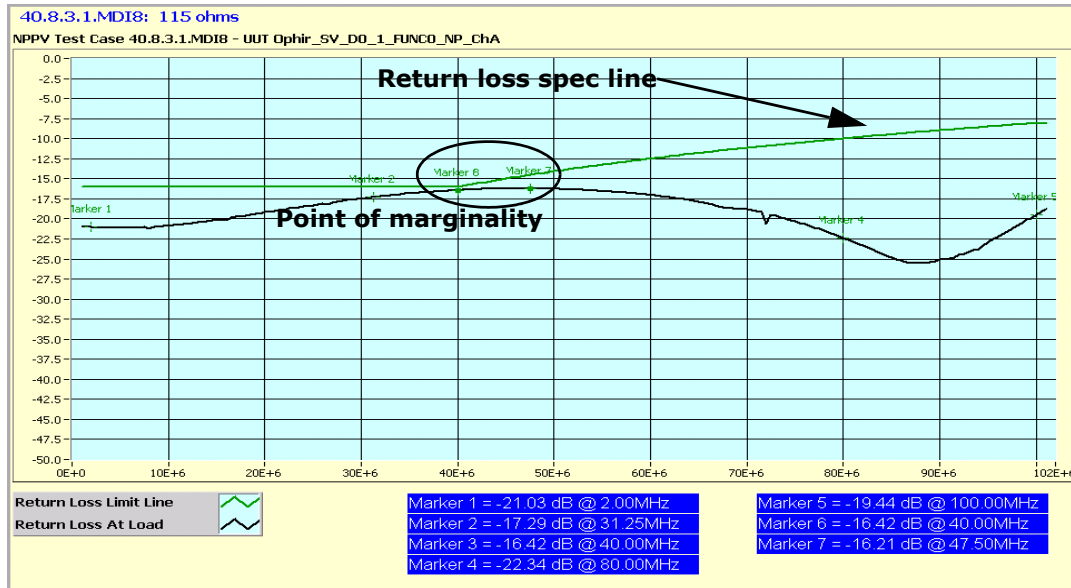
Clarification: Return loss for 115 ohm load is marginal (Gigabit IEEE specification Section 40.8.3.1) near the frequency of 40MHz. Return loss is acceptable throughout the rest of the frequency spectrum and conforms to the 10Base-T and 100Base-TX specification limits.

IEEE conformance is marginal. There is no impact on system-level performance.
