Cortina Systems® LXT973 10/100 Mbps Dual-Port Fast Ethernet PHY Transceiver

Specification Update

20 March 2007

Document Number 249737

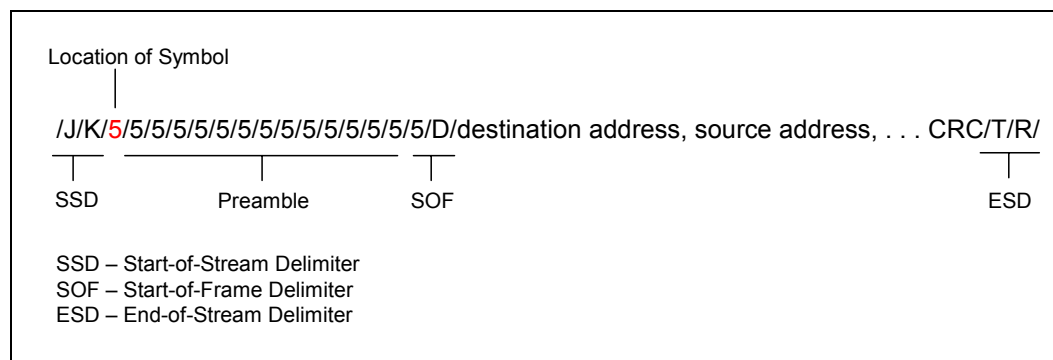
Item 9: Detection of Illegal Symbols After SSD

- Problem** An illegal symbol placed immediately after the Start-of-Stream Delimiter (SSD) (preamble after JK) is not detected. However, any subsequent corrupt symbol will be detected.

- Implication** RXER will not assert if this symbol location is corrupted. However, an error in this location does not affect packet integrity.
- Workaround** Use the MAC layer protocol to detect corrupt symbols in the packet.
- Status** There are no plans to fix this erratum.
