**Intel<sup>®</sup> Server Board S5000PAL**  
**Intel<sup>®</sup> Server Board S5000XAL**  
**Intel<sup>®</sup> Server System SR1500AL**  
**Intel<sup>®</sup> Server System SR1550AL**  
**Intel<sup>®</sup> Server System SR2500AL**

*Intel Order Number D65289-017*

**October 2007**

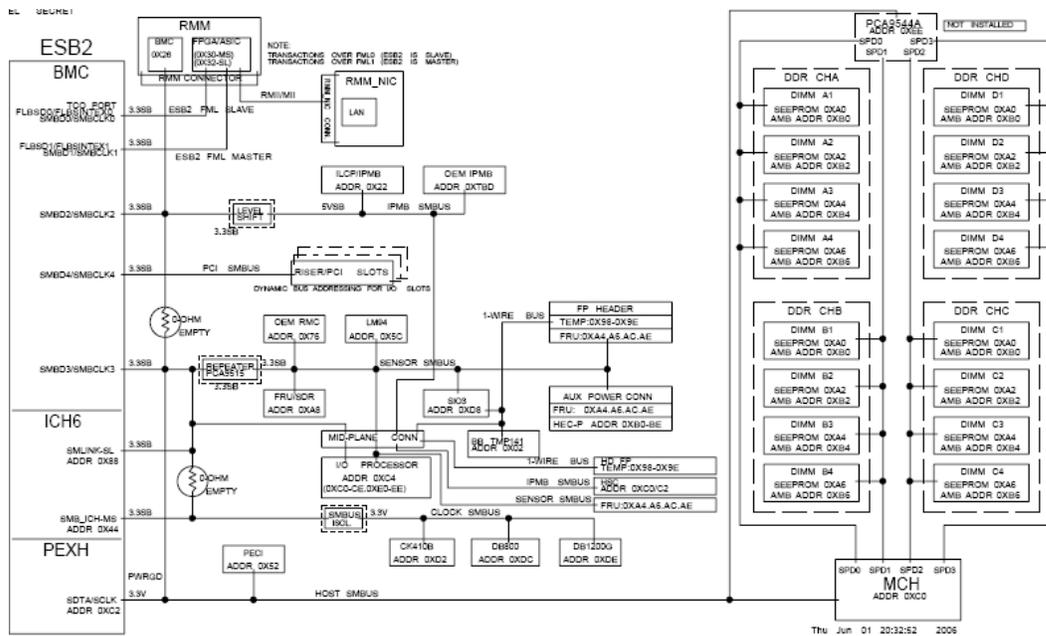
- o Add PECl controller
- o Remove separate HSC connector
- o Correct Midplane -> FP Smbus connections and 1-wire temp sensor
- o Correct Smbus and 1-wire temp sensor connections to FP connector.
- o Correct FBDIMM labeling

Implication: Inaccurate understanding of actual baseboard design with respect to specified diagram.

The correct diagram is shown below.

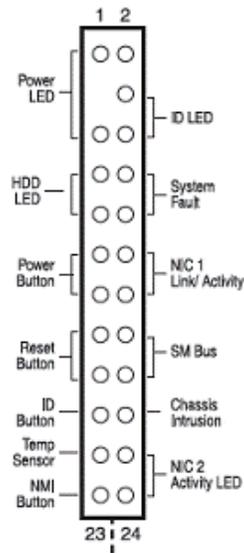
Problem: The current diagram incorrectly lists a 'cooling status' pin, does not have the temperature sensor listed, and shows incorrect locations for the ID LED. The corrected diagram is shown below.

Implication: This is a typo.
