# Intel<sup>®</sup> 80314 I/O Processor Companion Chip

## Specification Update

| *July 2005*

Order Number: 273759-010US

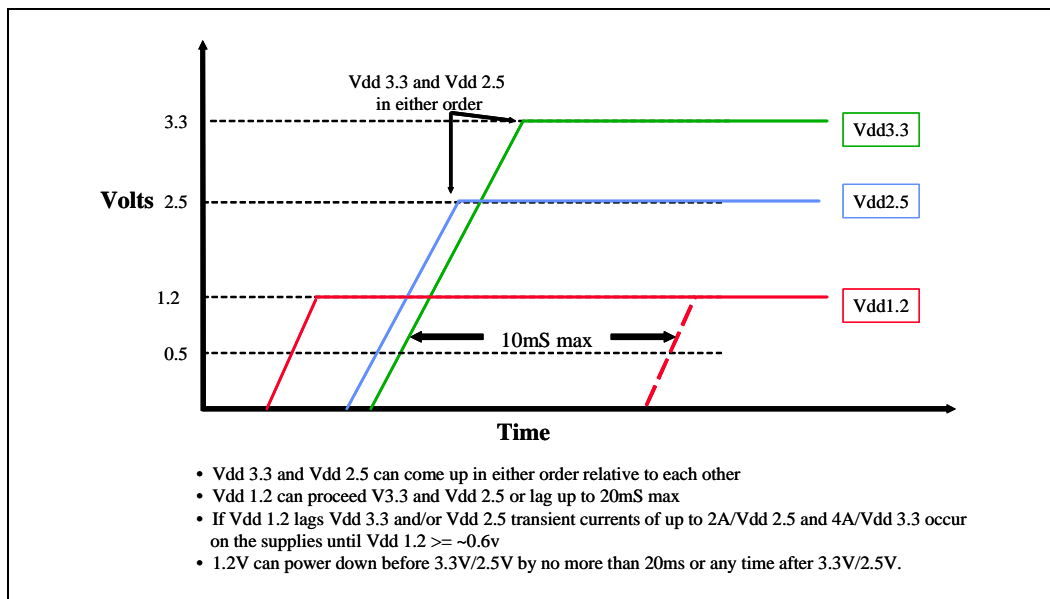
Figure 1. Power-Sequencing Requirements

Issue: The power-up and power-down sequences of the 80314 1.2 V/2.5 V/3.3 V supply rails has been revised from version 003 and 004 of this specification update. The power sequencing requirements initially presented in version 003 were designed to avoid transient current draw that could appear on the 2.5 V/3.3 V supply rails. Further investigation has determined that no current transients occur when the 1.2 V supply is ramped first. In addition, it is acceptable to ramp the 1.2 V supply after the 2.5 V and 3.3 V supplies as long as the lag is less than or equal to 20 mS. When the 1.2 V rail lags the 2.5 V and/or 3.3 V rail, transient currents of up to 2 A/V<sub>DD2.5</sub> and 4 A/V<sub>DD3.3</sub> can occur on the supplies until V<sub>DD1.2</sub> >= ~0.6 V. The 1.2 V supply can power down no more than 20 ms before or any time after the 3.3 V/2.5 V supplies power down. These requirements are illustrated in Figure 1.
