This errata sheet provides updated information on known device issues affecting Cyclone® IV devices.

Table 1 lists specific Cyclone IV issues and which Cyclone IV devices are affected by each issue.

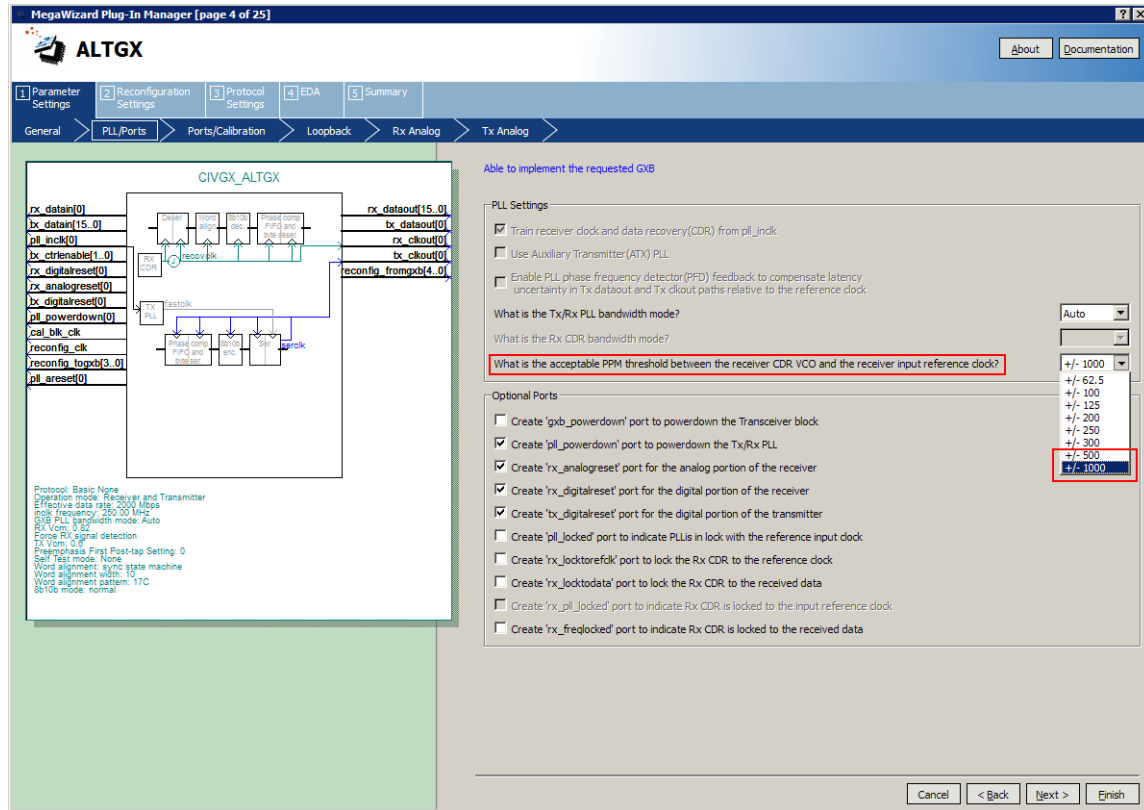
Figure 1. Programmable PPM Detector Options in the ALTGX MegaWizard Plug-In Manager

The  $\pm 500$  PPM and  $\pm 1000$  PPM options for the Programmable PPM Detector feature in the ALTGX MegaWizard™ Plug-In Manager, as shown in [Figure 1](#), are no longer supported in the Quartus II software version 10.0 SP1 and later. These options are removed because the programmed PPM threshold values exceed the receiver CDR PPM tolerance between the upstream transmitter reference clock and the local receiver reference clock.

Designs compiled with the Quartus II software version 10.0 and earlier may have a link failure risk when the receiver is operating in a system that has  $\pm 500$  PPM or  $\pm 1000$  PPM differences for the reference clock frequencies between the upstream transmitter and the local receiver. Using CDR Manual Lock mode does not overcome the link failure risk.

For a receiver design that has the  $\pm 500$  PPM or  $\pm 1000$  PPM options selected in the Programmable PPM Detector feature, Altera recommends evaluating the system operation with different options, ranging between  $\pm 62.5$  PPM and  $\pm 300$  PPM. To change the **Programmable PPM Detector** option, regenerate and recompile the ALTGX MegaWizard Plug-In Manager design file with the supported options.
