This errata sheet provides updated information about known device issues affecting Stratix® IV GX devices.

## Production Devices for Stratix IV GX Devices

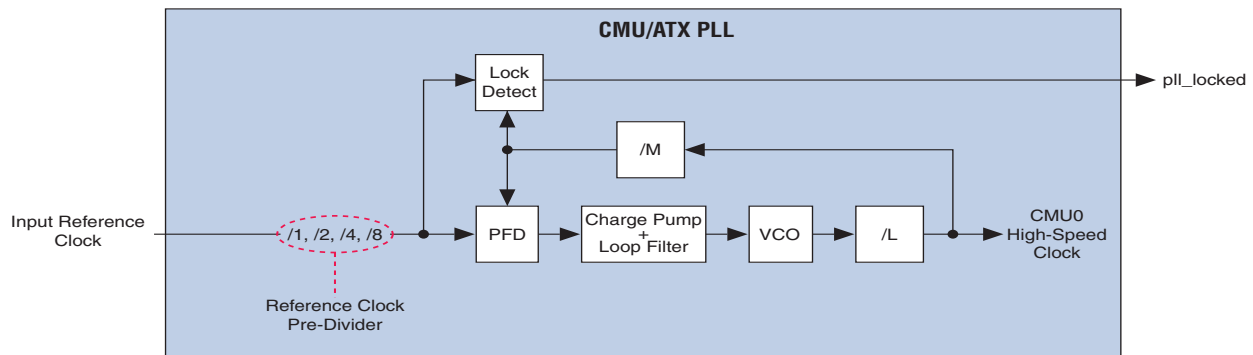
**Figure 1. Reference Clock Pre-Dividers in Transmitter PLLs**

The transmitter PLL lock status signal (pll\_locked) does not de-assert when the pll\_powerdown signal is asserted in configurations that use the reference clock pre-divider of 2, 4, or 8. [Figure 1](#) shows the reference clock pre-divider inside transmitter PLLs. This issue impacts the pll\_locked status signal in both the CMU PLL and the ATX PLL.

Designs that implement the recommended transceiver reset sequence described in the [Reset Control and Power Down](#) chapter in volume 2 of the *Stratix IV Device Handbook* could potentially see a link failure after coming out of reset.

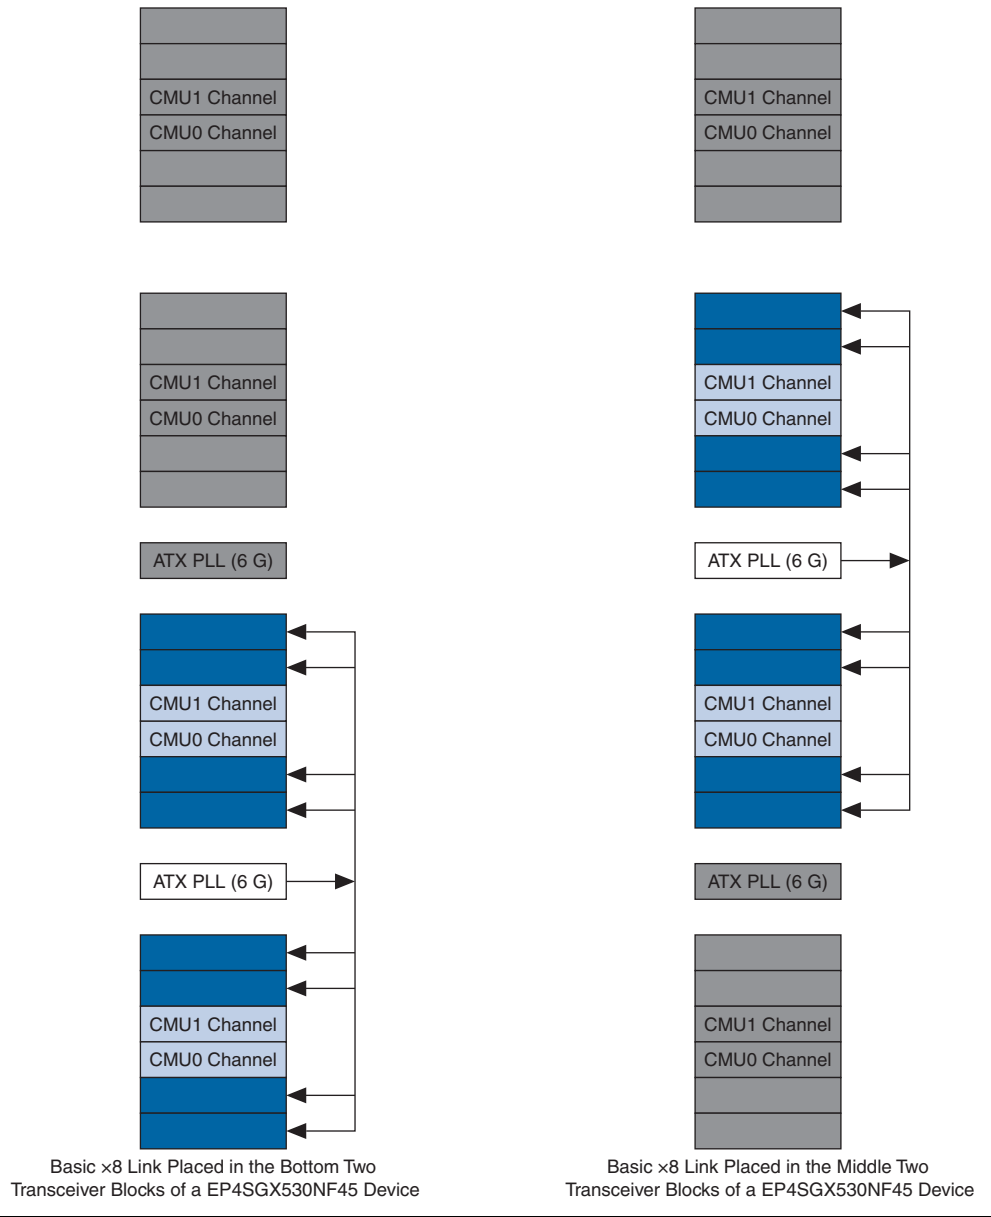
**Figure 4. Placement Restrictions in Basic x8 Mode using ATX PLL (6G)**

The ×N clock line timing issue in Stratix IV GX production devices affects the maximum data rate supported in the following transceiver configurations:

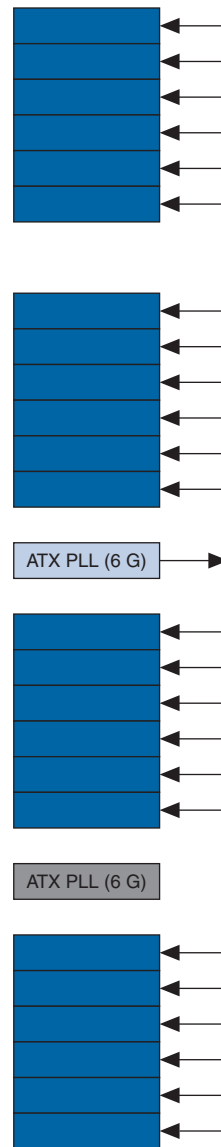
**Figure 7. Placement Restrictions in Basic (PMA Direct) xN (N=24) Mode using ATX PLL (6G)**

Basic (PMA Direct) x24 Link in a EP4SGX530NF45 Device

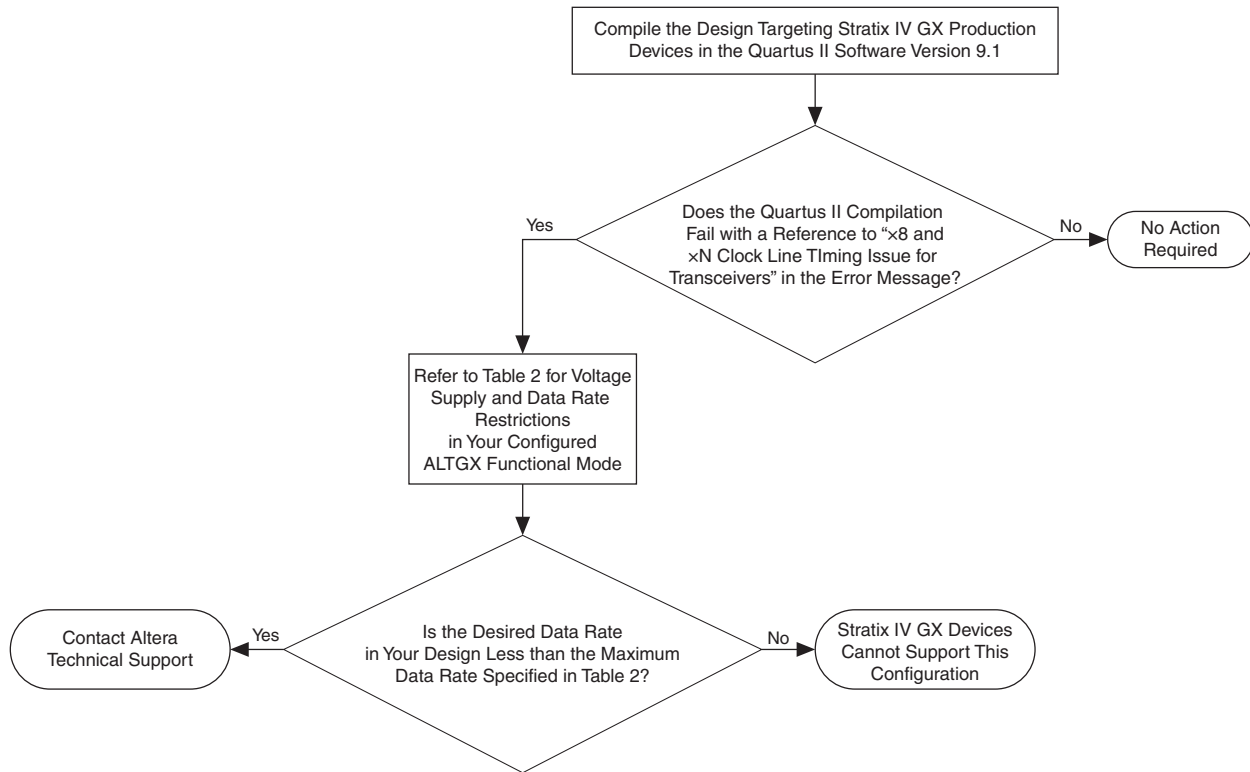
**Figure 8. Recommended Flow When Compiling Designs Targeting Stratix IV GX Production Devices**

The Quartus II software version 9.1 does not implement the correct data rate restrictions shown in [Table 2](#) for Stratix IV GX production devices.

Follow the recommended flow in [Figure 8](#) when you compile designs with Quartus II software version 9.1 that target Stratix IV GX devices.

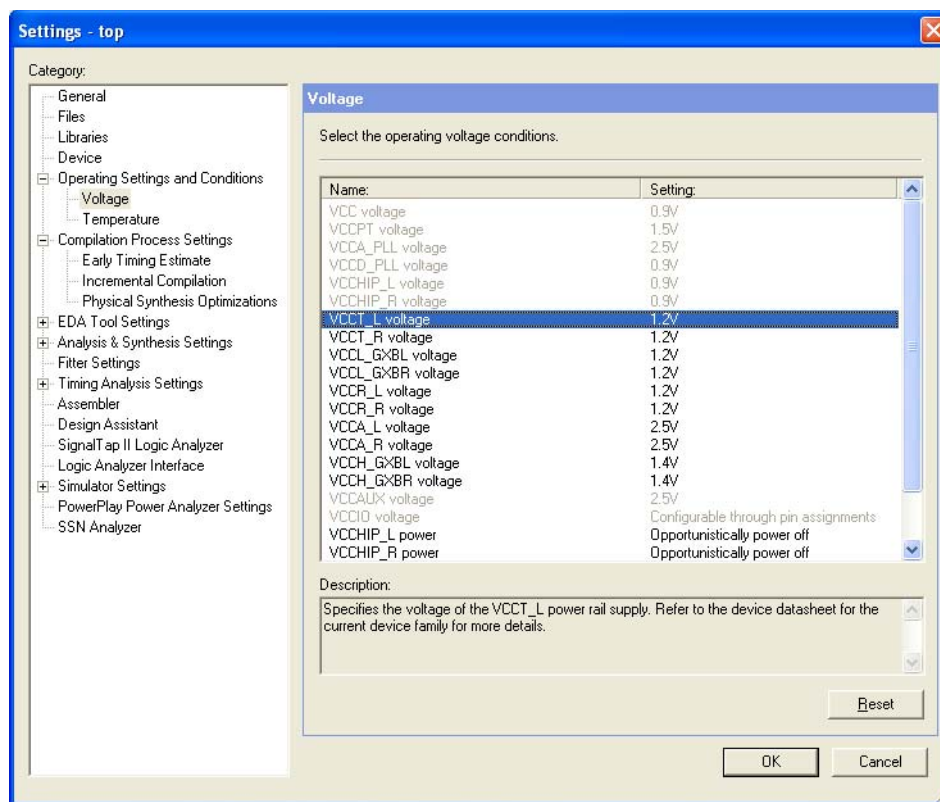
**Figure 9. Setting Voltage Levels**

- **Category 2:** The configured ×N line data rate is greater than the maximum data rate supported by 1.1 V, but less than or equal to that supported by the 1.2-V power supply level specified in [Table 2](#).

Action: In the Quartus II software, on the Assignments menu, click **Settings**. Click the "+" icon to expand **Operating Settings and Conditions** and select **Voltage**. Set the **VCCT\_L/R**, **VCCL\_GXBL/R**, and **VCCR\_L/R** voltage settings from **1.1V** to **1.2V**, as shown in [Figure 9](#). Then recompile the project.
