Introduction

This errata sheet provides updated information about known device issues affecting Arria® II GX devices.

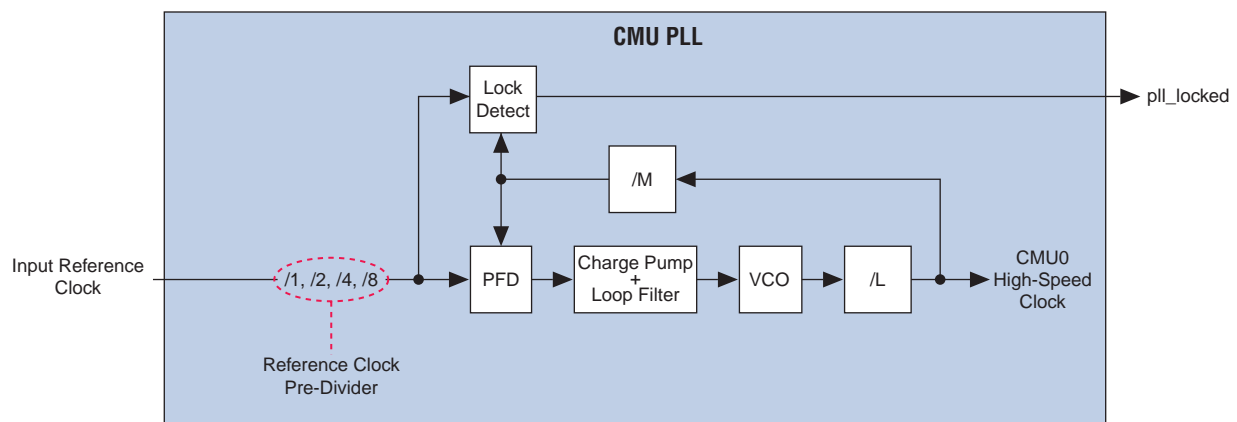
Figure 1. Reference Clock Pre-Dividers in Transmitter PLLs

The transmitter phase-locked loop (PLL) lock status signal (pll_locked) does not de-assert when the pll_powerdown signal is asserted in configurations that use the reference clock pre-divider of 2, 4, or 8. Figure 1 shows the reference clock pre-divider inside transmitter PLLs. This issue impacts the pll_locked status signal in the clock multiplier unit (CMU) PLL.

If the pll_locked issue impacts your design, instantiate and connect the pll_locked_soft_logic module, as shown in Figure 3. The pll_locked_to_corelogic output from this module must be used in the transceiver reset logic and any user logic that relies on the transmitter PLL lock status signal.

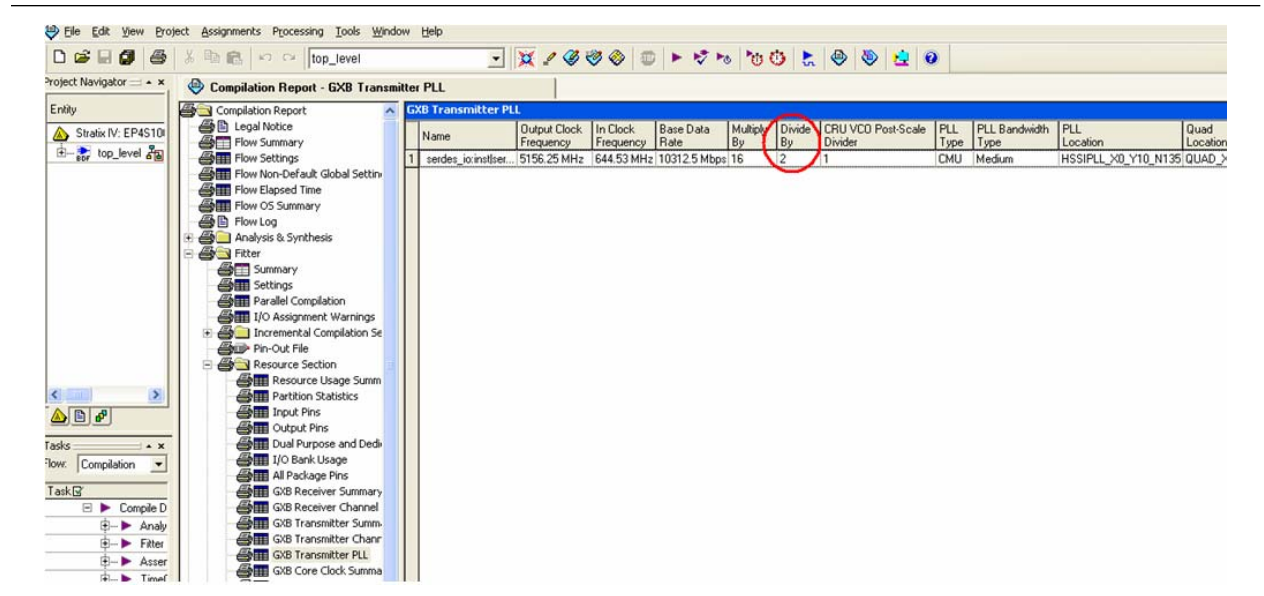
Figure 2. Determining Reference Clock Pre-Divider Value in the Compilation Report

You can determine if the Transmitter PLL in your design uses a reference clock pre-divider of 2, 4, or 8 by referring to the Quartus® II software Compilation Report. Figure 2 shows an example of the “GX B Transmitter PLL” report, which you find in the “Resources Section” under “Fitter” in the Compilation Report. If the value in the “Divide By” column reads 2, 4, or 8, your design is impacted by the pll_locked status signal issue.
