Mask Set Errata for Mask 3K45H

This mask set errata applies to the mask 3K45H for these products:

- MC68HC908JB8

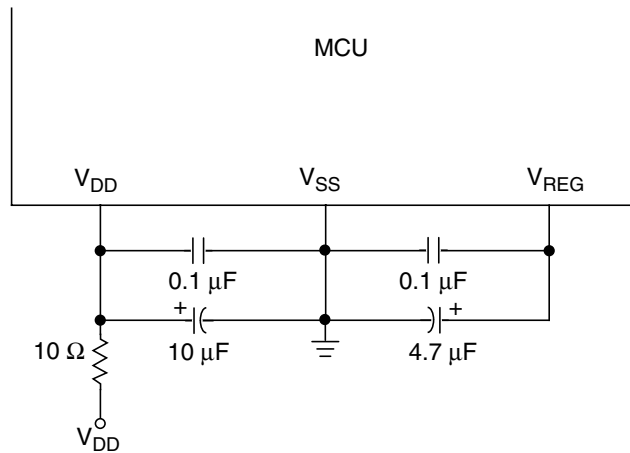
A few devices start abnormally during power-up. The issue is the release of the low voltage reset (LVR) earlier than the V_{REG} reaching the CMOS logic operating voltage (typical 0.65 V).

The LVR takes the V_{DD} but not the V_{REG} as a reference. LVR exists until the V_{DD} reaches the LVR threshold voltage (V_{LVR}). The problem happens in few devices when the V_{DD} rises quickly and the V_{REG} rises slowly. If the LVR has been released but the V_{REG} doesn't reach the CMOS logic operating voltage, the LVR does not have any effect. This might cause the internal logic to improperly initialize and the MCU might not start normally.

Therefore, the V_{DD} voltage must be lower than the VLVR minimum (2.8 V) when the V_{REG} voltage reaches the CMOS logic operating voltage.

To fix the problem, add a 10 Ω series resistor between the power supply and the V_{DD} , and place a 10 μF capacitor at the V_{DD} pin and a 4.7 μF capacitor at the V_{REG} pin.
