# 3 Volt Intel<sup>®</sup> Advanced+ Boot Block Flash Memory 28F800C3, 28F160C3, 28F320C3, 28F640C3

Specification Update

**November 2002**

Order Number: 297938-014

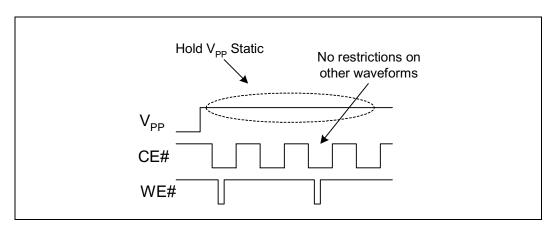
Problem: The 0.18µm 28F320C3xC devices can unintentionally reset under certain conditions where V<sub>PP</sub>

toggles.

Implication: When the reset occurs, any command being executed is interrupted and the flash switches to read

array mode.

3) Set V<sub>PP</sub> to a static high or static low level as shown here; and
