80C51 MCUs

T89C51CC01UA  
T89C51CC01CA

Errata Sheet

Rev. 4131C-8051-11/02

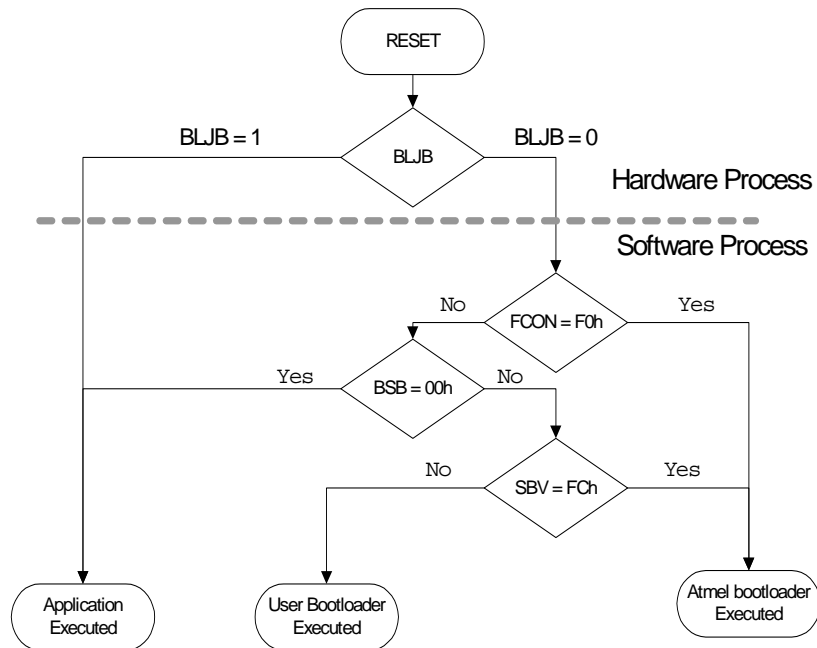
Version 1.2:

### 4. Boot Process Compatibility

There are some differences between Boot process of bootloader 1.2 and newer versions.

Use the fuse bit BLJB to start the application on both versions.
