3 Volt Intel StrataFlash[®] Memory

28F128J3, 28F640J3, 28F320J3

Specification Update

Order Number: 298130-015

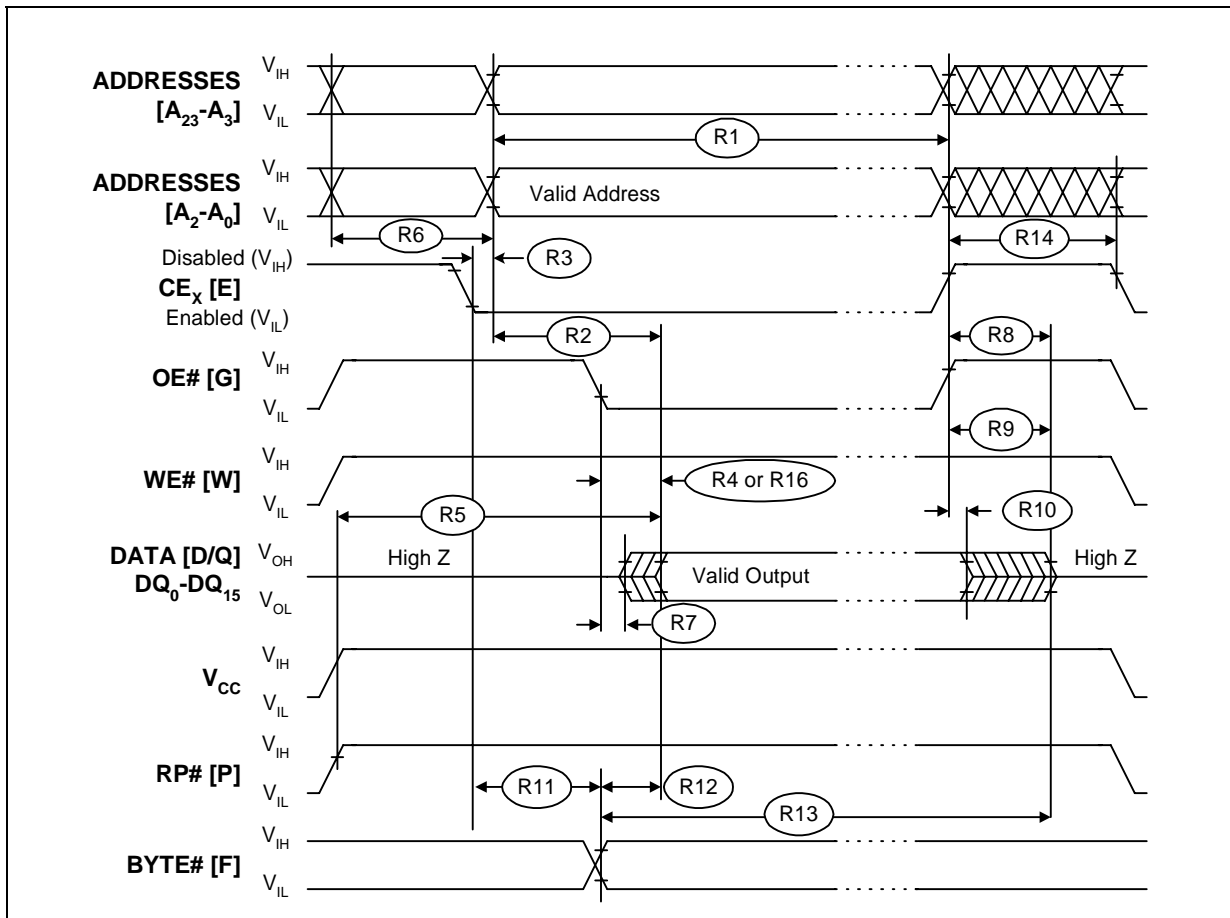
Figure 1. AC Waveform for Standard Word/Byte Read Operations

Problem: Devices need the parameter $t_{ELQX} = 150$ ns minimum. CE low to output in low Z (t_{ELQX}) is designated as R6 in Figure 1, in this Specification Update revision.

Problem: Devices need the parameter $t_{ELAV} = 500$ ns maximum. Chip Enable to Address Valid (t_{ELAV}) is designated as R3 in Figure 1, in this Specification Update revision.
