Intel[®] StrongARM^{*} SA-1110 Microprocessor

Specification Update

April 2001

Order Number: 278259-022

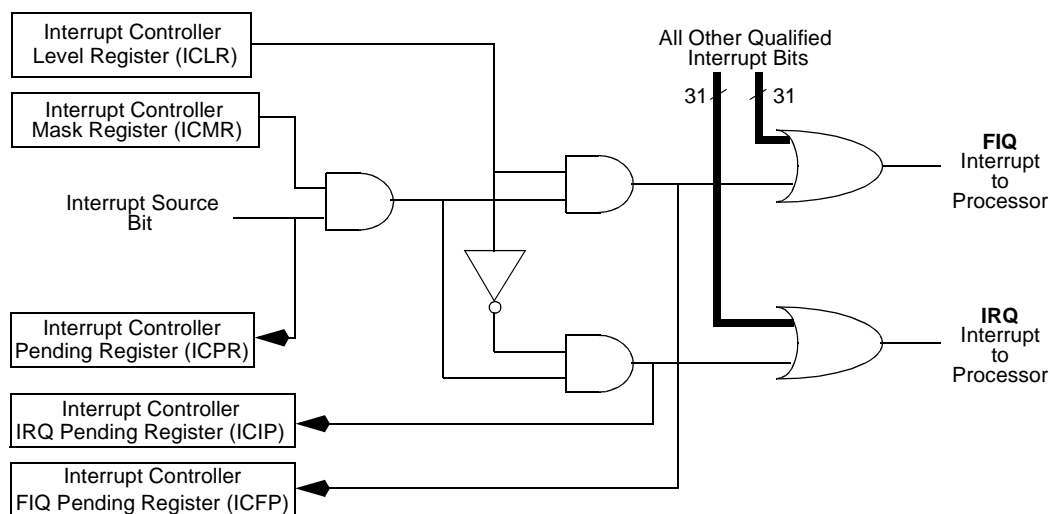
Figure 9-2. Interrupt Controller Block Diagram

Figure 9-2 now appears as:

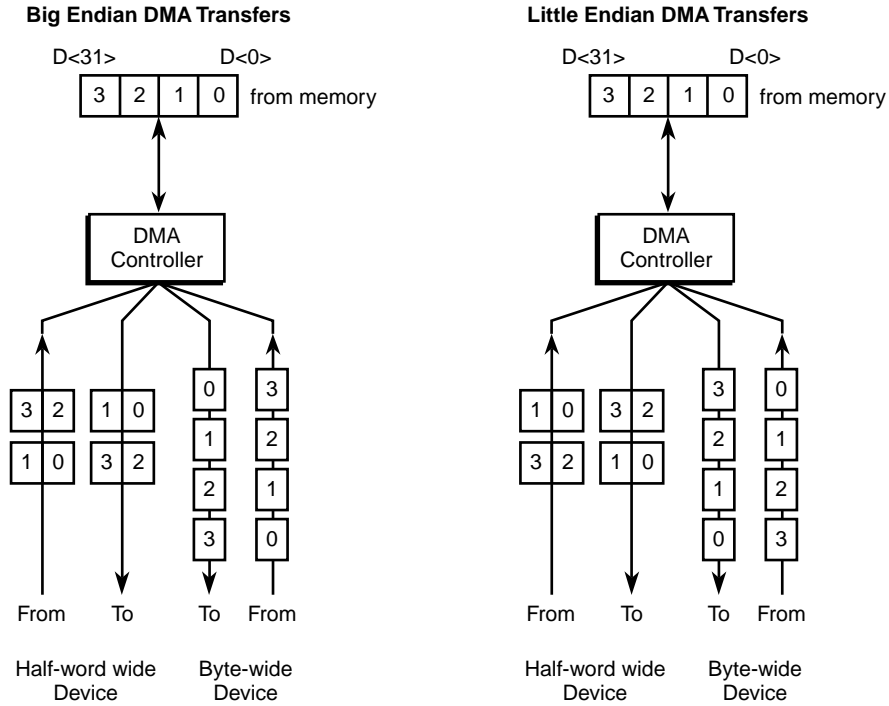
Corrected Figure 11-2.

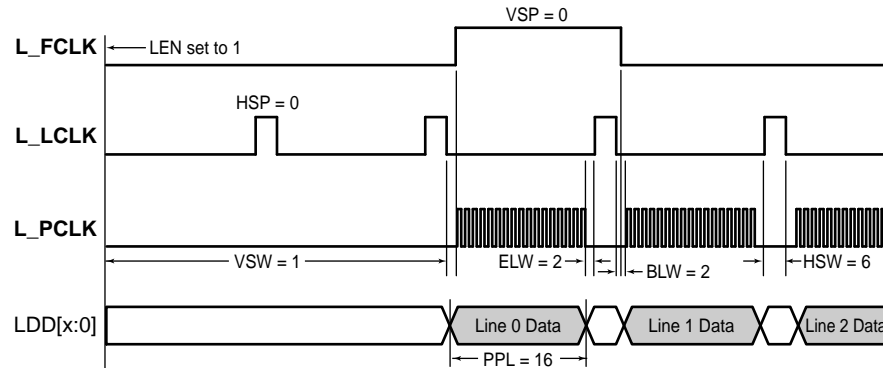
Figure 11-10. Passive Mode Beginning-of-Frame Timing

Changed the Notes: in Figure 11-10 to show the range of HSW as 1 to 64, not 0 to 64. The corrected figure is shown below:

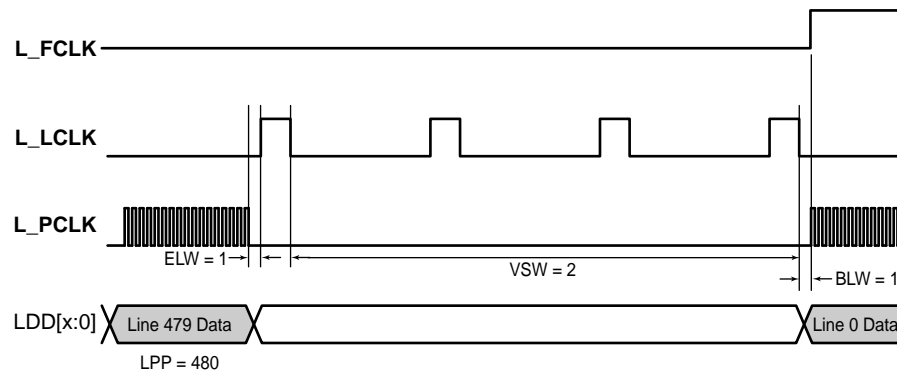
Figure 11-11. Passive Mode End of Frame Timing

Also, changed the Notes: in Figure 11-11 to show the range of BLW as 1 to 256, not 0 to 256. The corrected figure is shown below:

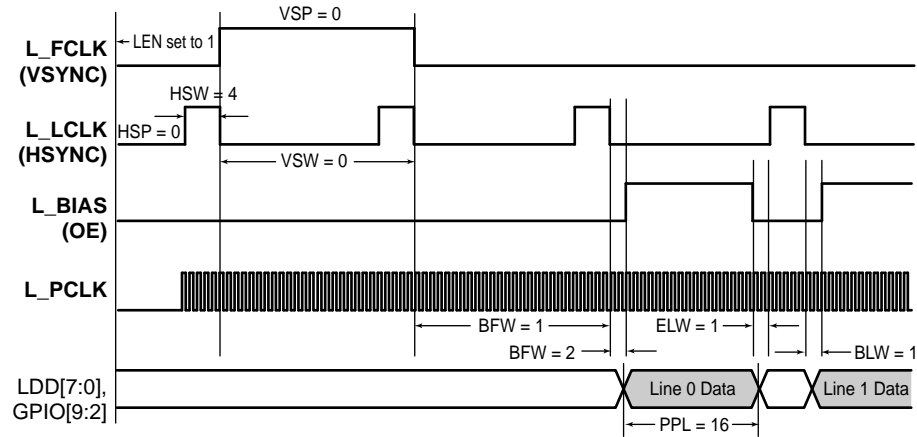
Figure 11-13. Active Mode Timing

Corrected Notes: in Figure 11-13 to show the range of PPL as 16 to 1024 (not 1 to 1024.) The corrected figure is shown below:
