PM4354

COMET-QUAD

**FOUR CHANNEL COMBINED E1/T1/J1
TRANSCEIVER/FRAMER**

Device Errata

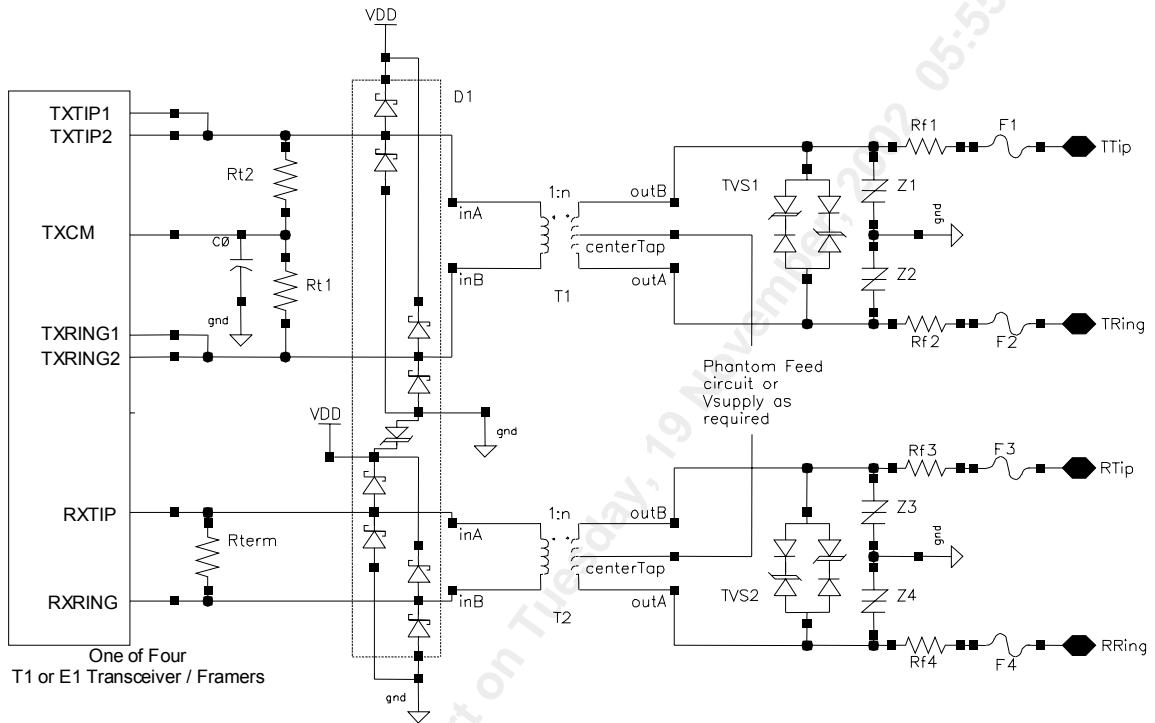
3.2 External Analog Interface Circuit Diagram Missing Lines

Figure 5 on page 34 of the COMET-QUAD Datasheet, “External Analog Interface Circuits,” is missing lines. The corrected version is shown below.

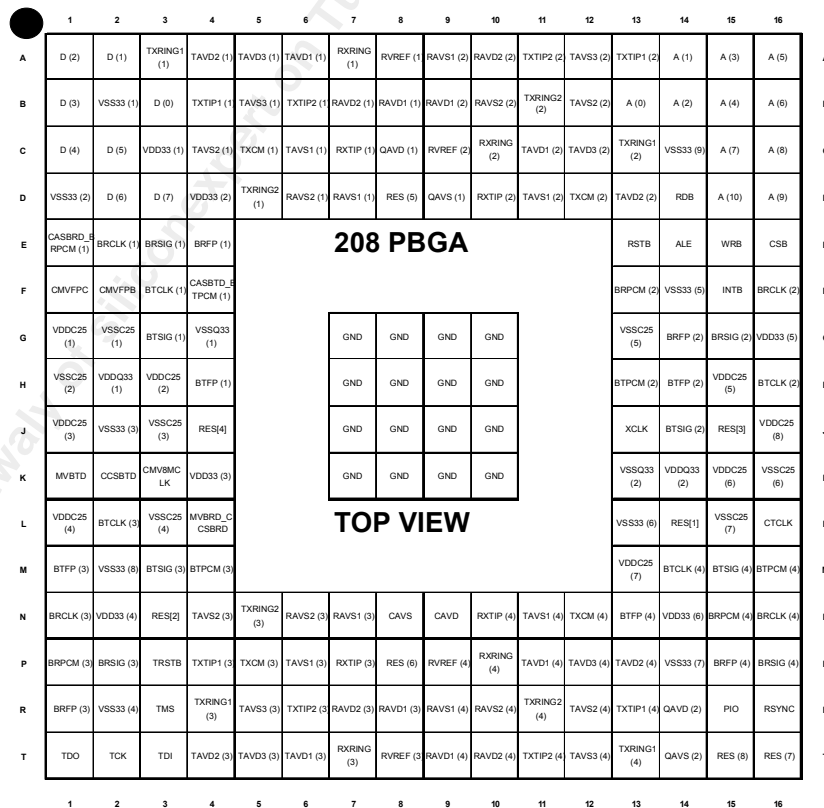
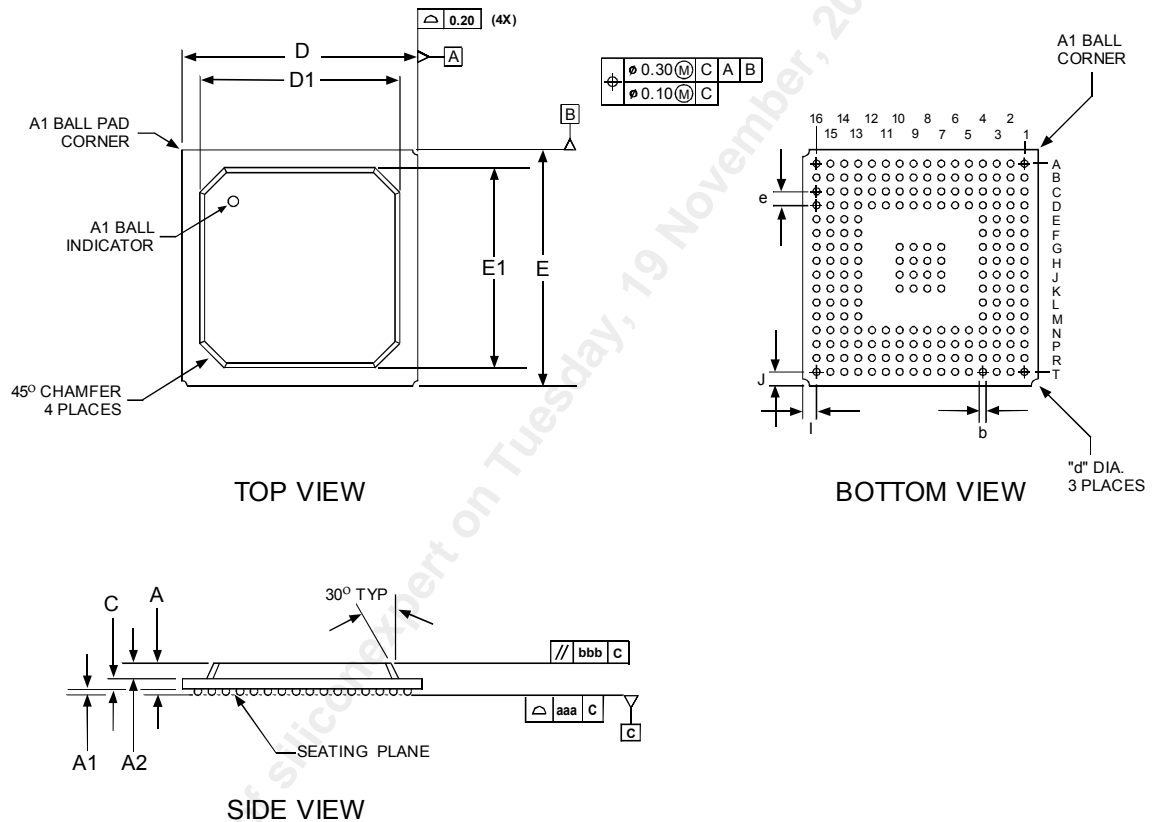
3.4 208 stPBGA Package

The COMET-QUAD package was changed to a 208-pin small thin Plastic Ball Grid Array (stPBGA).

- a) Reference to the old package on page 2 in Section 1 of the datasheet
- b) The Pin Diagram is on page 14 and 15 in Section 7 of the datasheet
- c) Table 110 is on page 445 in Section 18 of the datasheet
- d) The Mechanical Information is on page 446 in Section 19 of the datasheet
