Device TC1797
Marking/Step EES-AC, ES-AC, AC
Package P/PG-BGA-416-10

01710AERRA

This Errata Sheet describes the deviations from the current user documentation.

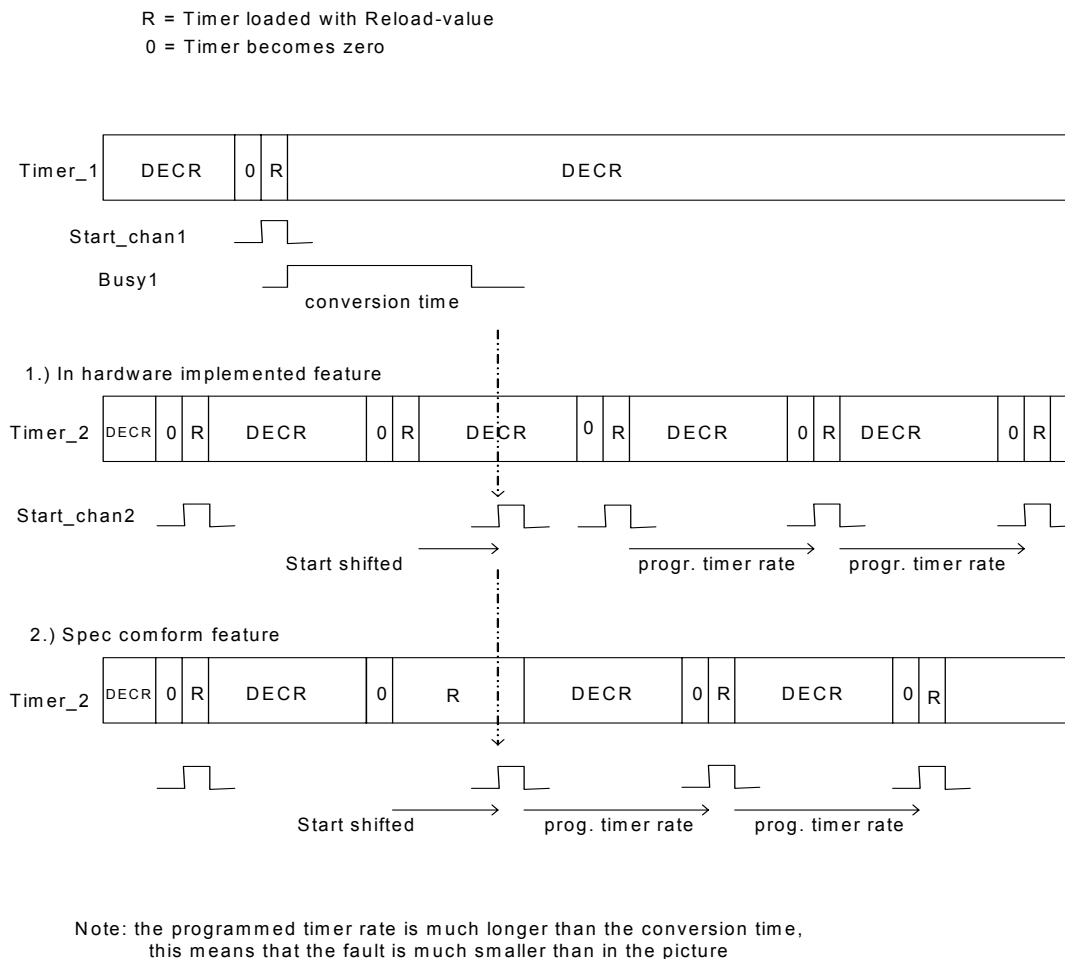
Figure 1 Timing concerning equidistant multiple timers

The correct behavior would be a reload when the requested conversion (of channel_2) is started.

Therefore the start of conversion for channel_2 is delayed by maximum one conversion-time. After this delay it will be continued with equidistant conversion-starts. Please refer to the following figure.

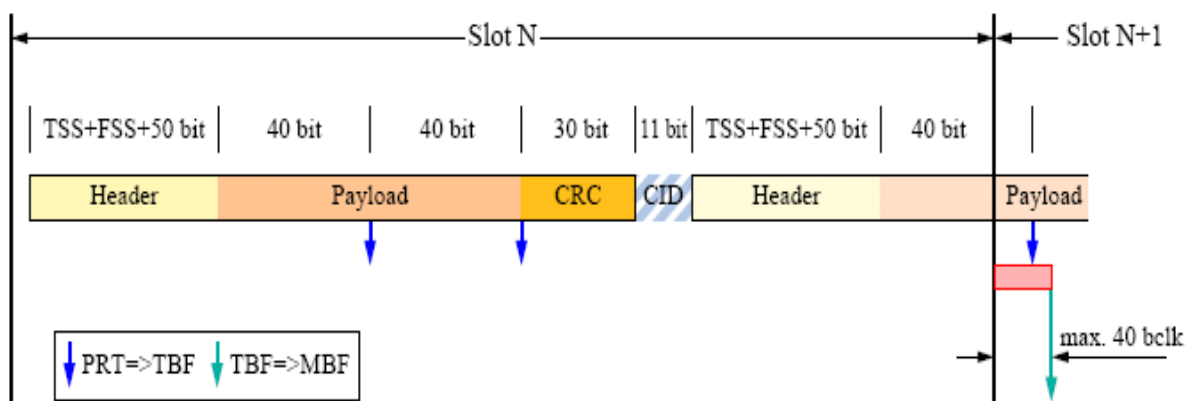
Figure 2 The second frame starts in the same slot

Scope:

The erratum is limited to cases where the complete header and a part of the payload of another frame is received in slot N.

The transfer of a received valid frame from TBF to MBF is initiated by the end of the actual slot. Execution is started not later than 40 bclk periods after the slot change. 40 bclk periods equate 10 bit times, when bclk=40MHz. Corruption of payload occurs when a transfer from PRT to TBF happens in the red marked time window between start of new slot and start of transfer from TBF to MBF.

1. Ensure that the static slot length is configured suited to the static payload length.
2. Check Message Buffer Status for boundary violation.

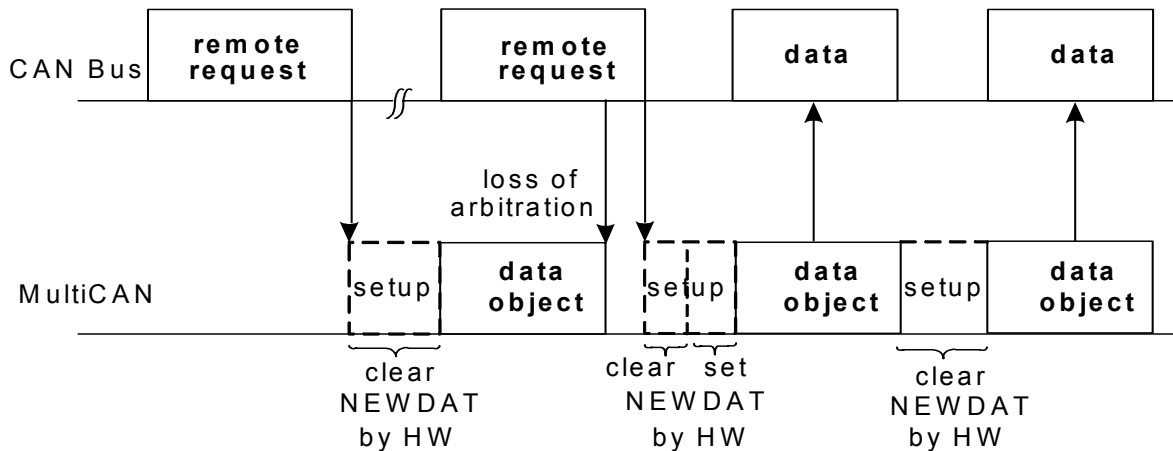
Figure 3 Loss of Arbitration

When the appropriate message object (data frame) triggered by the first remote frame wins the arbitration, it will be sent out and NEWDAT is not reset. This leads to an additional data frame, that will be sent by this message object (clearing NEWDAT).

There will, however, not be more data frames than there are corresponding remote requests.
