Intel[®] 810 Chipset Family: 82810/82810-DC100 Graphics and Memory Controller Hub (GMCH)

Specification Update

January 2001

Document Number: 290659-003

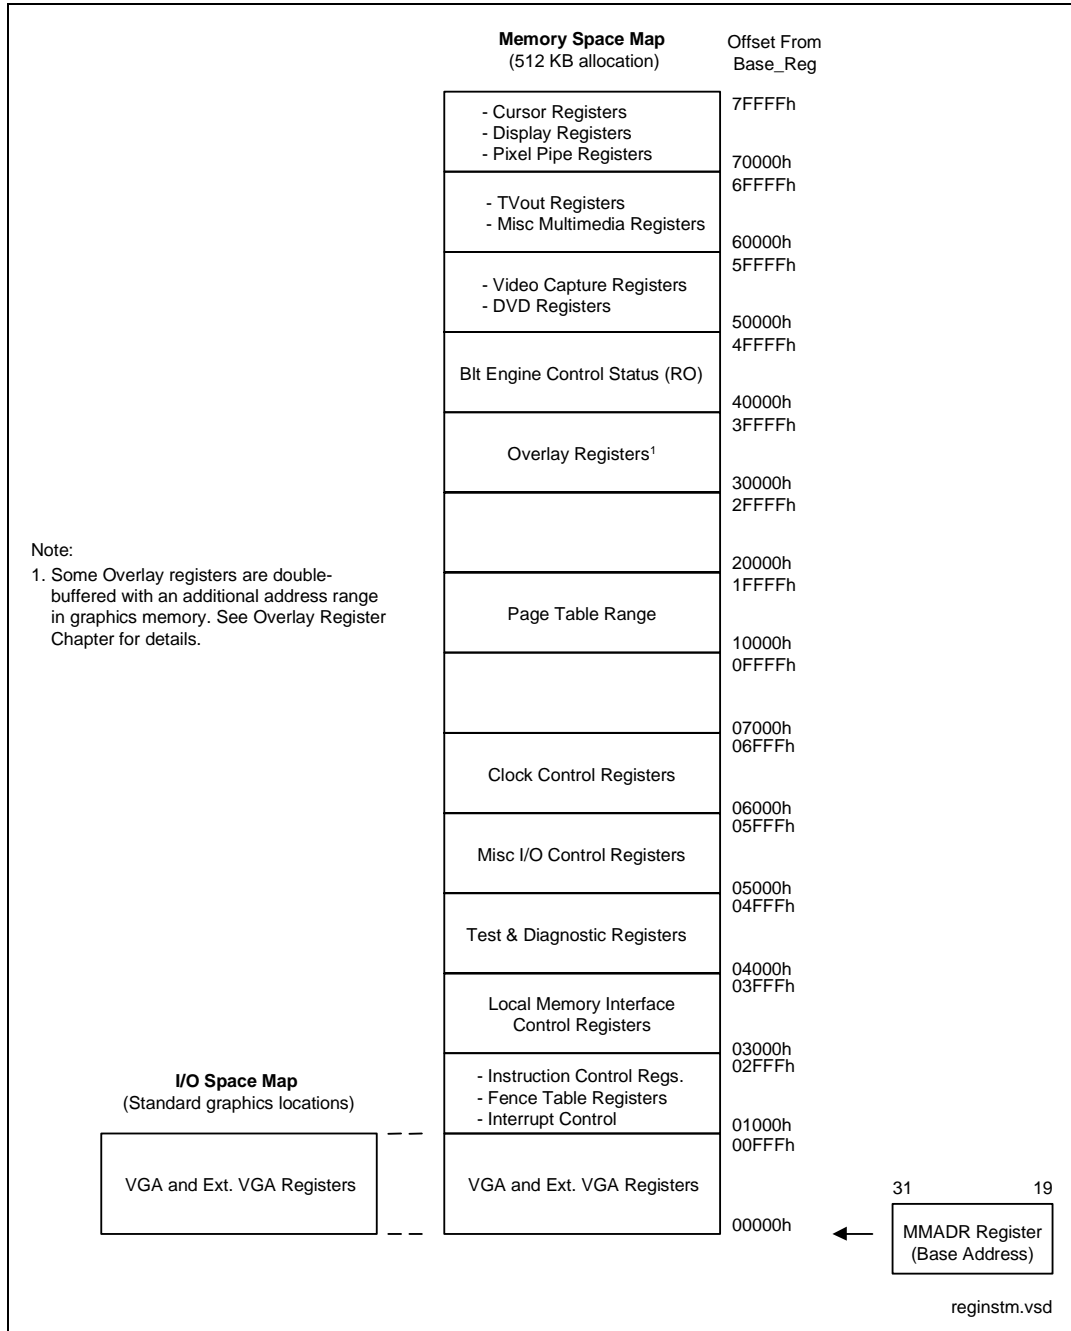
1. Changed: GMCH Graphics Controller Register Memory

Figure 6 (*GMCH Graphics Register Memory Address Space*), Section 4.1.1.2, Extended Memory Area, is replaced with the figure below.
