21154 PCI-to-PCI Bridge

Specification Update

July 2004

Order Number: [278295-017](#)

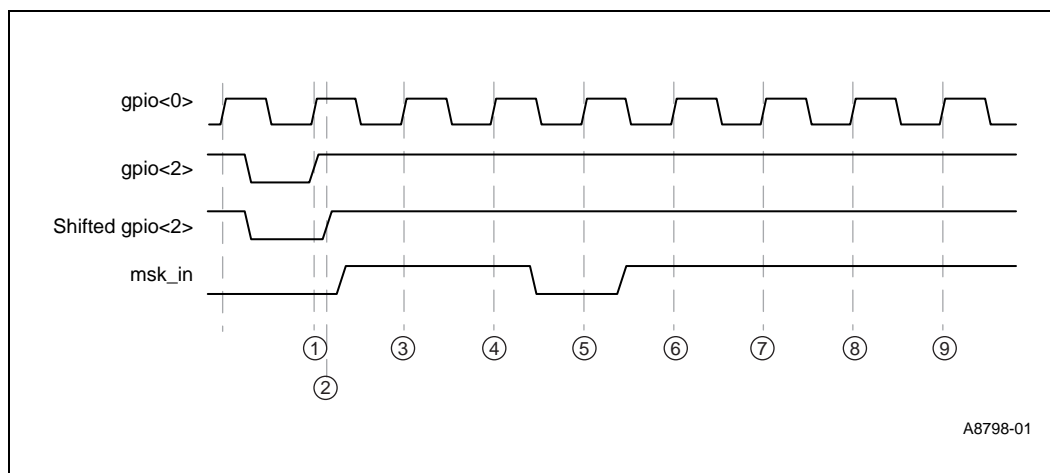
Figure 21. Clock Mask and Load Shift Timing

1. The **gpio<2>** original coming from the 21154 does not provide 3ns setup time needed to provide the parallel load enable **PE#** of the 74F166.
2. The shifted **gpio<2>** is delayed by ~9ns to provide ample setup time to enable the parallel of the shift register connected to pin 15 of the 74F166.
3. Bit 15 input **D6** of the shift register is pulled high, to Vcc.
4. Bit 14 input **D7** is pulled high, to Vcc. These signals are not used internally in the 21154.
5. Bit **13 s_clk_o<9>** is a feedback to the 21154 **s_clk_o** input. To enable **s_clk_o<9>** in all cases the **D5** input of the shift register is grounded, to Vss.
6. Bit 12 **s_clk_o<8>** is disabled.
7. Bit 11 **s_clk_o<7>** is disabled.
8. Bit 10 **s_clk_o<6>** is disabled.
9. Bit 9 **s_clk_o<5>** is disabled.
