# 21154 PCI-to-PCI Bridge

## Specification Update

*July 2004*

Order Number: [278295-017](#)

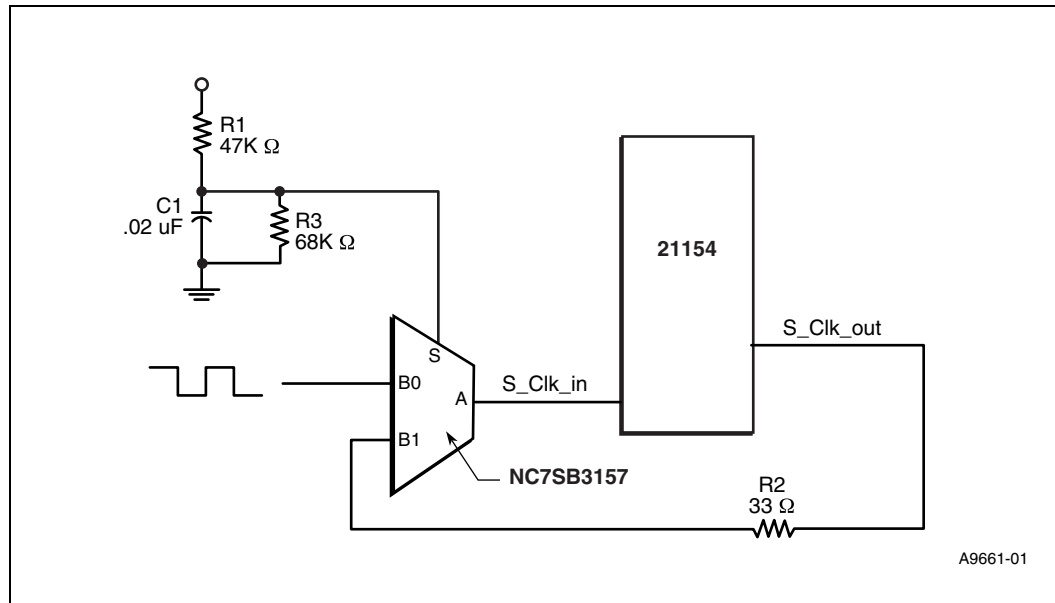
Figure 1. S\_Clock Multiplexer Workaround Circuit for Errata 6.

**Problem:** This problem has been found on the 21154AC and 21154BC. Under repeated and frequent power cycling, the secondary clock circuits may not power up in the proper state, resulting in the device not coming out of reset after power up.

**Implication:** In a system with a 21154AC or 21154BC that has one of its s\_clk\_o<9:0> outputs fed back to provide the s\_clk, it is possible that the s\_clk\_o<9:0> output clocks will be driven and remain low, keeping s\_rst\_l asserted, during system power up.

This happens occasionally when a latch whose output disables the serial shift registers on the Secondary clock control powers up in a high state and the shift register bit corresponding to the s\_clk\_o<9:0> output that is fed back also powers up in the high state.

1. [Figure 1](#) illustrates the first recommendation - a circuit where an on-board pulse source is gated via the B0 input of the multiplexer to the S\_Clock\_in pin of the 21150.

At time 0, the S input of the multiplexer is low, allowing pulses from the on-board pulse source, connected to the B0 input, to be provided to the 21150 S\_Clk input pin. When the time determined by the R/C network is satisfied, the S input pin will be in a logic High state. The multiplexer will then shut off the input pulse from S0 and will direct the S\_Clock\_out pulses via the B1 multiplexer input, into S\_Clock\_in

The values used for the R/C network should be selected to allow a minimum of 2 pulses to be delivered to the 21150 after Vdd has reached 3.0V at a frequency not to exceed the appropriate PCI component. i.e. 30 ns for a 33Mhz bridge. These values should be chosen based on the rise time of the power supply and the frequency of the on board pulse source. The values given for R1, R3, and C1 are for example purposes only.

**Note:** The NC7SB3157 2:1 Multiplexer / Demultiplexer Bus Switch used in this example has a maximum propagation delay of 800ps that should be taken into consideration when matching trace lengths of the clock lines to avoid introducing excessive skew in the clocks. All S\_Clock etch lengths must be matched to within 2ns @ 33Mhz or 1ns @ 66Mhz. The addition of this circuit requires that the etch length for the S\_clock\_in signal be reduced to compensate for the 800ps delay.

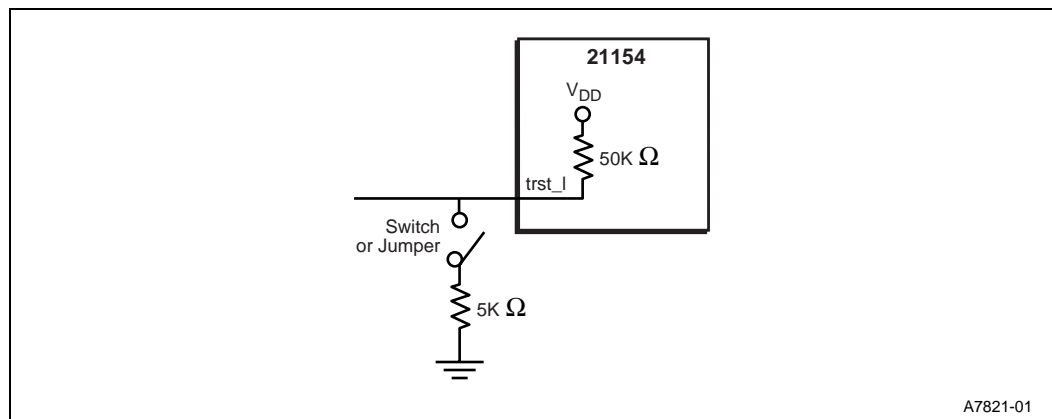
**Figure 6. Removal of Pull-Down Resistor for JTAG Testing**

A 5 K  $\Omega$  pull-down resistor is required on trst\_l for normal PCI-to-PCI bridge operation. However, some JTAG test results may be inconclusive if the 5 K  $\Omega$  resistor remains in the circuit. To obtain accurate JTAG results, Intel recommends one of the following solutions:

- Verify that the JTAG test equipment, after driving trst\_l low to reset the TAP controller, constantly drives trst\_l high during JTAG tests. If this signal is not constantly driven high, the 5 K  $\Omega$  resistor will pull the signal to a low state.
- Remove the 5 K  $\Omega$  resistor during JTAG tests. This resistor must be installed during normal PCI-to-PCI bridge operation.
- Design external circuits with a switch or jumper to isolate the 5 K  $\Omega$  resistor during JTAG tests (see Figure 6). This switch must enable the resistor during normal PCI-to-PCI bridge operation.

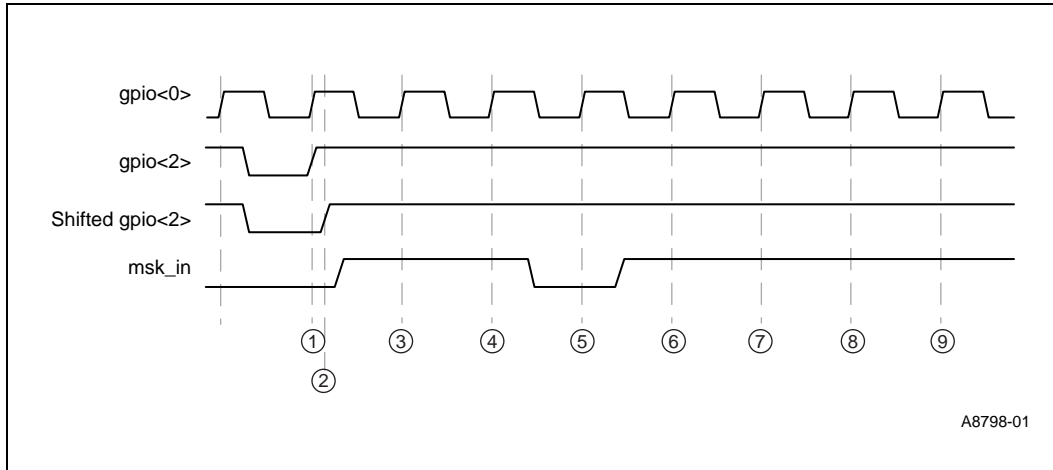
**Figure 21. Clock Mask and Load Shift Timing**

1. The **gpio<2>** original coming from the 21154 does not provide 3ns setup time needed to provide the parallel load enable **PE#** of the 74F166.
2. The shifted **gpio<2>** is delayed by ~9ns to provide ample setup time to enable the parallel of the shift register connected to pin 15 of the 74F166.
3. Bit 15 input **D6** of the shift register is pulled high, to Vcc.
4. Bit 14 input **D7** is pulled high, to Vcc. These signals are not used internally in the 21154.
5. Bit **13 s\_clk\_o<9>** is a feedback to the 21154 **s\_clk\_o** input. To enable **s\_clk\_o<9>** in all cases the **D5** input of the shift register is grounded, to Vss.
6. Bit 12 **s\_clk\_o<8>** is disabled.
7. Bit 11 **s\_clk\_o<7>** is disabled.
8. Bit 10 **s\_clk\_o<6>** is disabled.
9. Bit 9 **s\_clk\_o<5>** is disabled.

**Workaround:** In order to provide an appropriate setup time, a buffer must be added to delay **gpio<2>** with respect to **gpio<0>**. This buffer (or buffers) provides the delay for **gpio<2>** to correctly load the parallel data inputs of 74F166 registers. A setup time of at least 3ns is required at the shift register for **PE#** to load.
