Active T89C51AC2, AT89C51AC2 Errata List

80C51 MCUs

AT89C51AC2
T89C51AC2

Errata Sheet

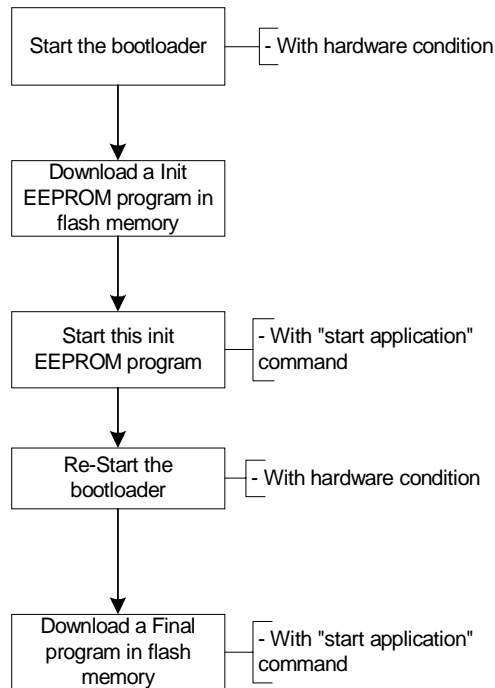
13. EEPROM – Lock-up during ISP write.

Program lock-up can be experienced when using Atmel FLIP software or a custom In system Programming tools to write in the internal EEPROM. This problem occurs with clock frequency > 12MHz in X2 mode or 24MHz in X1 mode. Neither the code Flash nor the EEPROM are corrupted by the lock-up. Although the EEPROM cannot be written by the bootloader.

This problem is bootloader related and doesn't affect the capability for the user to read and write into the EEPROM. This problem is technology dependant. The likelihood of experiencing the problem is low at Clock frequency > 24 MHz in X1 mode and null below. A reset can be applied to recover from the lock-up.

Workaround

The following process can be done to work around the problem.

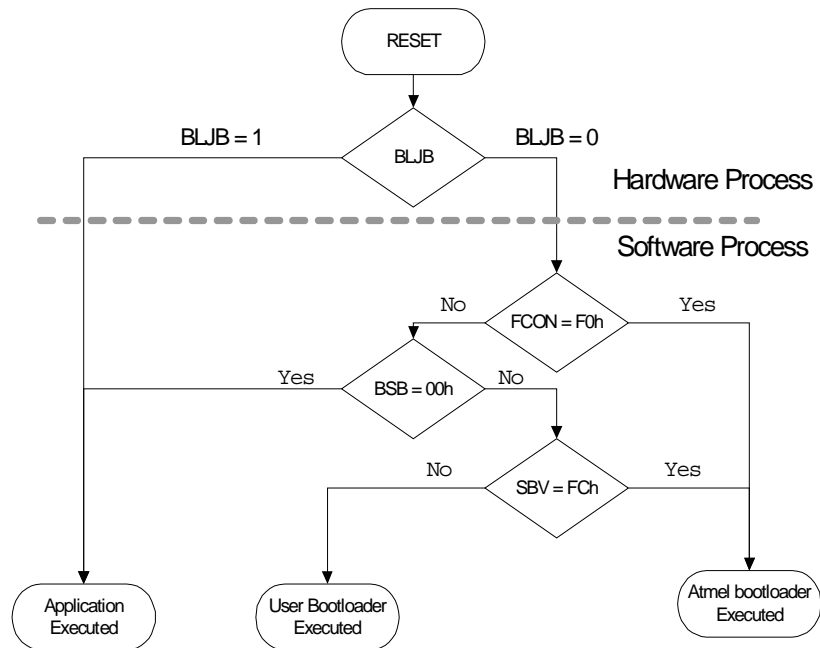
Version 1.2:

4. Boot Process Compatibility

There are some differences between Boot process of bootloader 1.2 and newer versions.

Workaround

Use the fuse bit BLJB to start the application on both versions.
