CAN Microcontrollers

T89C51CC01
T89C51CC01UA
T89C51CC01CA

Errata Sheet

4131J-CAN-05/06

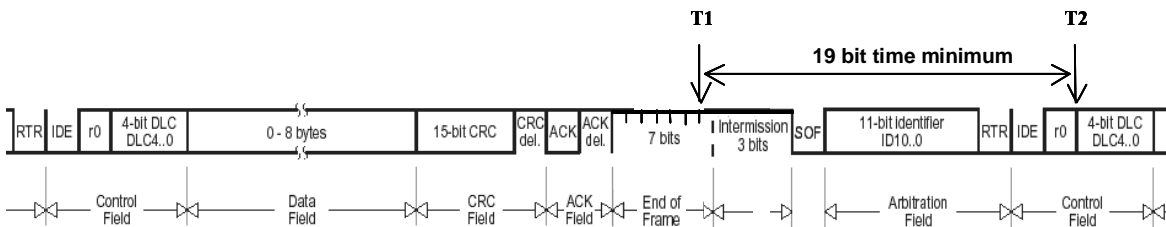
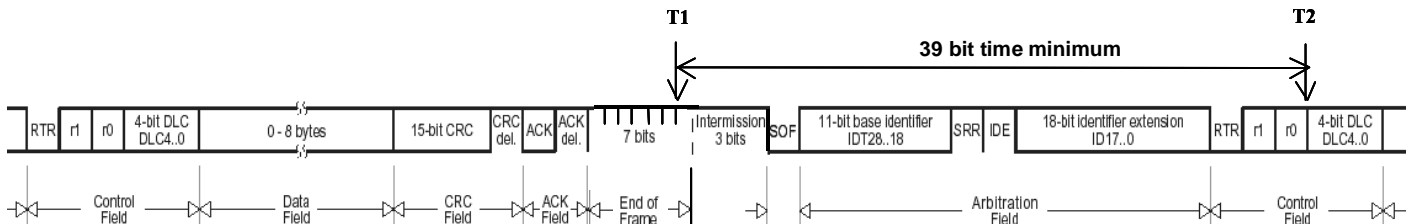
17. Transmission after a 3 bit Intermessage

If a Transmit Message Object (MOB) is enabled while the CAN bus is busy with an on going message, the transmitter will wait for the 3-bit Intermission before starting its transmission. This is in full agreement with the CAN recommendation.

If the transmitter lost arbitration against another node, two conditions can occur :

1. At least one Receive MOB of the chip are programmed to accept the incoming message. In this case, the transmitter will wait for the next 3-bit Intermission to retry its transmission.
2. No Receive MOB of the chip are programmed to accept the incoming message. In this case the transmitter will wait for a 4-bit Intermission to retry its transmission. In this case, any other CAN nodes ready to transmit after a 3-bit Intermission will start transmit before the chip transmitter, even if their messages have lower priority IDs.

Workaround

Always have a Receive MOB enabled ready to accept any incoming messages. Thanks to the implementation of the CAN interface, a Receive MOB must be enable at latest, before the 1st bit of the DLC field. The Receive MOB status register is written (RXOK if message OK) immediately after the 6th bit of the End of Frame field. This will leave in CAN2.0A mode a minimum 19-bit time delay to respond to the end of message interrupt (RXOK) and re-enable the Receive MOB before the start of the DLC field of the next incoming message. This minimum delay will be 39-bit time in CAN2.0B. See CAN2.0A CAN2.0B frame timings below.

The workaround is to have the last MOB (MOB14) as "spy" enabled all the time; it is the MOB of lowest priority : If a Mob other than MOB14 is programmed in receive mode and its acceptance filter matches with the incoming message ID, this Mob will take the message. MOB14 will only take messages than no other MOBs will have accepted. MOB14 will need to be re-enabled fast enough to manage back to back frames. The deadline to do this is the beginning of DLC slot of incoming frames as explained above.

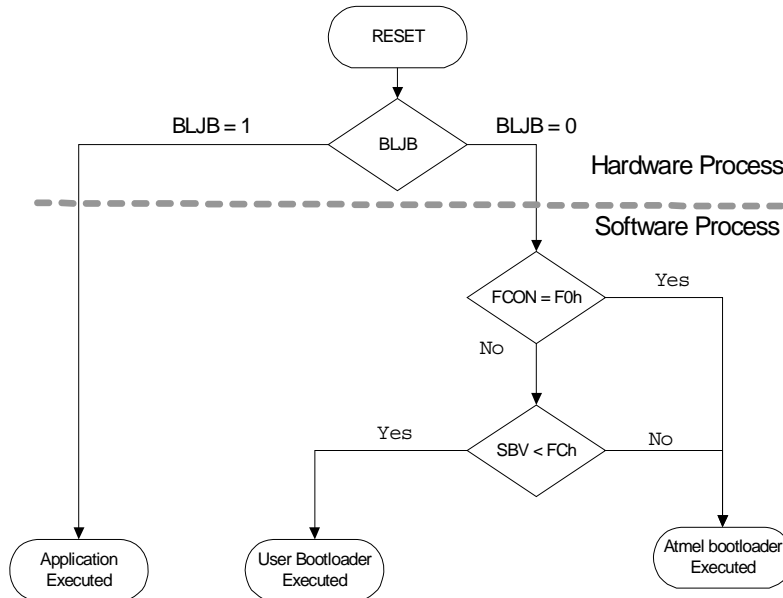
4. Boot Process Compatibility

There are some differences between Boot process of bootloader 1.2 and newer versions (see below).

Workaround

Use the fuse bit BLJB to start the application in both versions.
