## CAN Microcontrollers

**T89C51CC02**  
**T89C51CC02UA**  
**T89C51CC02CA**

## Errata Sheet

4160F-CAN-05/06

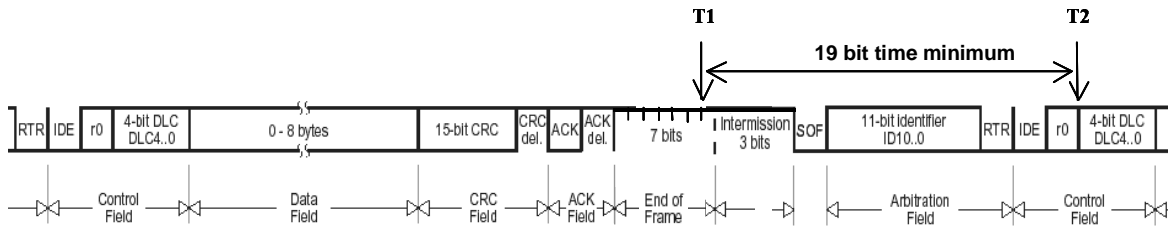
## CAN2.0A

If a Transmit Message Object (MOB) is enabled while the CAN bus is busy with an on going message, the transmitter will wait for the 3-bit Intermission before starting its transmission. This is in full agreement with the CAN recommendation.

If the transmitter lost arbitration against another node, two conditions can occur :

1. At least one Receive MOB of the chip are programmed to accept the incoming message. In this case, the transmitter will wait for the next 3-bit Intermission to retry its transmission.
2. No Receive MOB of the chip are programmed to accept the incoming message. In this case the transmitter will wait for a 4-bit Intermission to retry its transmission. In this case, any other CAN nodes ready to transmit after a 3-bit Intermission will start transmit before the chip transmitter, even if their messages have lower priority IDs.

Always have a Receive MOB enabled ready to accept any incoming messages. Thanks to the implementation of the CAN interface, a Receive MOB must be enable at latest, before the 1<sup>st</sup> bit of the DLC field. The Receive MOB status register is written (RXOK if message OK) immediately after the 6<sup>th</sup>-bit of the End Of Frame Field. This will leave in CAN2.0A mode a minimum 19-bit time delay to respond to the end of message interrupt (RXOK) and re-enable the Receive MOB before the start of the DLC field of the next incoming message. This minimum delay will be 39-bit time in CAN2.0B. See CAN2.0A CAN2.0B frame timings below.
