## CAN Microcontrollers

**AT89C51CC03**  
**AT89C51CC03C**  
**AT89C51CC03U**

## Errata Sheet

4293G-CAN-06/05

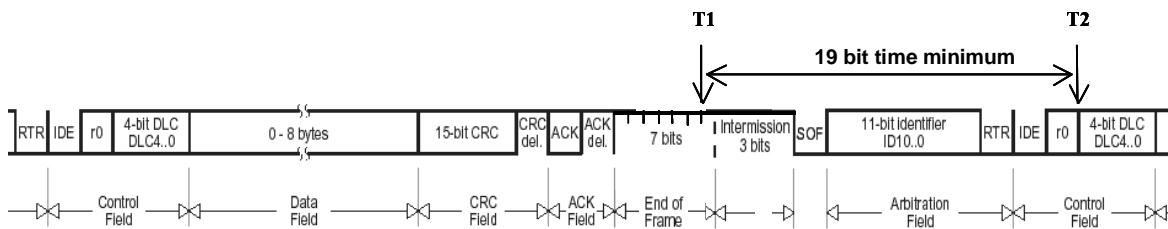
#### CAN2.0A

1. At least one Receive MOB of the chip are programmed to accept the incoming message. In this case, the transmitter will wait for the next 3-bit Intermission to retry its transmission.
2. No Receive MOB of the chip are programmed to accept the incoming message. In this case the transmitter will wait for a 4-bit Intermission to retry its transmission. In this case, any other CAN nodes ready to transmit after a 3-bit Intermission will start transmit before the chip transmitter, even if their messages have lower priority IDs.

Always have a Receive MOB enabled ready to accept any incoming messages. Thanks to the implementation of the CAN interface, a Receive MOB must be enable at latest, before the 1<sup>st</sup> bit of the DLC field. The Receive MOB status register is written (RXOK if message OK) immediately after the 6th bit of the End of Frame field. This will leave in CAN2.0A mode a minimum 19-bit time delay to respond to the end of message interrupt (RXOK) and re-enable the Receive MOB before the start of the DLC field of the next incoming message. This minimum delay will be 39-bit time in CAN2.0B. See CAN2.0A CAN2.0B frame timings below.
