## Errata Sheet V1.0

AT91  
ARM<sup>®</sup> Thumb<sup>®</sup>  
Microcontrollers

AT91M42800A  
Errata Sheet  
V1.0

Rev. 1782B-01/02

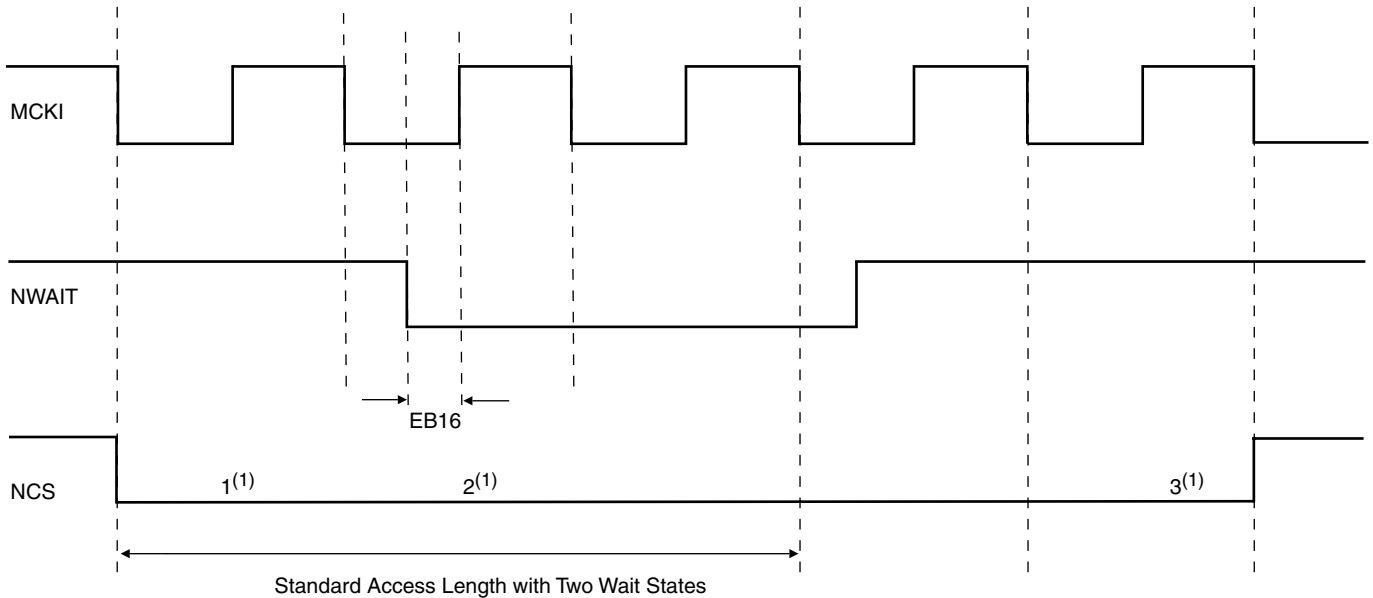
**Figure 2. Number of Standard Wait States is Two**

If the NWAIT setup time is satisfied on the following edges of MCKI and if at least one standard wait state remains to be executed, the behavior is accurate. In the following example, the number of standard wait states is two. The NWAIT setup time on the second rising edge of MCKI must be met.

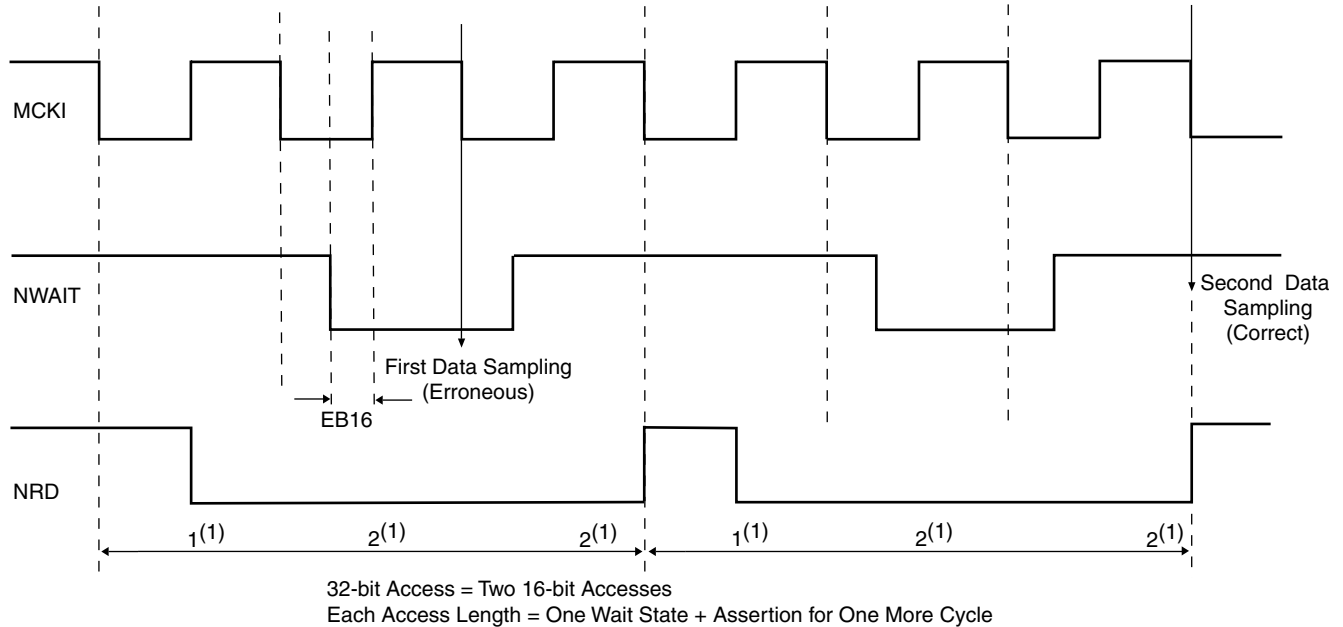
**Figure 3.** Number of Standard Wait States is One

If the first two conditions are not met during a 32-bit read access, the first 16-bit data is read at the end of the standard 16-bit read access. In the following example, the number of standard waits is one. NWAIT assertions do affect both NRD pulse lengths, but first data sampling is not delayed. The second data sampling is correct.

At maximum speed, asserting the NWAIT in the first access cycle is not possible, as the sum of the timings “MCKI Falling to Chip Select” and “NWAIT setup to MCKI rising” are generally higher than one half of a clock period. This leads to using at least one standard wait state. However, this is not sufficient except to perform byte or half-word read accesses. Word and write accesses require at least two standard wait states.

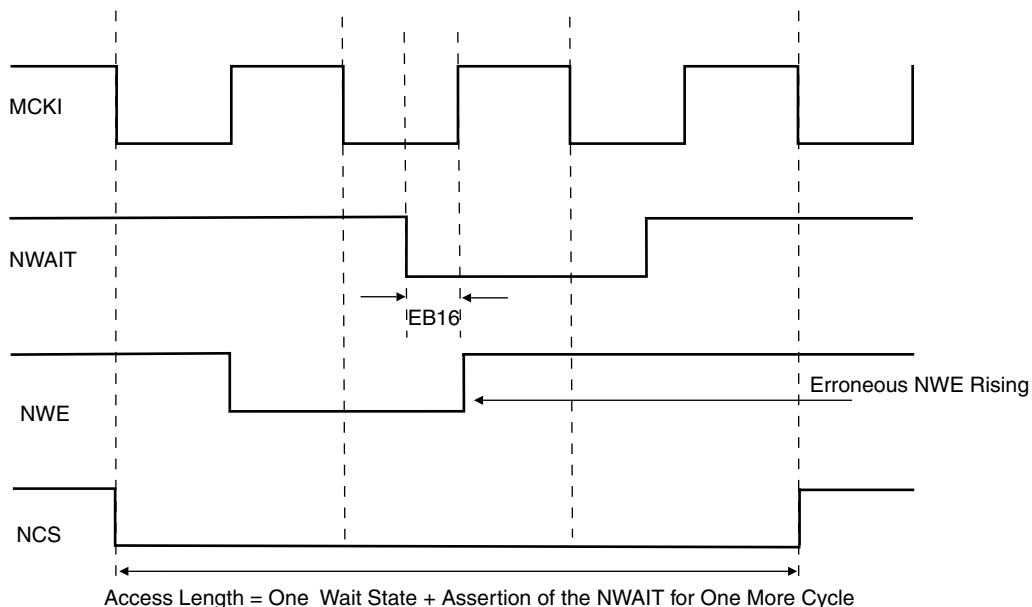
**Figure 4.** Description of the Number of Standard Wait States

If the first two conditions are not met during write accesses, the NWE signal is not affected by the NWAIT assertion. The following example illustrates the number of standard wait states. NWAIT is not asserted during the first cycle, but is asserted at the second and last cycle of the standard access. The access is correctly delayed as the NCS line rises accordingly to the NWAIT assertion. However, the NWE signal waveform is unchanged, and rises too early.
