January 7, 2011

PSoC[®] 3: CY8C34 Family Errata Silicon Revision ES2 (Datasheet Document Number: 001-53304 Rev. *H)

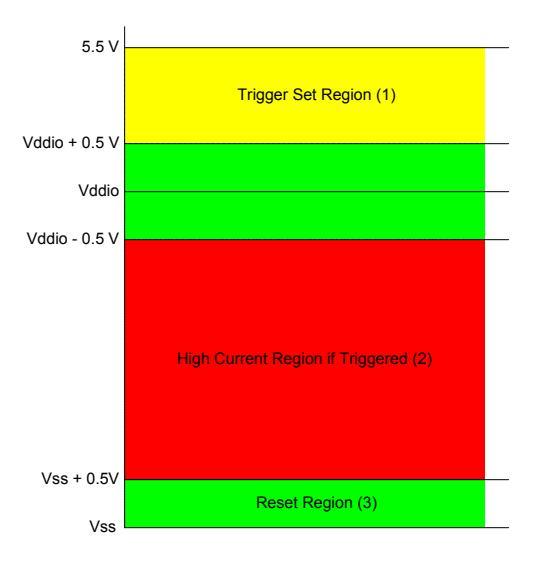
If an SIO pin's voltage exceeds its Vddio supply by 0.5 V, the trigger condition is set (region 1). After the trigger condition is set, the SIO pin causes increased current when its voltage is between Vss + 0.5 V and Vddio – 0.5 V (region 2). The trigger condition is reset when the SIO pin is brought within the range of Vss to Vss + 0.5 V (region 3). The trigger condition may unknowningly be met during device powerup due to differences in supply ramps.

Up to 1 mA of additional current per SIO is possible on the SIO pin's Vddio supply when in the high current region after the trigger condition is met. No additional Vddio current will occur when not in the high current region even if the trigger condition is met. No other features of the SIO pin are impacted.

- 1. If trigger condition cannot occur based on system design then no action is required
- 2. If trigger condition can occur in the system:
 - a) If increased Vddio current is acceptable no action is required

- b) If the SIO pin is used as a digital input or output that will only quickly transition through the high current region, then no action is required. Higher current is seen during the brief transition period through the high current region from high to low logic levels if the trigger condition is met

- c) If the SIO pin must operate in the high current region after the trigger condition is met, no direct workaround is available and increased current is seen. If the SIO can be brought back between Vss and Vss+0.5 V, the trigger condition can be reset until the pin retriggers the condition. The SIO can be brought back to Vss by setting the pin to a low logic level by using API, DMA, or hardware. This will minimize the duration of the extra Vddio current
