PIC18F87J90 FAMILY

PIC18F87J90 Family
Silicon Errata and Data Sheet Clarification

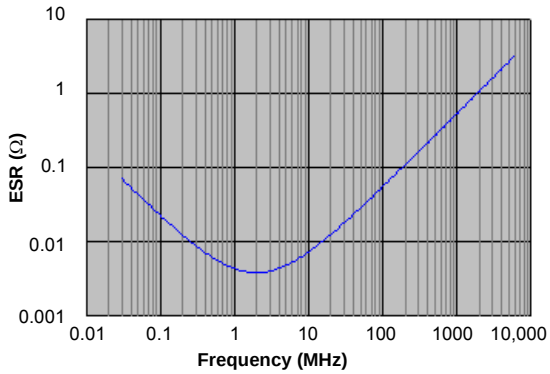
FIGURE 2-3 FREQUENCY vs. ESR PERFORMANCE FOR SUGGESTED VCAP

When the regulator is enabled, a low-ESR (< 5Ω) capacitor is required on the VCAP/VDDCORE pin to stabilize the voltage regulator output voltage. The VCAP/VDDCORE pin must not be connected to VDD and must use a capacitor of 10 µF connected to ground. The capacitor type can be ceramic or tantalum. Suitable examples of capacitors are shown in Table 2-1. Capacitors with equivalent specifications can be used.

Designers may use Figure 2-3 to evaluate ESR equivalence of candidate devices.

Note: Typical data measurement at 25°C, 0V DC bias.

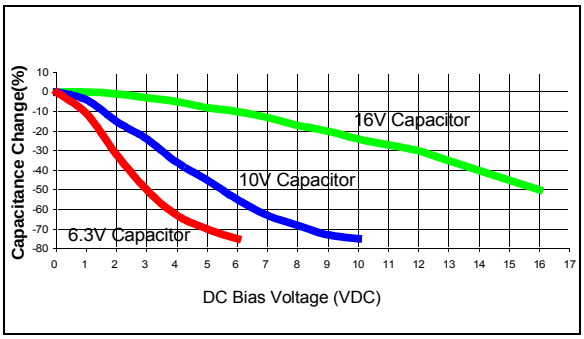
FIGURE 2-4 DC BIAS VOLTAGE vs. CAPACITANCE CHARACTERISTICS

In addition to temperature tolerance, the effective capacitance of large value ceramic capacitors can vary substantially, based on the amount of DC voltage applied to the capacitor. This effect can be very significant, but is often overlooked or is not always documented.

Typical DC bias voltage vs. capacitance graph for X7R type and Y5V type capacitors is shown in Figure 2-4.

When selecting a ceramic capacitor to be used with the internal voltage regulator, it is suggested to select a high-voltage rating, so that the operating voltage is a small percentage of the maximum rated capacitor voltage. For example, choose a ceramic capacitor rated at 16V for the 2.5V core voltage. Suggested capacitors are shown in Table 2-1.
