Errata Sheet V1.0

AT91
ARM® Thumb®
Microcontrollers

AT91M55800A
Errata Sheet
V1.0

Rev. 1780B–01/02

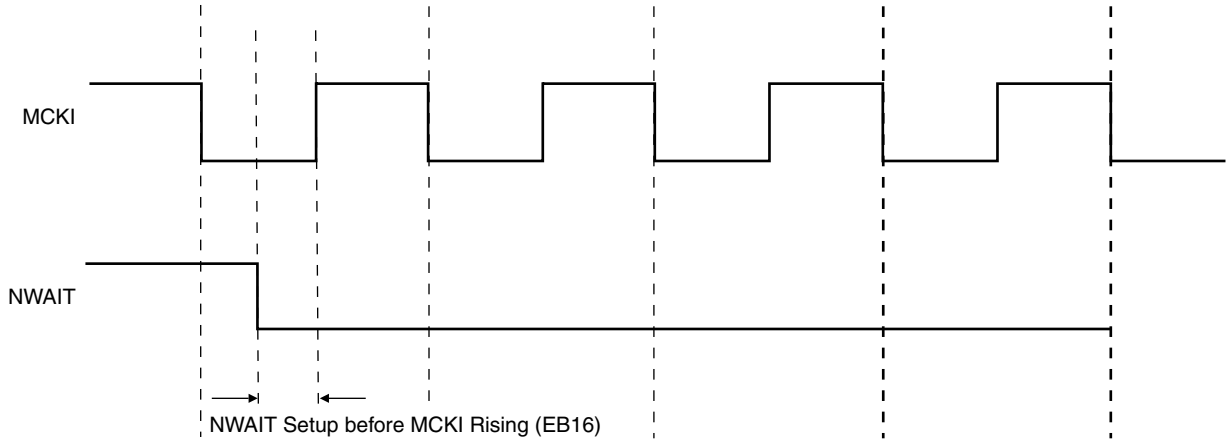
Figure 1. NWAIT Rising

If the NWAIT setup time is satisfied on the first rising edge of MCKI, the behavior is accurate. The EBI operations are not affected when the NWAIT rises.

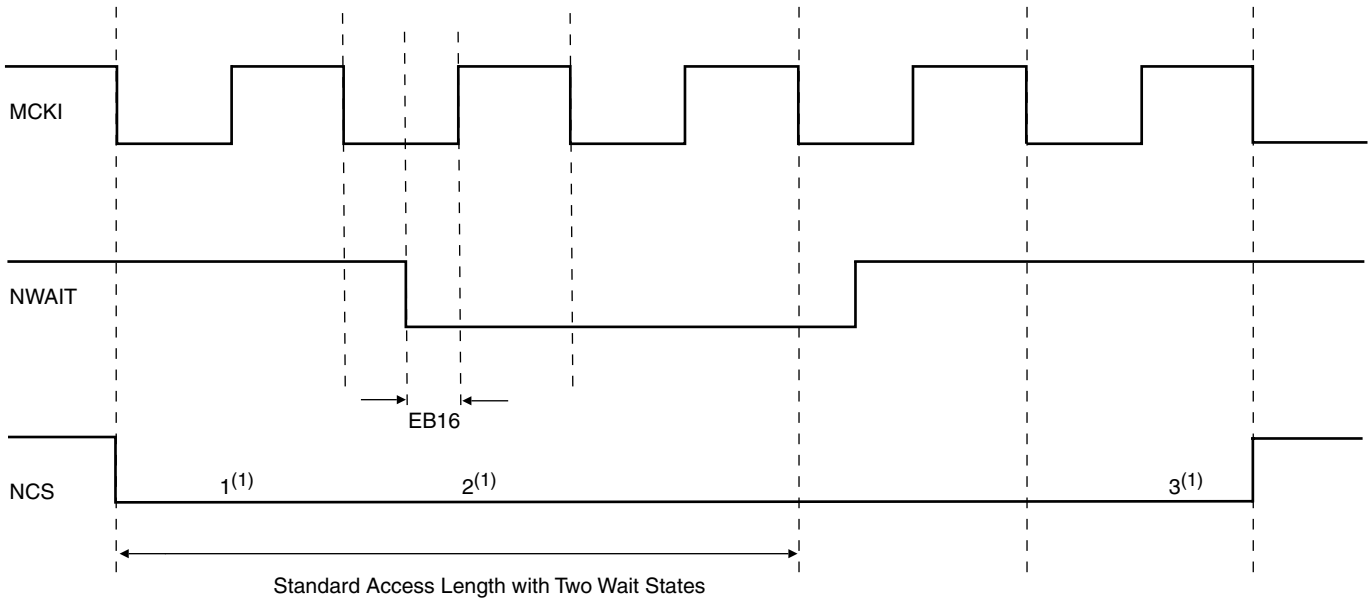
Figure 2. Number of Standard Wait States is Two

If the NWAIT setup time is satisfied on the following edges of MCKI and if at least one standard wait state remains to be executed, the behavior is accurate. In the following example, the number of standard wait states is two. The NWAIT setup time on the second rising edge of MCKI must be met.

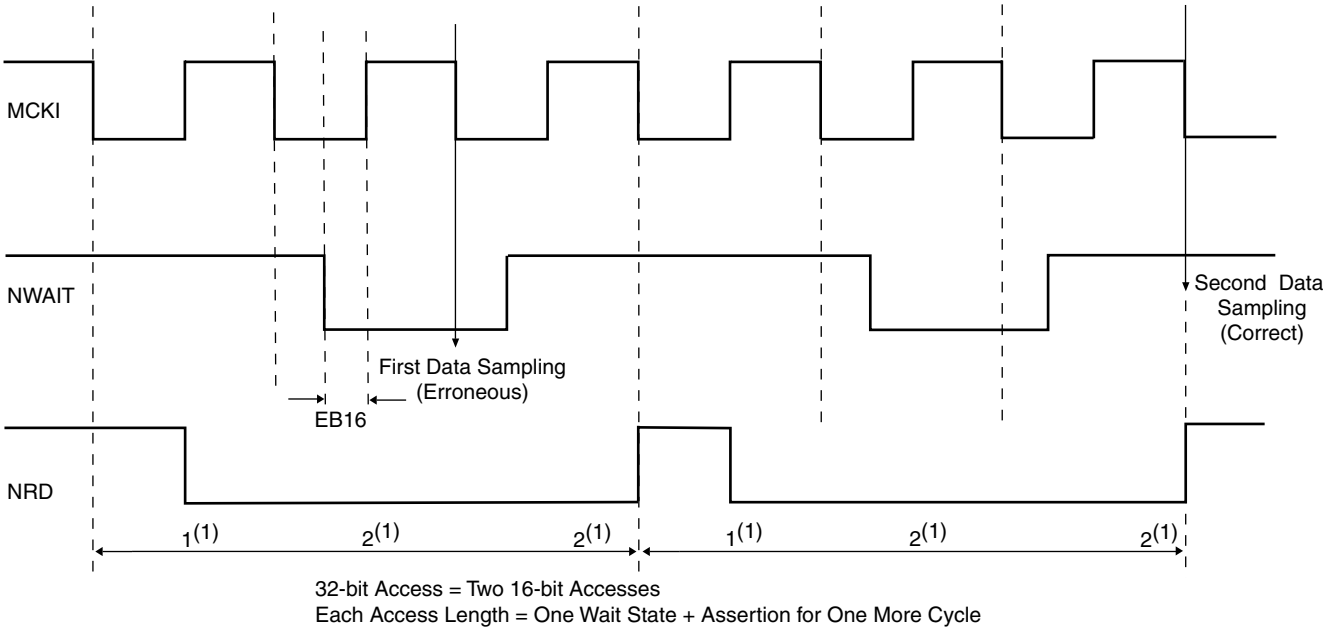
Figure 3. Number of Standard Wait States is One

– 32-bit read accesses are not managed correctly and the first 16-bit data sampling takes into account only the standard wait states. 16- and 8-bit accesses are not affected.

If the first two conditions are not met during a 32-bit read access, the first 16-bit data is read at the end of the standard 16-bit read access. In the following example, the number of standard waits is one. NWAIT assertions do affect both NRD pulse lengths, but first data sampling is not delayed. The second data sampling is correct.

At maximum speed, asserting the NWAIT in the first access cycle is not possible, as the sum of the timings “MCKI Falling to Chip Select” and “NWAIT setup to MCKI rising” are generally higher than one half of a clock period. This leads to using at least one standard wait state. However, this is not sufficient except to perform byte or half-word read accesses. Word and write accesses require at least two standard wait states.

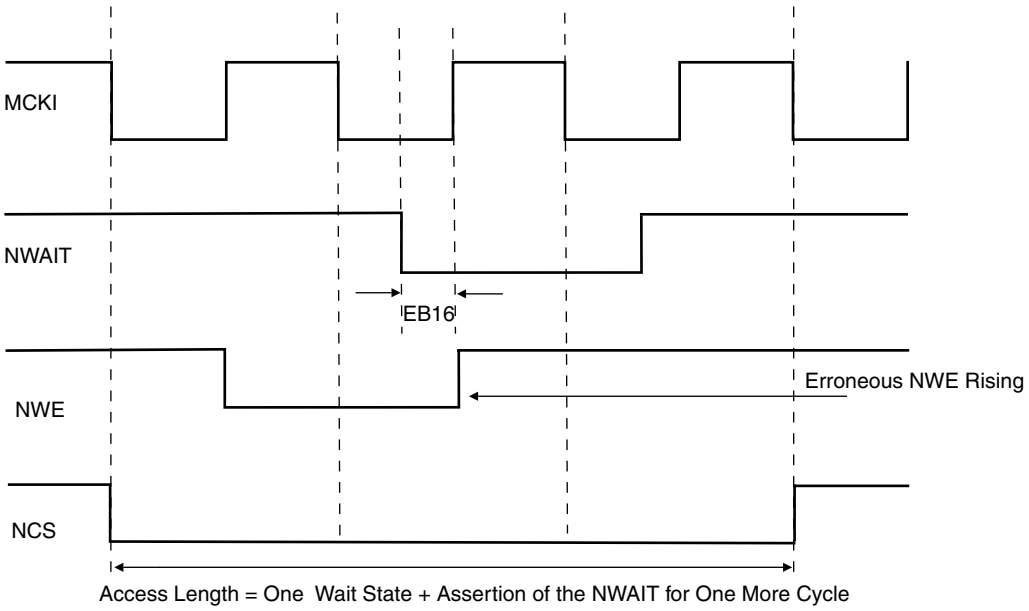
Figure 4. Description of the Number of Standard Wait States

– During write accesses of any type, the NWE rises on the rising edge of the last cycle as defined by the programmed number of wait states. However, NWAIT assertion does affect the length of the total access. Only the NWE pulse length is inaccurate.

If the first two conditions are not met during write accesses, the NWE signal is not affected by the NWAIT assertion. The following example illustrates the number of standard wait states. NWAIT is not asserted during the first cycle, but is asserted at the second and last cycle of the standard access. The access is correctly delayed as the NCS line rises accordingly to the NWAIT assertion. However, the NWE signal waveform is unchanged, and rises too early.
