21154 PCI-to-PCI Bridge

Specification Update

July 2004

Order Number: [278295-017](#)

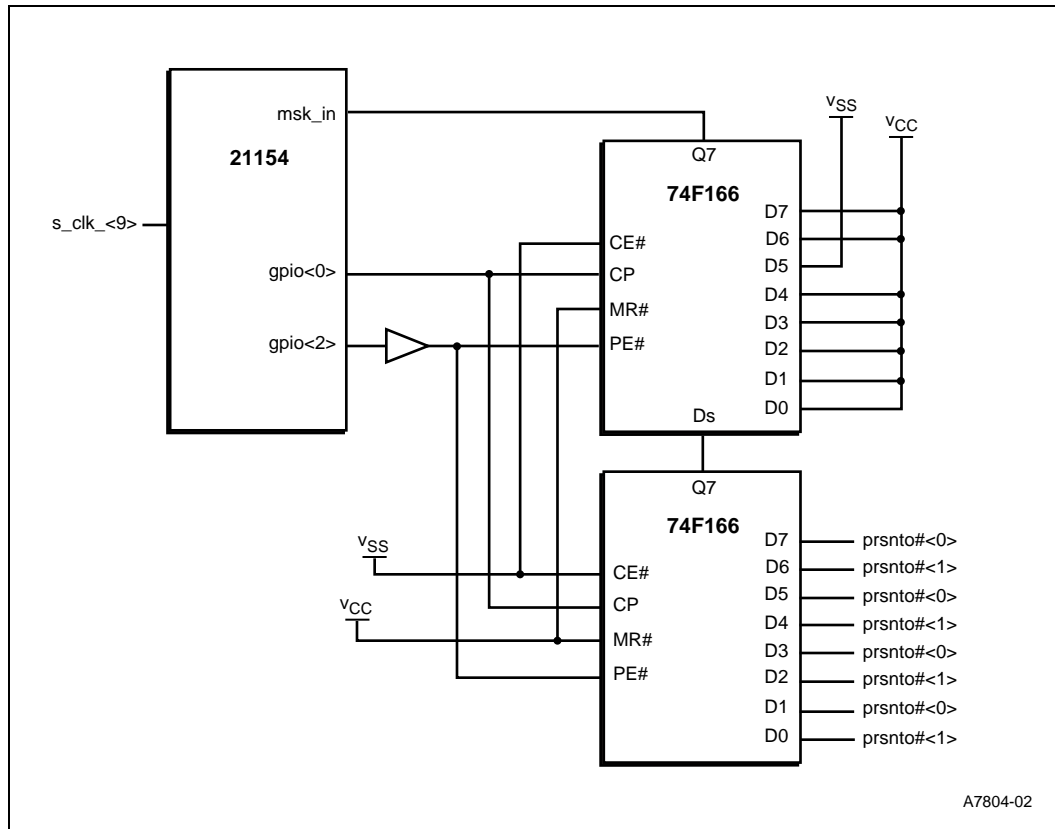
Figure 19 Example of GPIO Clock Mask Implementation on the System Board

12. Section 10.2, Secondary Clock Control, Figure 19

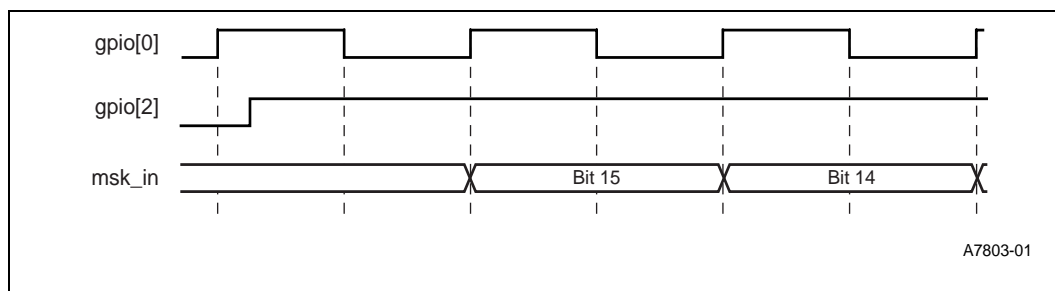
Figure 20. Clock Mask and Load Shift Timing

13. Section 10.2, Secondary Clock Control, Figure 20
